QUASI-STATIC OUT-OF-PLANE TESTING OF CLT AND NLT PANELS

Edwin Nagy, Ph.D., P.E.¹ Mark K. Weaver, S.E.²

December 21, 2016

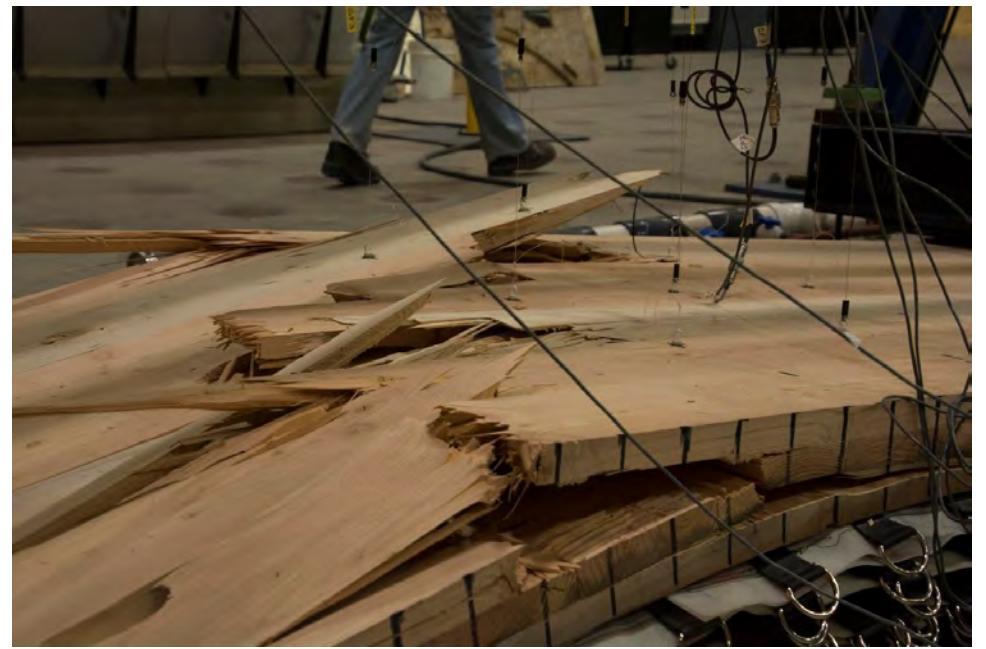
Typically, one or more SP would detach during the initial violent failure, occasionally more would come off in subsequent failures, and eventually, in general, the remaining 10-inch SP would reach the end of their stroke. Testing was typically complete within ten minutes. Figure 3-10 shows a typical 3-ply CLT panel near the end of its test.

Figure 3-10. Photo of Typical 3-ply CLT Panel at End of Test.

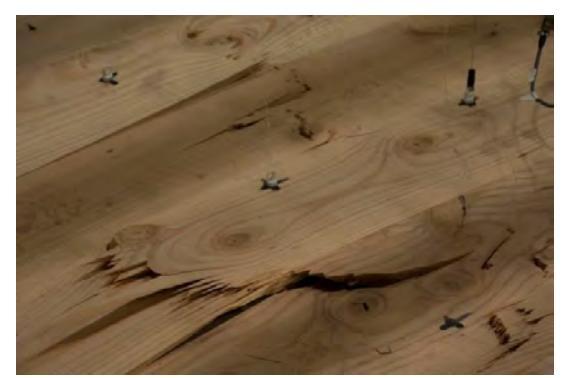
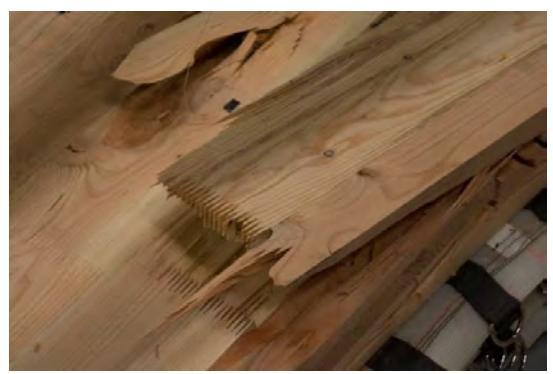
Figure 4-1. Typical Panel Failure Locations.

Table 4-1 records the observed limit state and the peak panel strength for each test. With one notable exception, all CLT panels without connections (i.e., "simple" test setup configuration) failed near panel mid-span, presumably due to flexural stress. The location of panel rupture typically centered on knots, sloped grain, and finger joints (see Figure 4-1). No shear slip between panel plies away from the location of panel rupture was observed.

(a) Sloped Grain.

(b) Finger Joint.

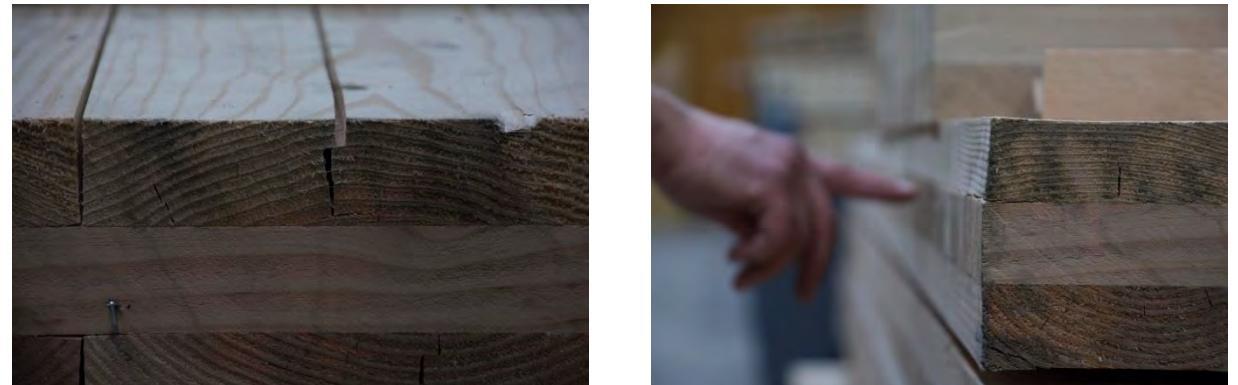
(a) Checking. (b) Bond Failure. Figure 4-3. Localized Deformation in CLT Panels.

- When CLT panels ruptured due to flexure, negligible shear slip between panel plies away from the location of panel rupture was observed.
- As panels dried, significant inter-layer stresses developed leading to checking and some joint failure along the panel edges. The shear failure observed for the final 5-ply test could be related to panel moisture content and the imperfections that resulted, but in the absence of further testing this theory is conjecture.

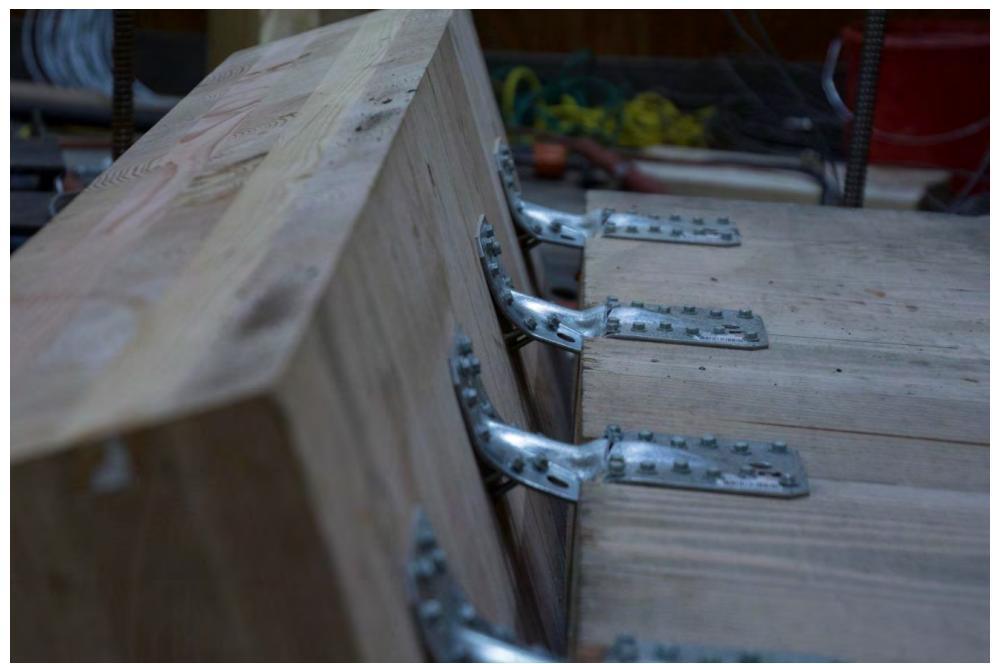
The first test on a panel with connections (i.e., V1CA-1) resulted in one of the end pieces rotating, causing significant angle bracket deformation but minimal panel deformation (see Figure 4-4). Based on this test, modifications were made to the "semi-rigid" test setup configuration to constrain the end pieces. It should be noted that by constraining the end pieces, it is possible that panel arching between supports could occur, thus potentially augmenting the panel strength from a purely simply-supported condition.

Figure 4-4. Deformation of Simpson Bracket in V1-CA1.

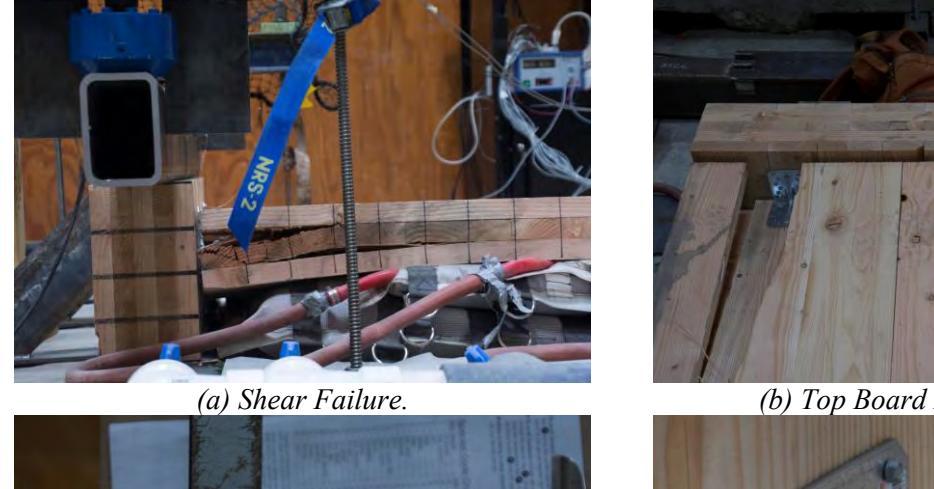
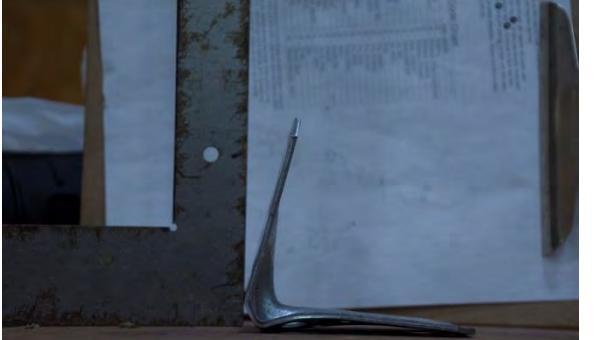
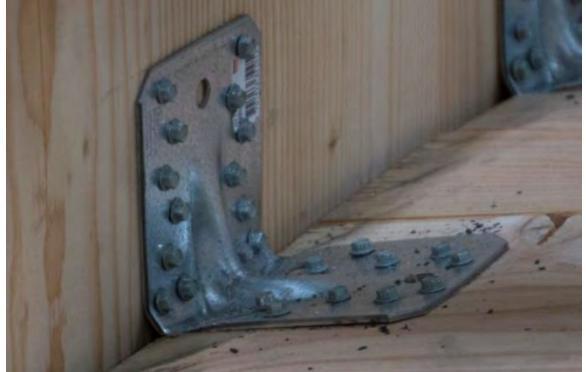
The panels with the Simpson Strong-Tie (SST) angle brackets (i.e., V1CA-2 through V1CA-4) typically exhibited shear failures near one end of the panel (see Figure 4-5(a)). For the test in which four SST brackets were installed at each end (i.e., V1CA-2), the shear failure precipitated a flexural failure near panel mid-span. For the tests in which two and three SST brackets were installed at each end (i.e., V1CA-3 and V1CA-4), top boards not directly supported by angle brackets pulled away from those that were (see Figure 4-5(b)). In general, the SST brackets were capable of deforming significantly while still being able to support their respective loads (see Figure 4-5(c)). Additionally, both a small amount of wood crushing beneath the SST angle brackets and fastener pullout was observed (see Figure 4-5(d)).

(b) Top Board Disengagement.

(c) Bracket Deformation. (d) Wood Crushing & Fastener Pullout. Figure 4-5. Failure Modes Associated with Simpson Brackets.

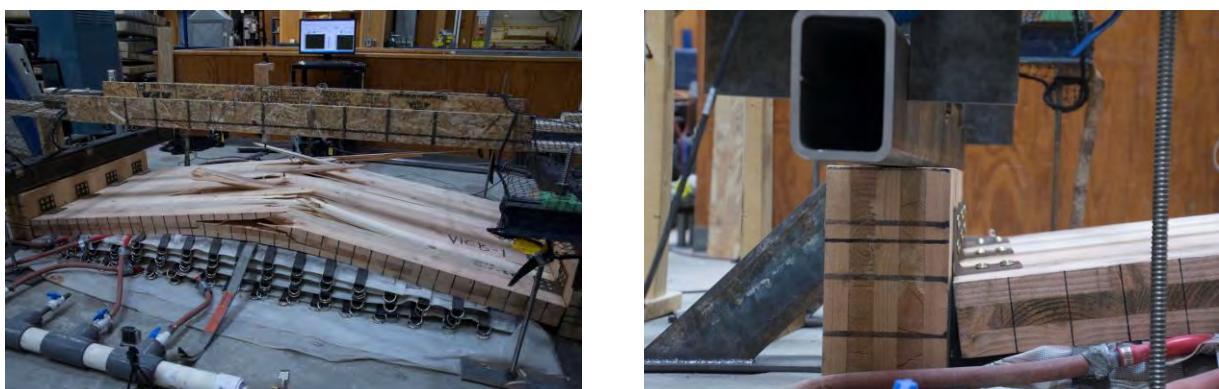
By contrast, the panels with L4x4x1/4 angle brackets typically exhibited a flexural failure response near mid-span (see Figure 4-6(a)) similar to the predominant failure mode observed for panels tested in the "simple" test setup configuration. For the tests in which two brackets were installed at each end (i.e., V1CB-4), a few of the top boards not directly supported by angle brackets pulled away from those that were. As with the SST brackets, the L4x4x1/4 brackets yielded (see Figure 4-6(b)), but unlike the SST brackets, no fastener pullout or wood crushing was observed.

(a) Flexural Failure. (b) Bracket Deformation. Figure 4-6. Failure Modes Associated with L4x4x1/4 Brackets.

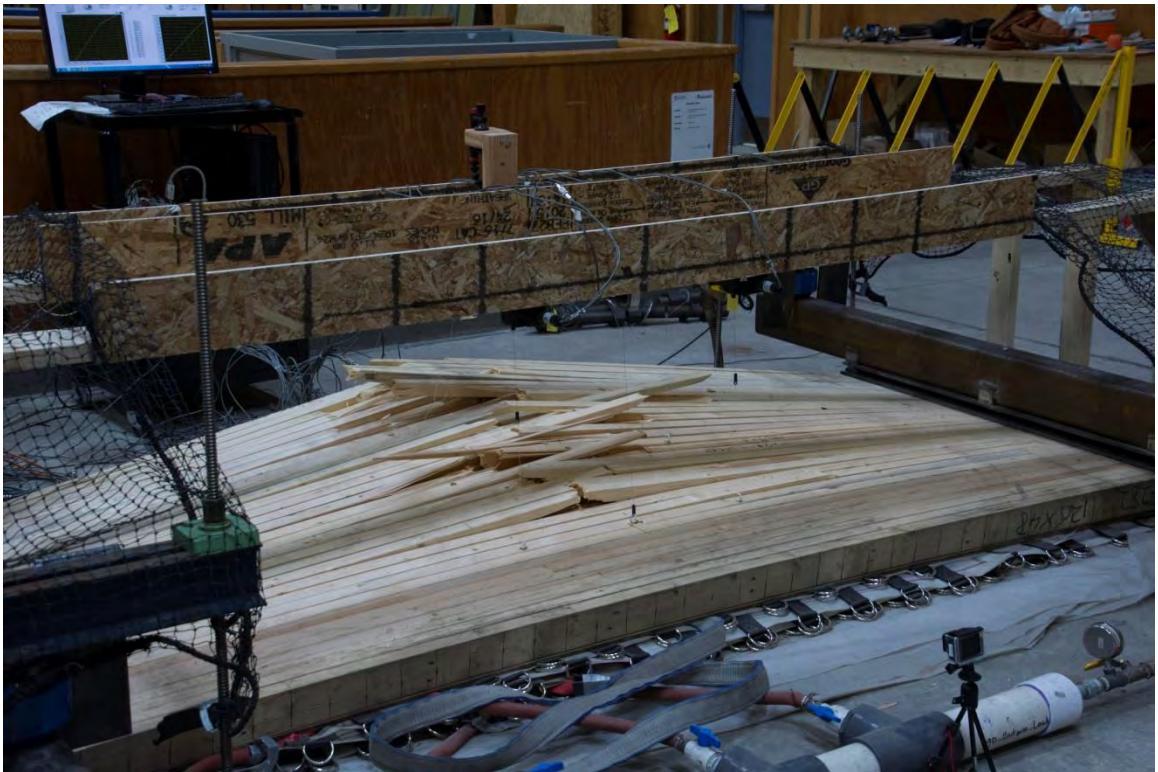
The NLT panels failed in flexure near panel mid-span. Typically, one stud would rupture first and then its neighbors would fail in a zippering fashion. This response led to highly unbalanced panels where one half was nearly intact and showed minimal deflection while the other half would be completely ruptured and have a mid-span deflection upwards of 10 inches. Figure 4-7 shows a typical example of this response.

Figure 4-7. Asymmetric Flexural Failure of NLT Panel.

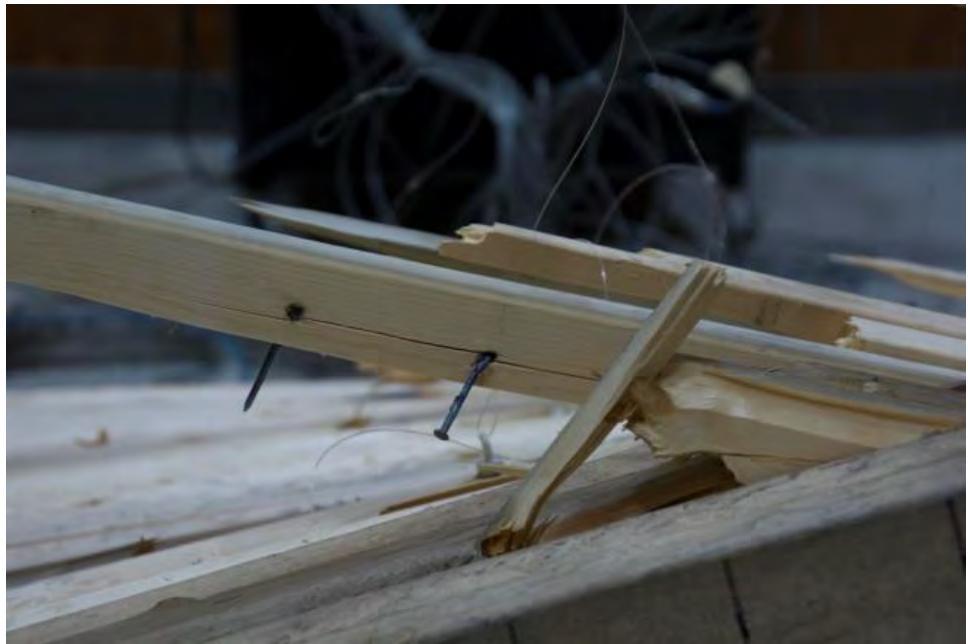
Significant rotation of the boards relative to one another occurred due to the asymmetric deformation. Nail pullout and yielding was observed as well (see Figure 4-8). Prior to failure, panels were uniformly deflected. As some of the boards broke, the others rebounded as the pressure diminished and the water shifted to the failed portions of the panel.

Figure 4-8. Details of NLT Panel Failure.

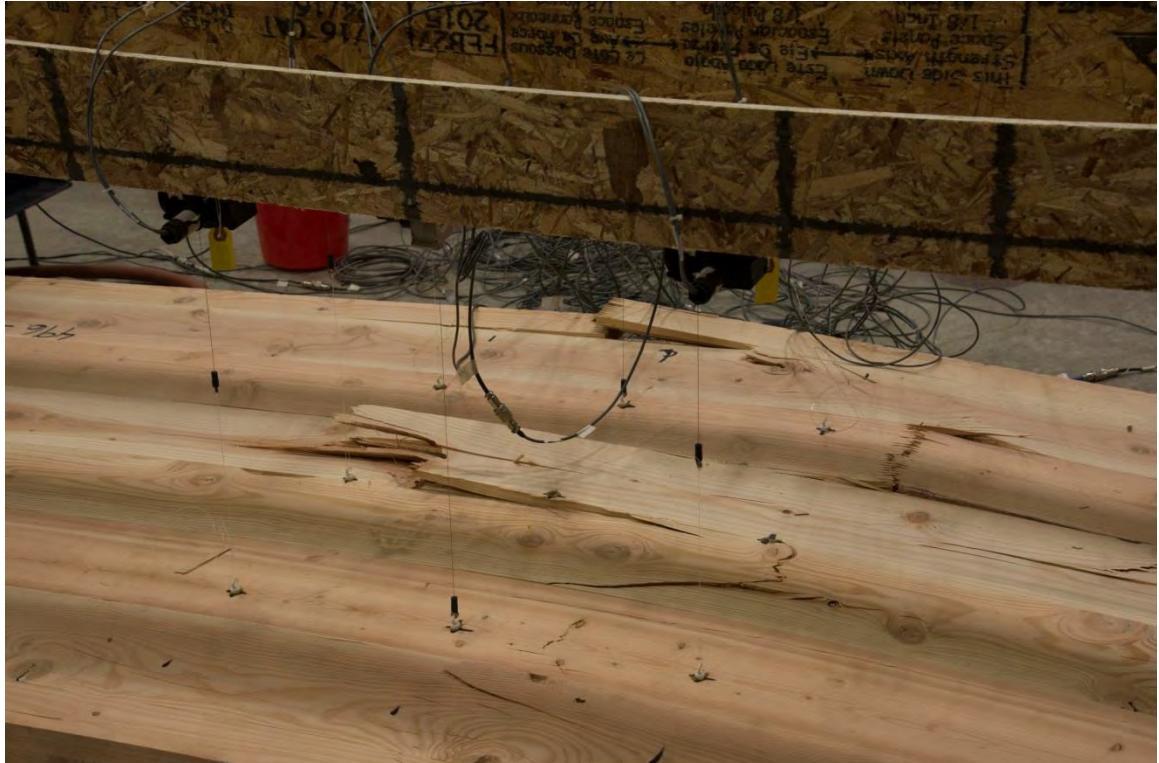
(b) Initiation of failure (looking east). (Note failure at finger joint outside middle two feet.) **Figure A-4. 3-Ply Grade V1 CLT – Test 4 (V1-4).**

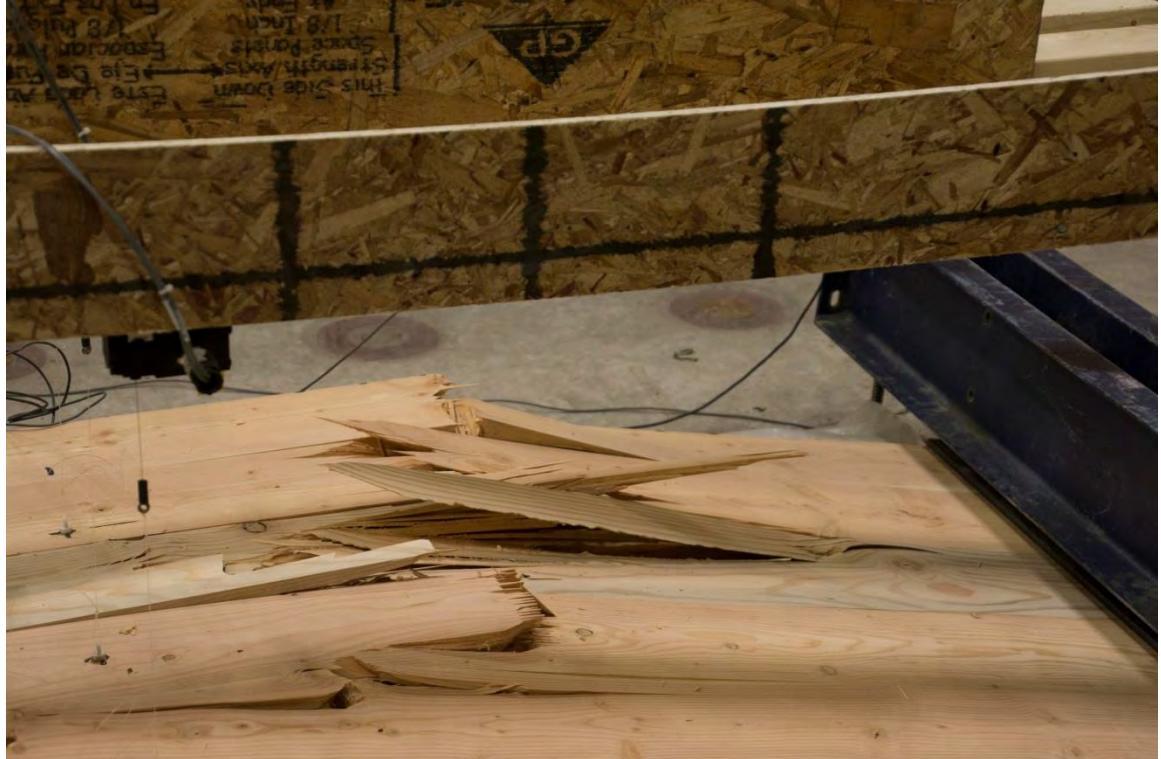
(b) Top view (looking east). (Note failure at finger joints near support, no finger joints located near panel mid-span.)
Figure A-5. 3-Ply Grade V1 CLT – Test 5 (V1-5).

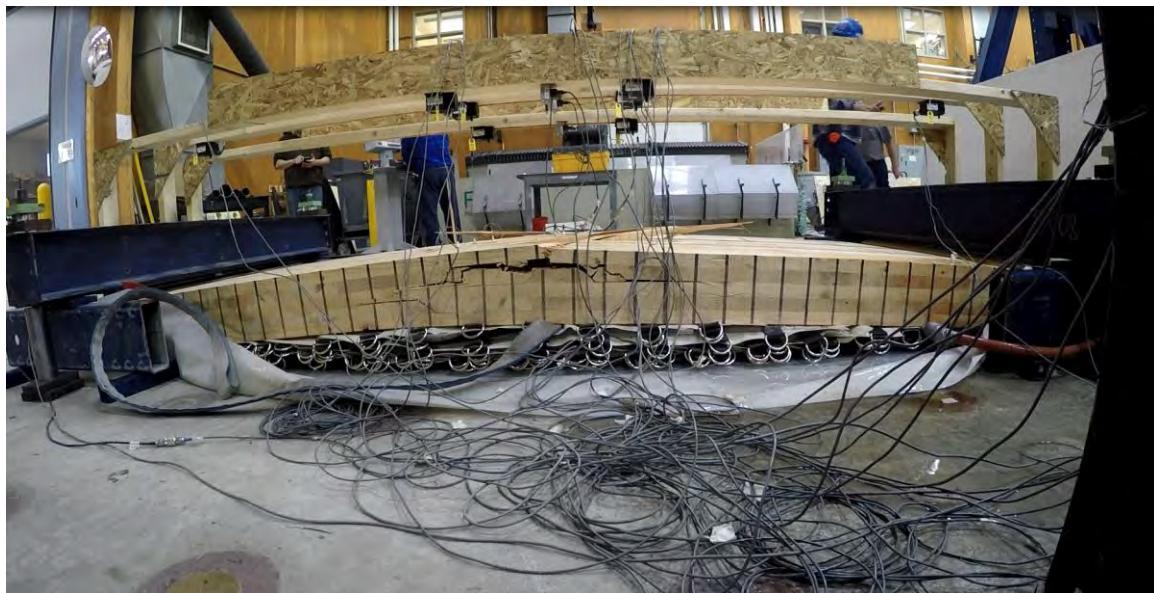
(a) Elevation view (looking west). (Note bladder leakage at lower right.)

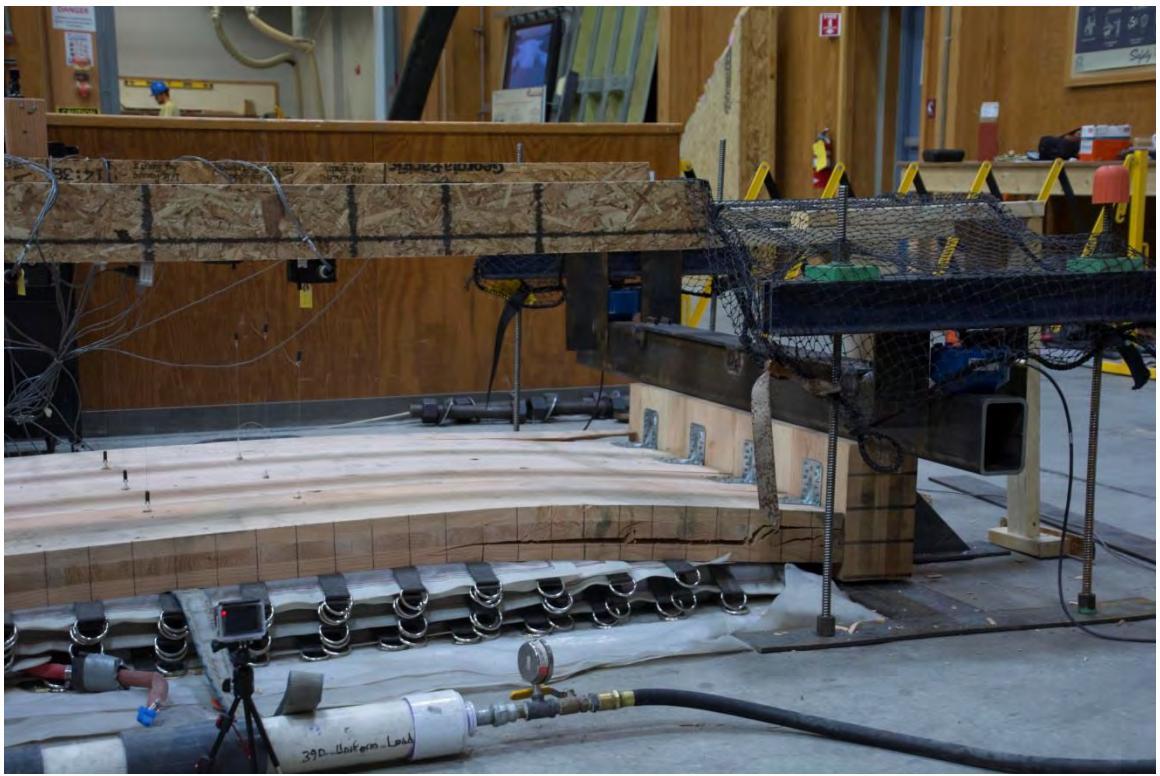
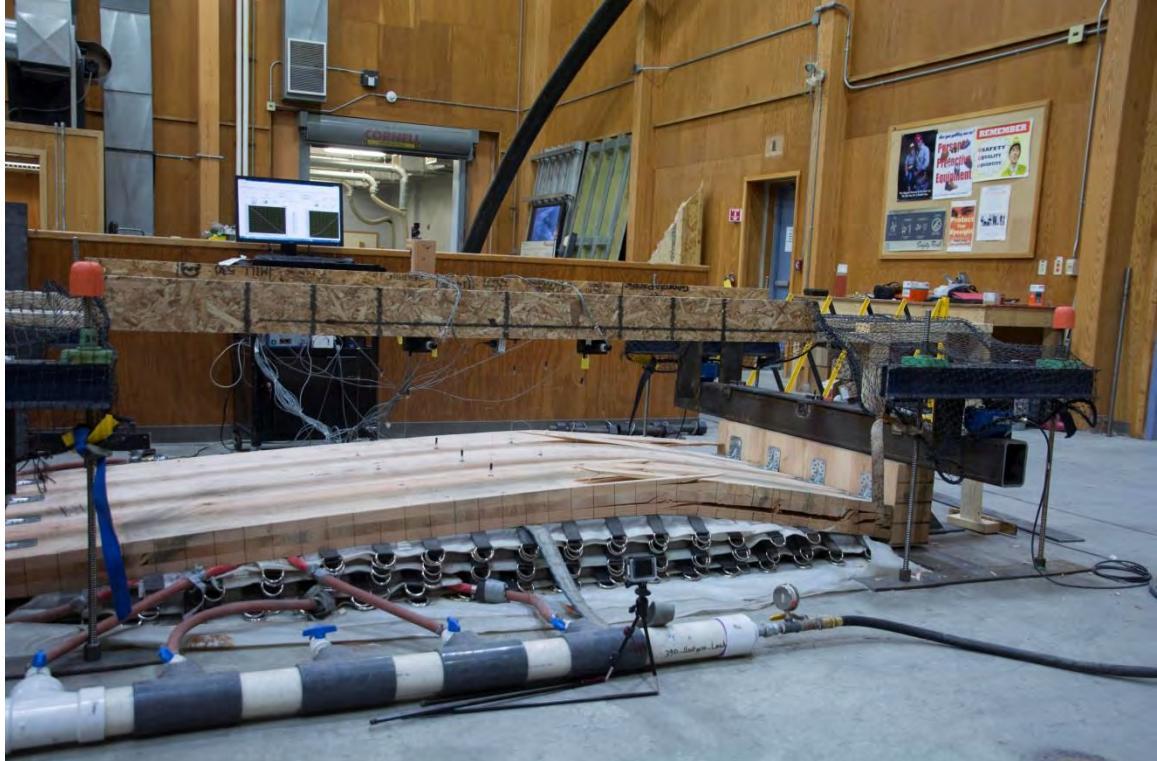
(a) Initial shear failure (looking west).

(b) Subsequent flexural failure (looking west). Figure A-12. 3-Ply Grade V1 CLT w/ SST Brackets at Each End – Test 2 (V1CA-2).

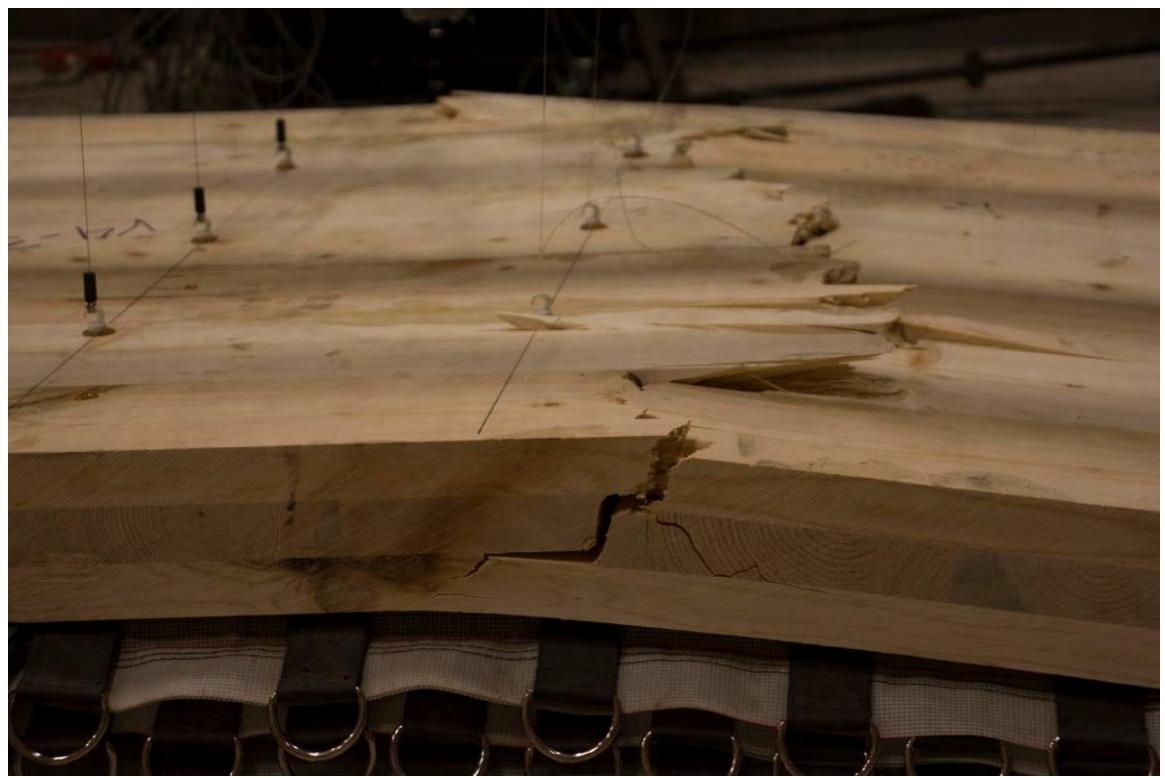
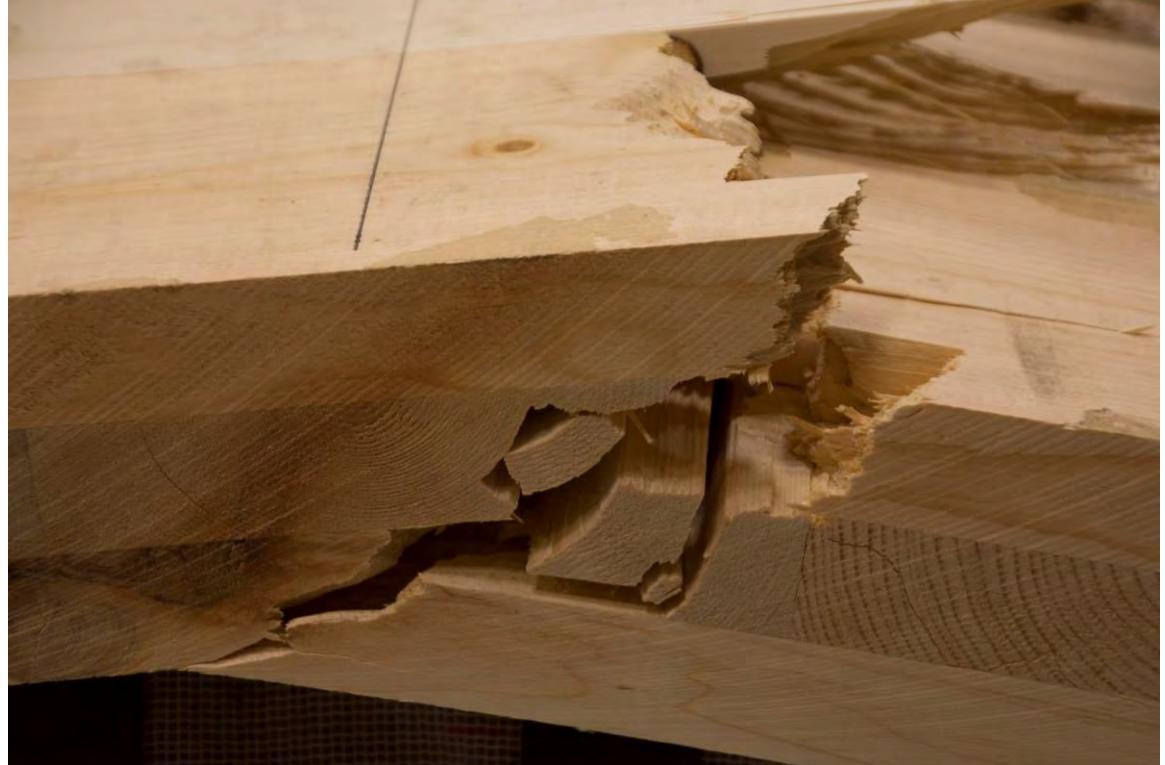
(a) Initial failure.

(b) Subsequent failure. **Figure A-24. 3-Ply Grade V4 CLT – Test 3 (V4-3).**
