# **RESULTS FROM PHASE 2 BLAST TESTS OF FULL-SCALE CROSS-LAMINATED TIMBER STRUCTURES**

Mark K. Weaver, S.E.<sup>1</sup> Charles Newberry, P.E.<sup>2</sup> Casey O'Laughlin, P.E.<sup>3</sup> Lisa Podesto, P.E.<sup>4</sup>

October 9, 2020

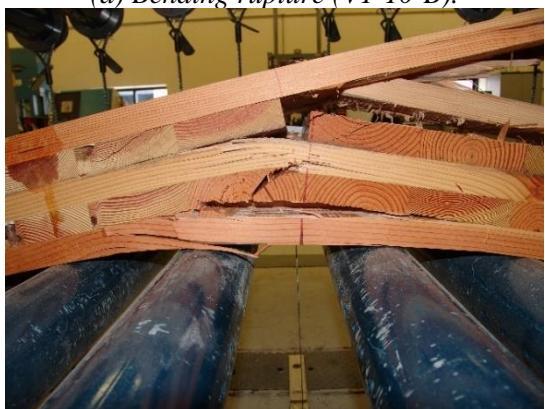
For a few tests with lower axial loads, planar (or rolling) shear damage appeared to occur (Figure 2-3b). Additionally, in most of the 5-ply panel tests, portions of the top-most ply detached from the crosswise ply near panel mid-span prior to rupturing in tension (Figure 2-3c). Whether or not the "rolling shear" noted in Table 2-2 is instead more aptly characterized as "top ply detachment followed by rupture" could be argued.

*(c) Top ply detachment followed by rupture (5V1-20-A).*

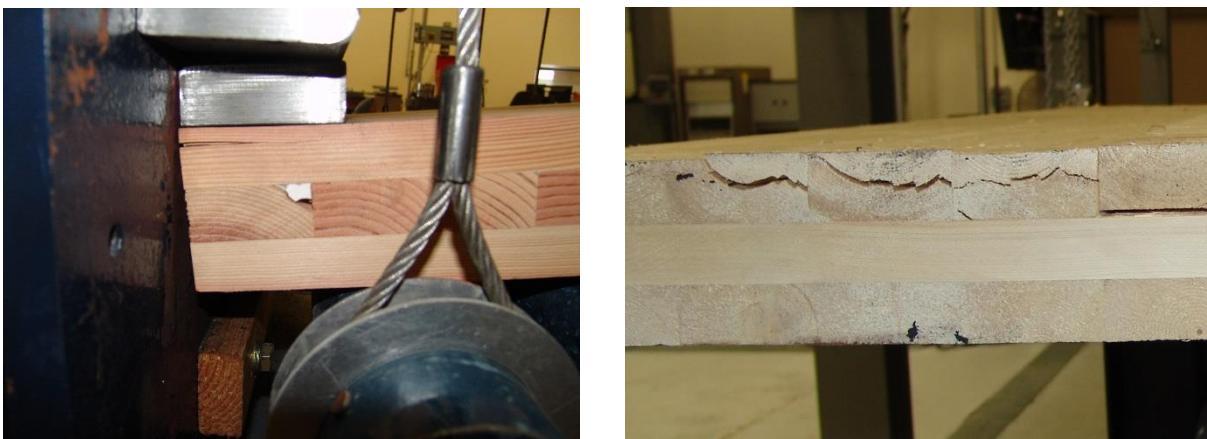
For all tests with an axial load greater than or equal to 10%  $F_c^*$ , (i.e., except for the Grade V4 panels) damage to either the top or side of the panel was observed near the support. (It is suspected that the Grade V4 panels did not exhibit this damage because it had the smallest ASD reference axial compressive stress value (i.e., 1,000 psi) and thus the smallest applied axial load of any grade at 10%  $F_c^*$ . This damage consisted of crushing due to the concentrated compressive stress imparted by the bearing support angle (Figure 2-3d) or splitting due to the tension perpendicular to grain stress associated with the friction force applied by the load platen (Figure 2-3e and f).

(e) Splitting at side of panel (V1-20-A). (f) Splitting at end of panel (E1-10-A). **Figure 2-3. Examples of Observed Damage. (Cont'd)**

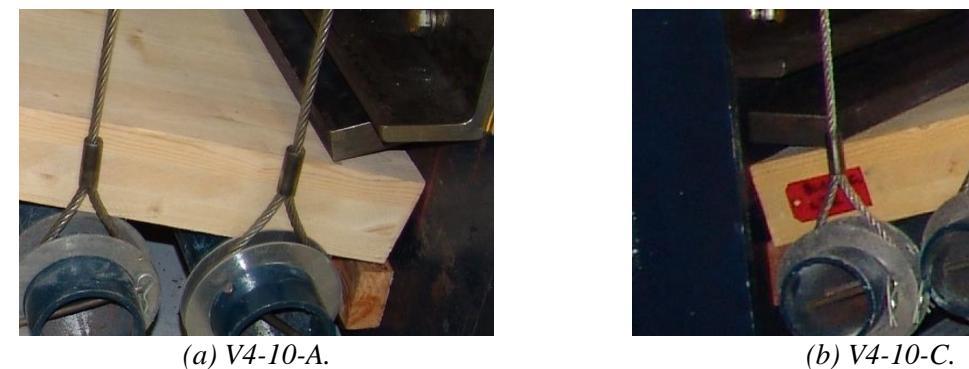
*(a)* V4-10-A. *(b)* V4-10-C. Figure 2-8. Typical Grade V4 End of Panel Damage (Axial Load:  $10\% F_c^*$ ).

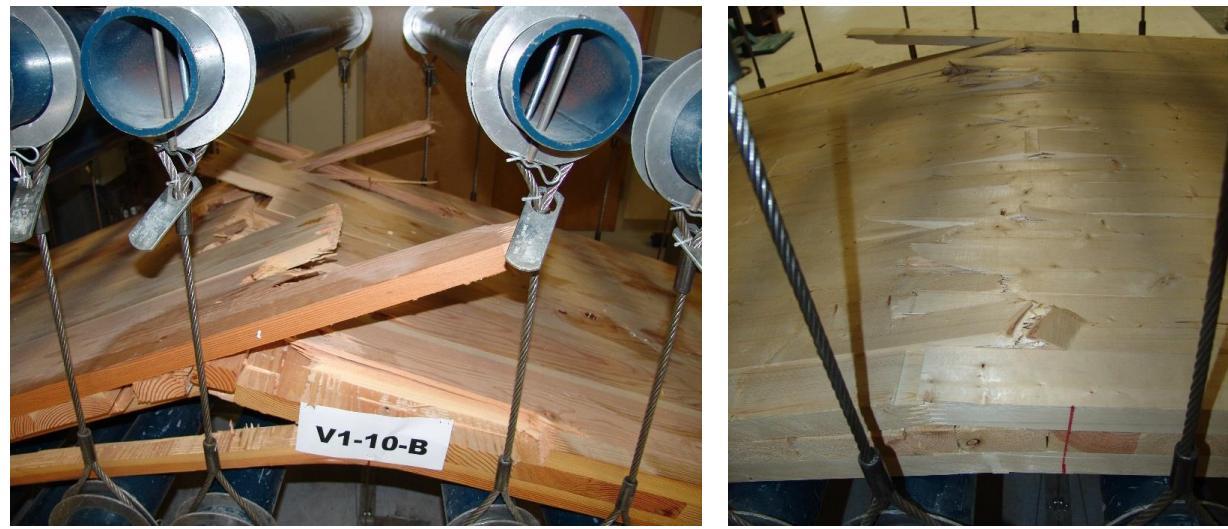
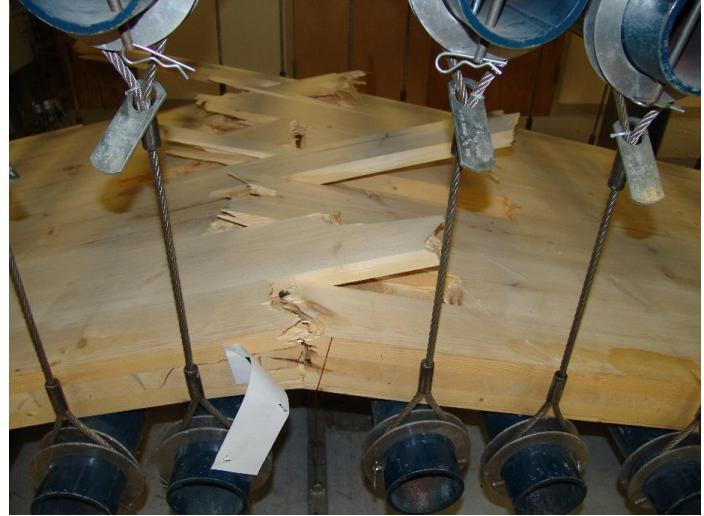
Representative photographs of the typical localized top of panel damage at mid-span incurred during these tests are included in Figure 2-9a, Figure 2-9b, and Figure 2-9c for the Grade V1, E1, and V4 panels, respectively.

(a) Grade V1 (V1-10-B).

(b) Grade E1 (E1-10-A).

(c) Grade V4 (V4-10-C). Figure 2-9. Photographs of Panel Mid-Span Damage by CLT Grade (Axial Load: 10%F<sub>c</sub>\*).

These photographs illustrate the phenomenon noted in comment (2) above, namely that the Grade E1 panels exhibited greater post-peak residual capacity and fewer sudden drops in capacity. Instead of the points of rupture localizing at finger joints or knots, as was typically observed in the Phase 1 testing and for the CLT composed of solely visually graded lumber, it appears a "hinge" is formed at panel mid-span and that the wood ruptures near this hinge. Finger joint orientation combined with modulus of rupture (MOR) variability could at least partially account for this difference in post-peak response. Whereas the Grade V1 and V4 panels have finger joints consisting of vertical grooves (Figure 2-10a), the Grade E1 panels have finger joints consisting of horizontal grooves (Figure 2-10b). The presence of axial load could serve to better "lock" the finger joints and minimize the potential for this discontinuity to serve as a point of failure. This combined with the lower MOR variation for MSR lumber could serve to localize failure and force rupture in sections of wood absent imperfection, which may enable more incremental, rather than large sudden, drops in flatwise bending capacity.

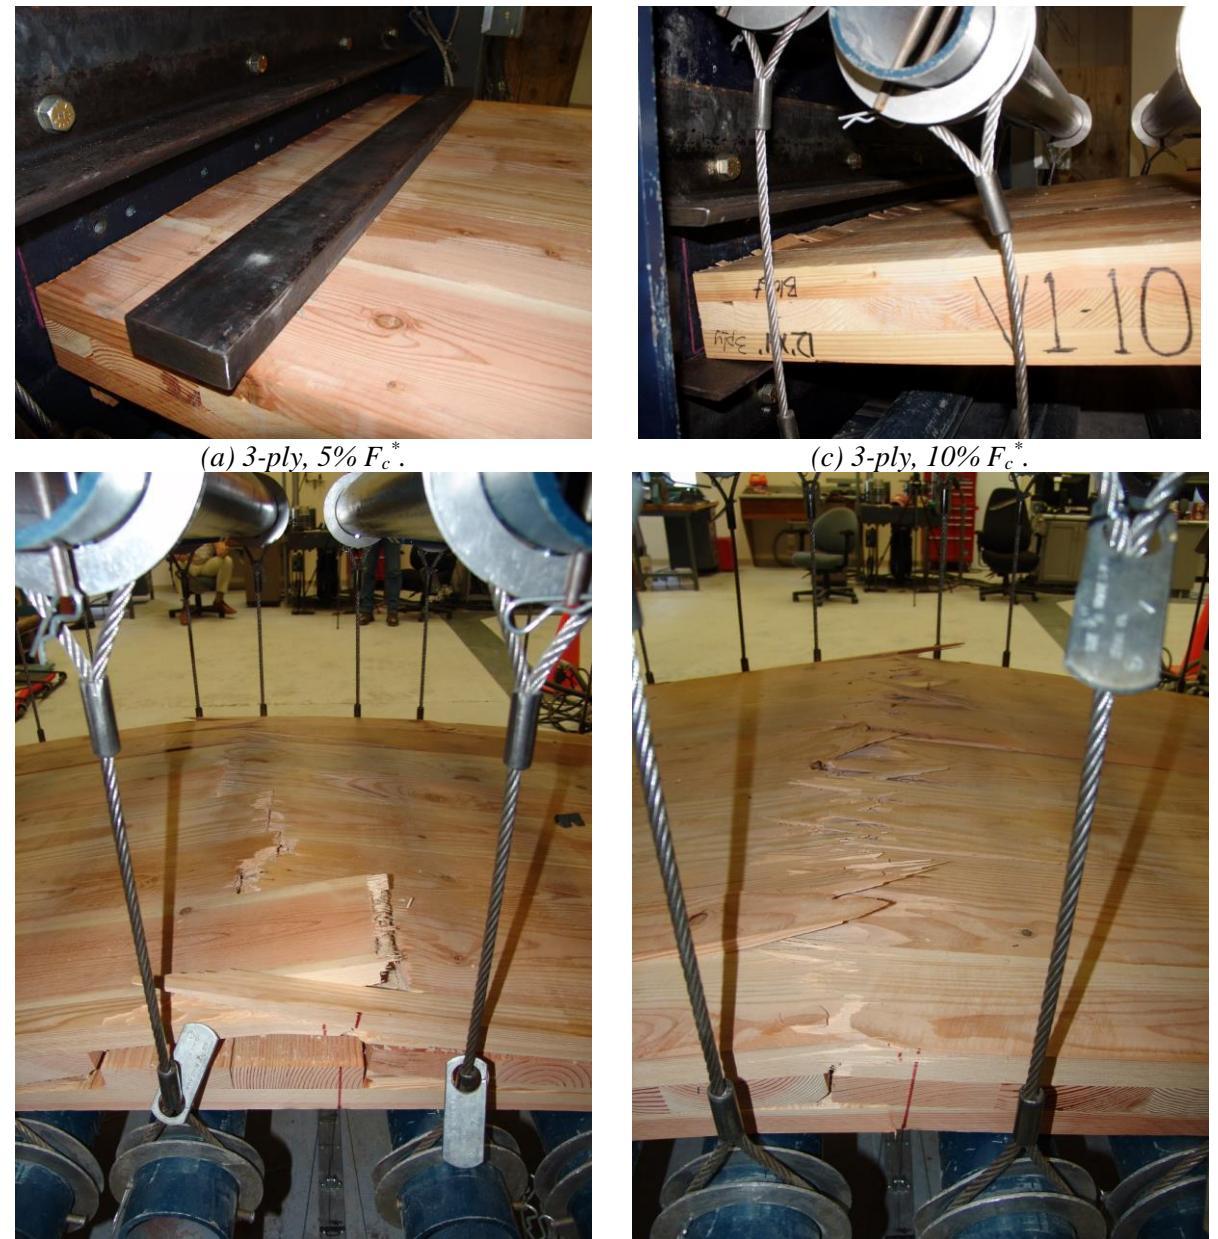
- (3) The loading stiffness for the 0%  $F_c^*$  and 5%  $F_c^*$  cases for both 3-ply and 5-ply panels, as well as the 10%  $F_c^*$  case for 5-play panels, is noticeably higher than that for the remaining cases. Not surprisingly, these are the cases in which negligible localized damage was observed at panel ends (Figure 2-12a) when compared to other tests (Figure 2-12b).

(c) 3-ply, 10%  $F_c^*$ . Figure 2-12. Photographs for 12-Foot Grade V1 CLT Panels at Various Axial Loads .

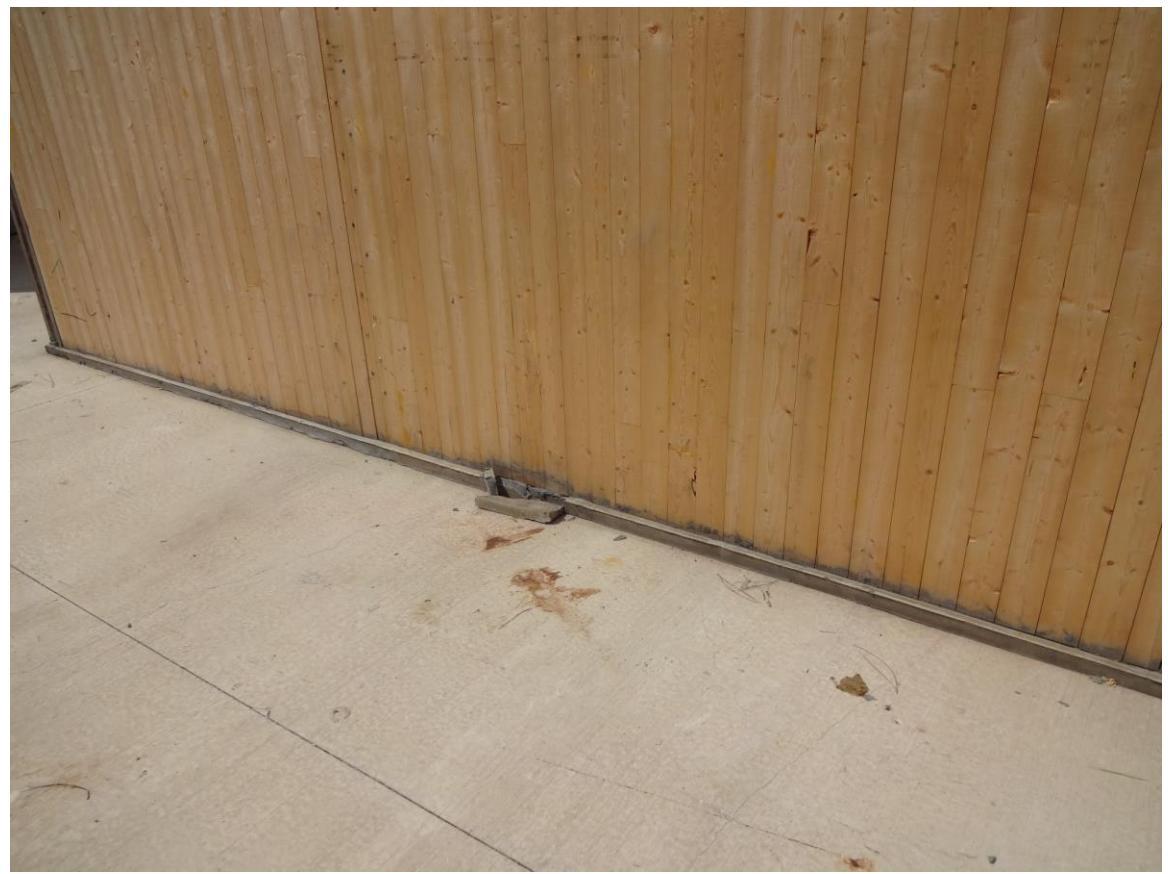
Figure 4-1. Test 4 Post-Test Photograph of Grout Breakup.

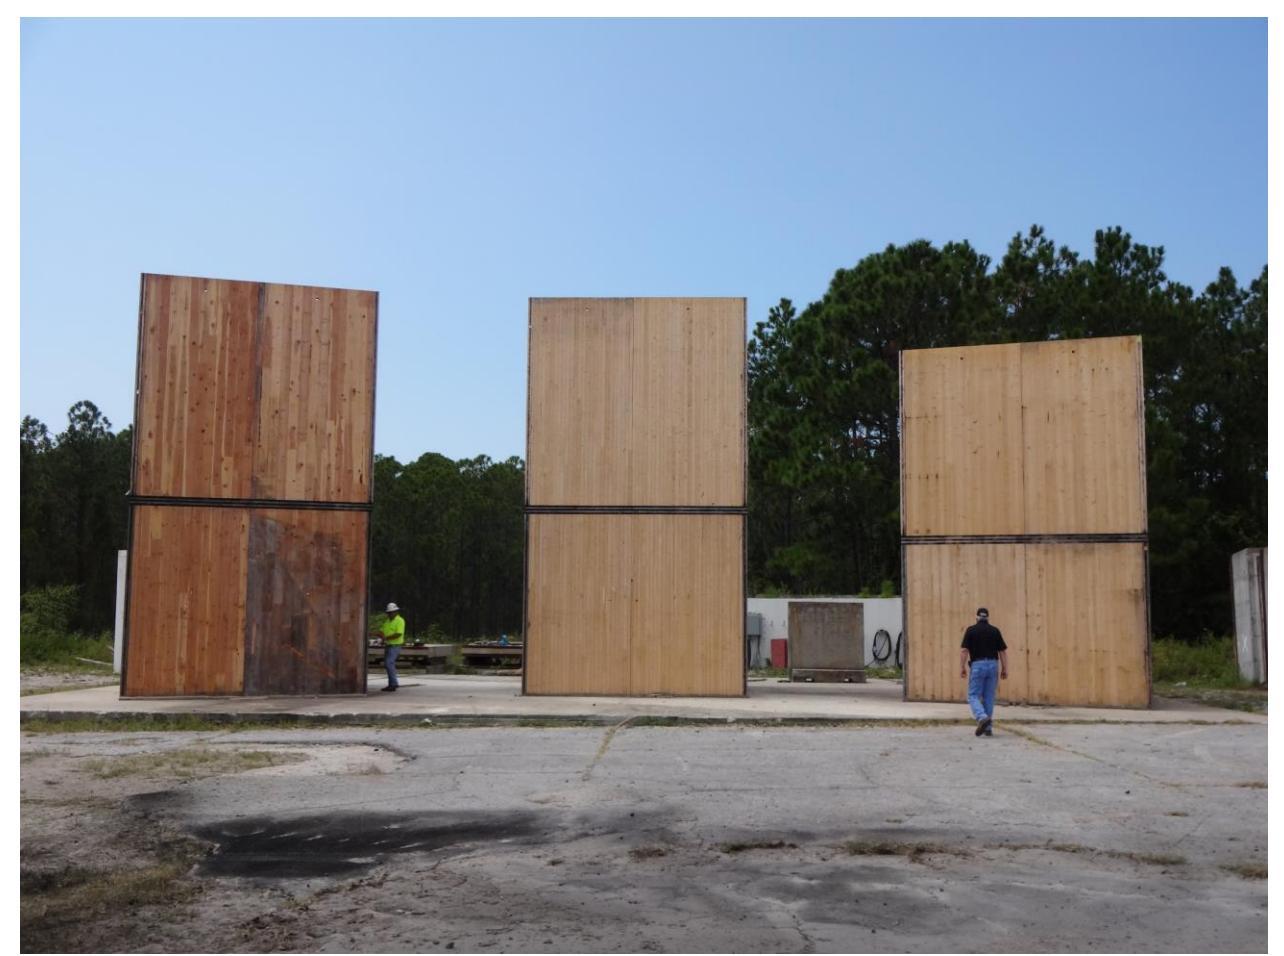
Figure 4-3. Test 5 Post-Test Photograph of All Test Structures.

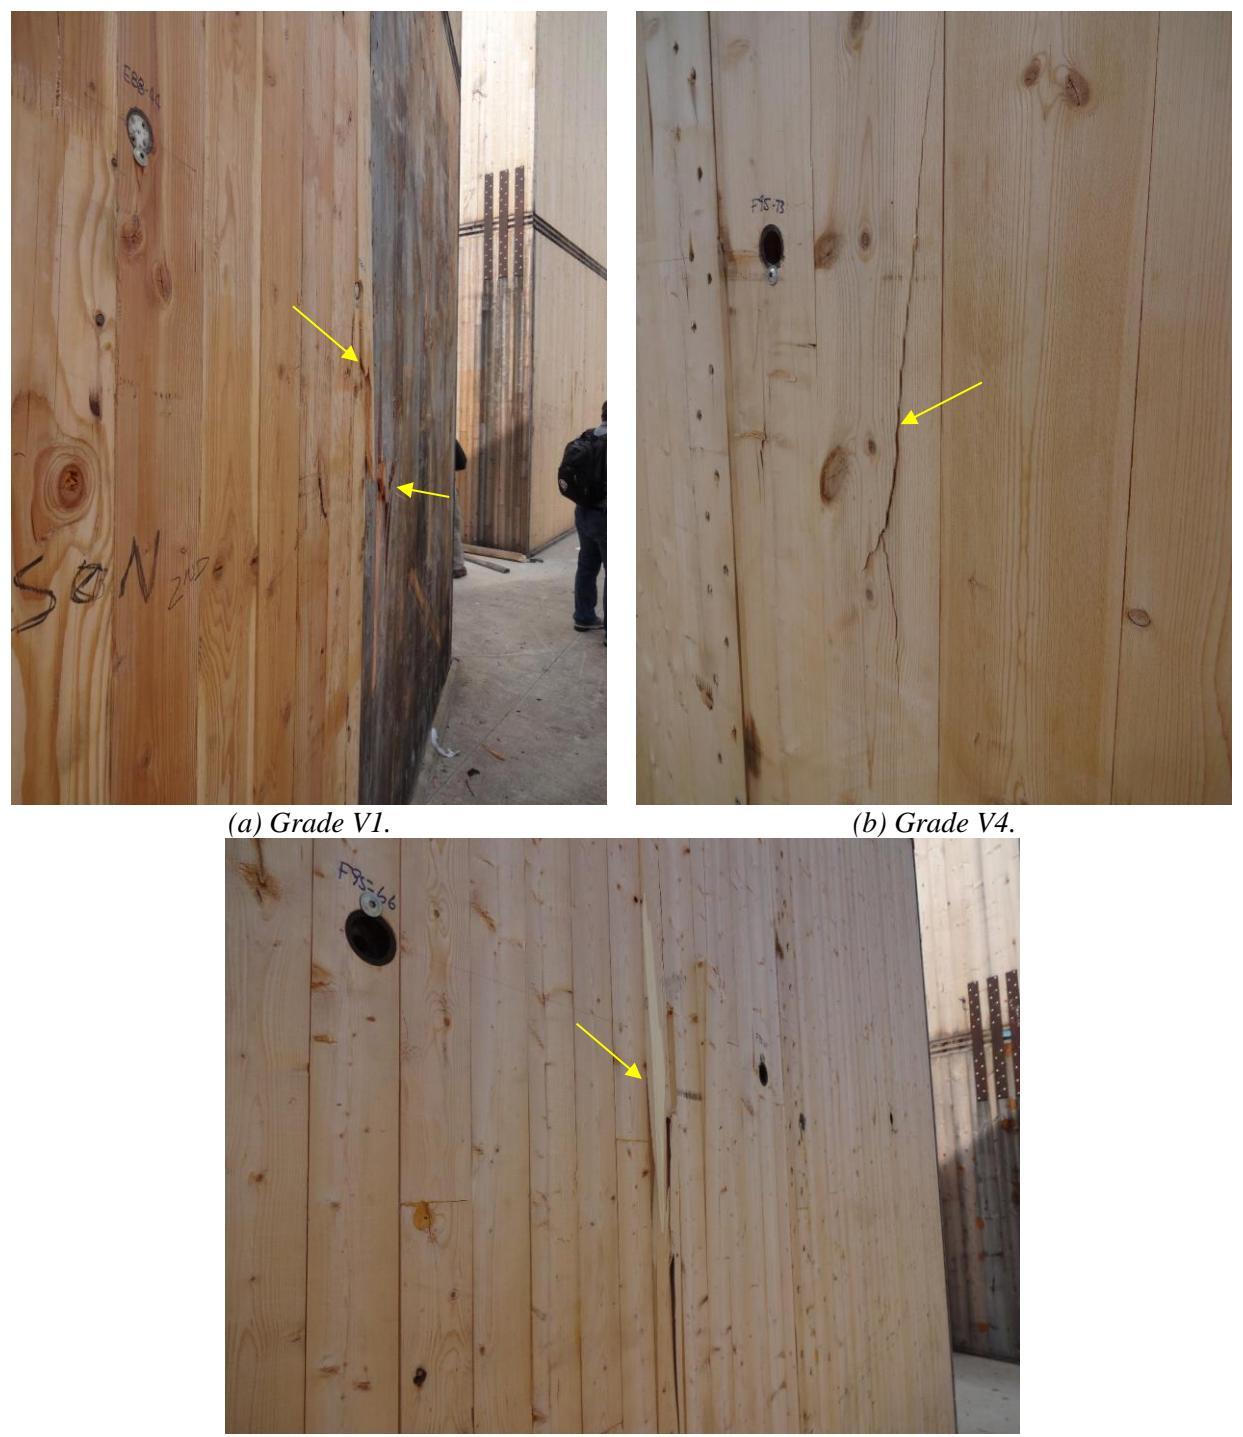
(c) Grade E1. Figure 4-5. Test 5 Post-Test Photograph of Exterior Face Damage at 1<sup>st</sup> Floor Front Panel.

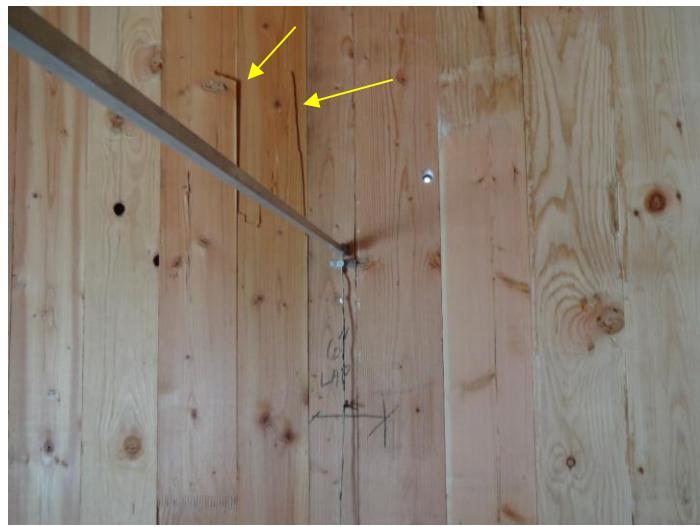
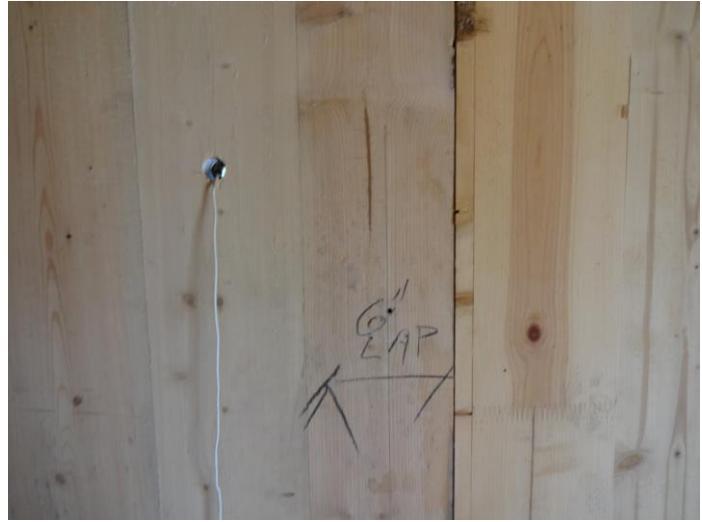
(a) Grade V1.

(b) Grade E1.

(c) Grade V4. Figure 4-6. Test 5 Post-Test Photograph of Interior Face Damage at 1<sup>st</sup> Floor Front Panel.

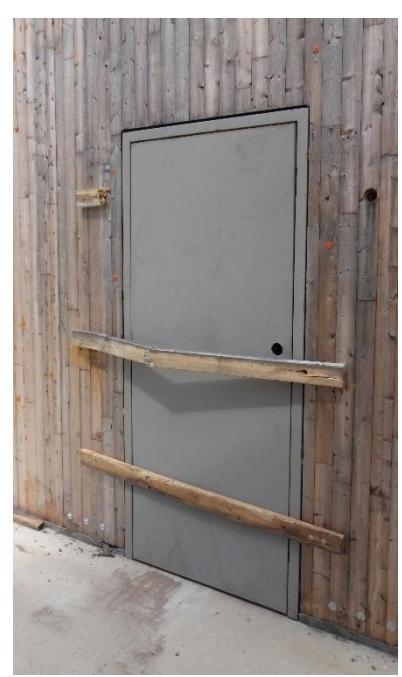
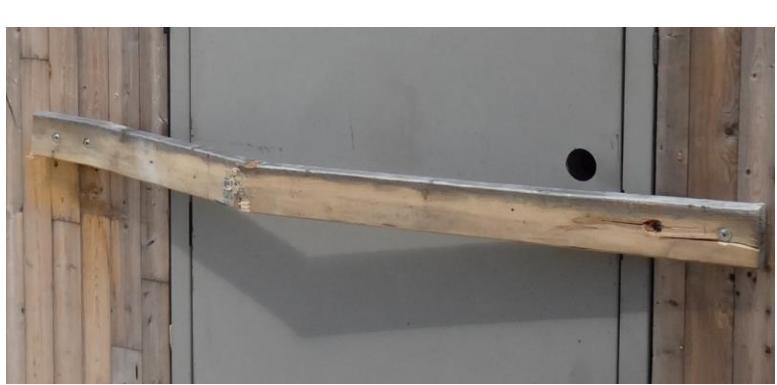
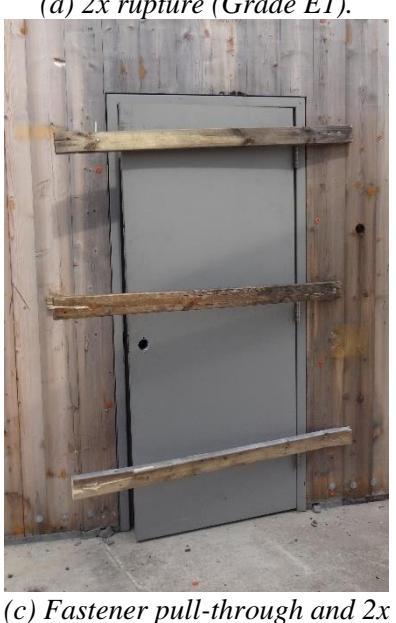
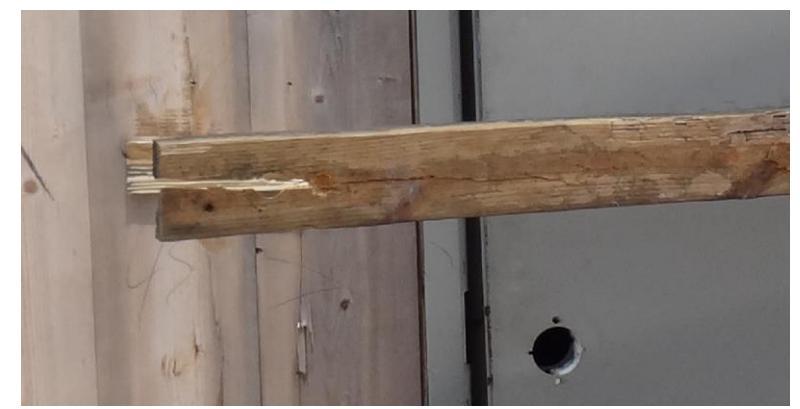
*(c) Grade V4.* **Figure 4-7. Test 3 Post-Test Photographs of Floors.**
All doors opened (in rebound) during Test 5. Either rupture of the dimensional lumber restraints securing the door or withdrawal of the fasteners securing this dimensional lumber was observed in the test structures (Figure 4-8). It should be noted these lumber restraints were installed to merely keep the door closed at the outset of the test. They were not designed to resist the imposed blast loading, nor would they be installed in an actual building.

(a) 2x rupture (Grade E1).

(b) Close-up of 2x rupture (Grade E1).

splitting (Grade V4).

(d) Close-up of fastener pull-through and 2x splitting (Grade V4).

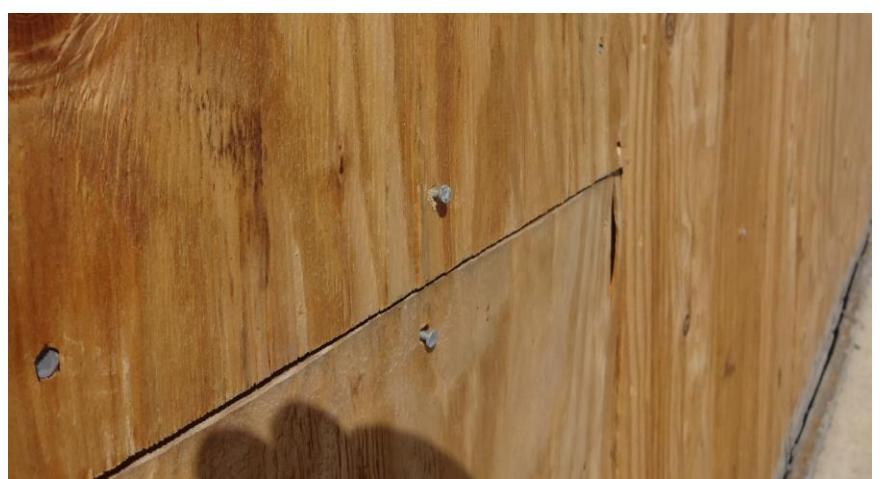
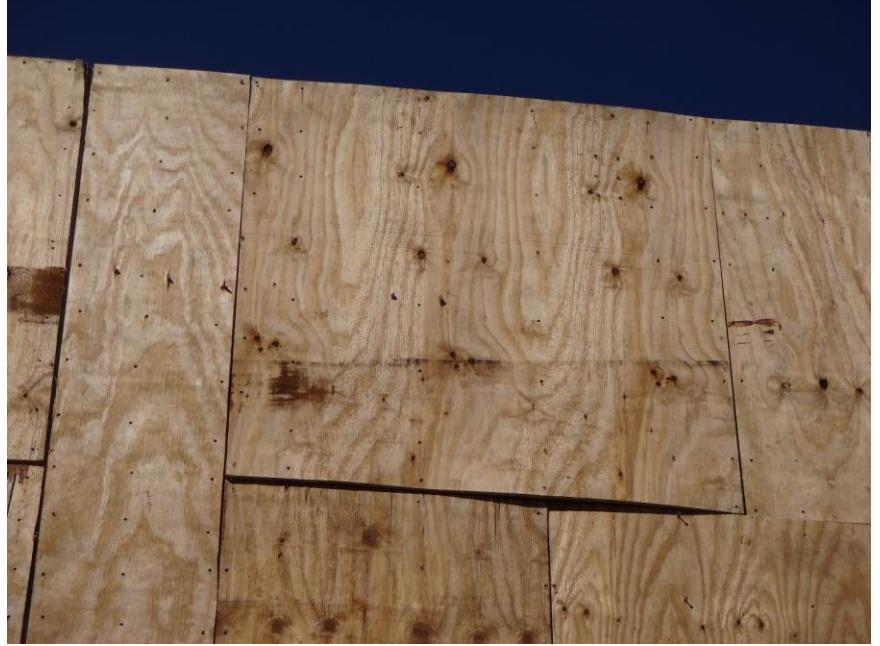
(a) Typical nail pullout observed.

(b) Panel disengagement due to nail pullout at top of structure. Figure 4-9. Test 6 Post-Test Photograph of Nail Pullout.

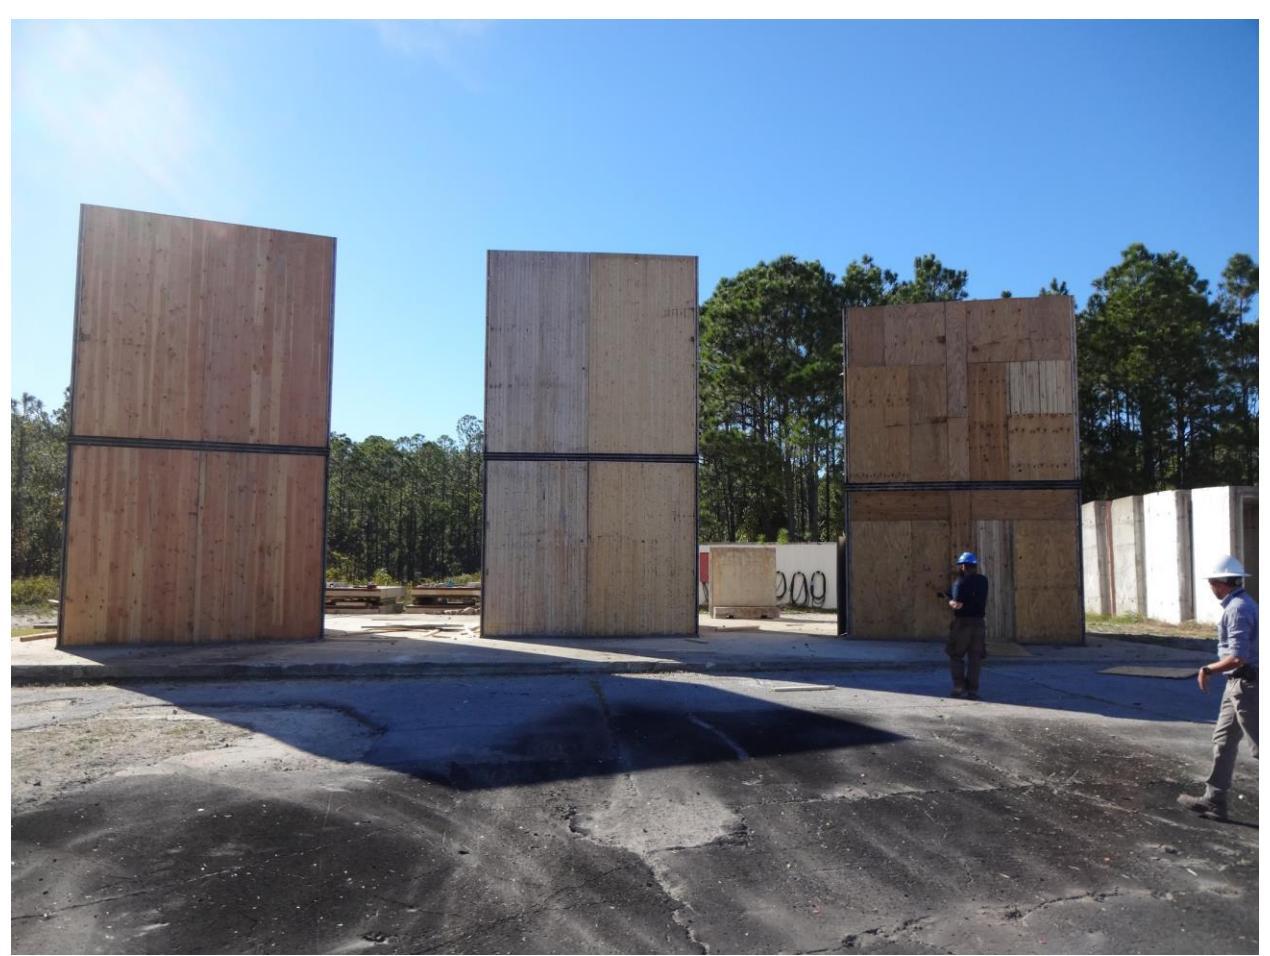
Figure 4-12. Test 7 Post-Test Photograph of All Test Structures.

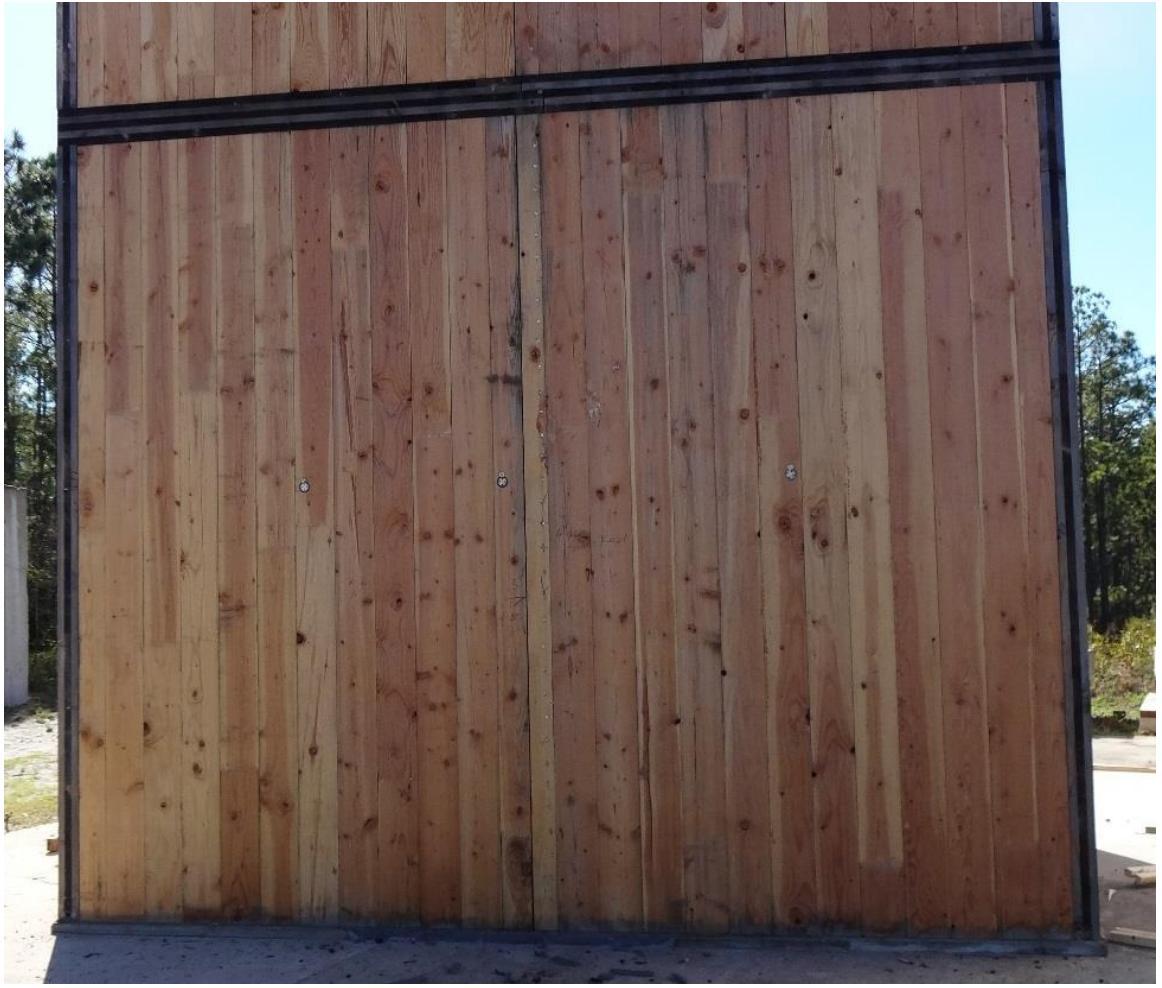
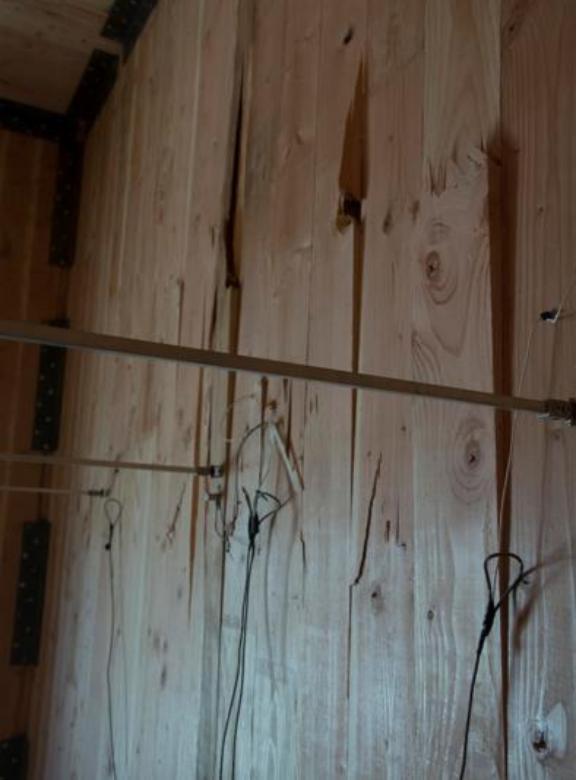
(a) Exterior Face. Figure 4-13. Test 7 Post-Test Photographs of Front Panels in Grade V1 Structure.

(c) Close-Up of Interior Face Damage. Figure 4-13. Test 7 Post-Test Photographs of Front Panels in Grade V1 Structure. (Cont'd)

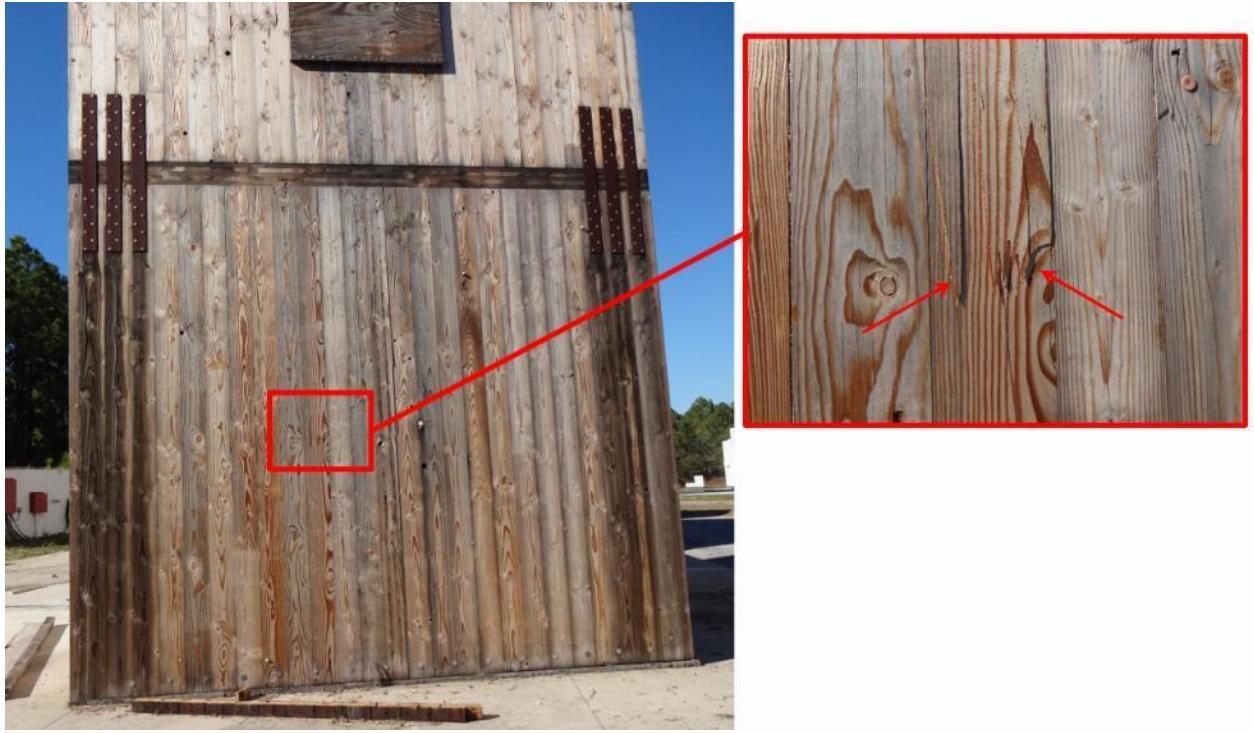
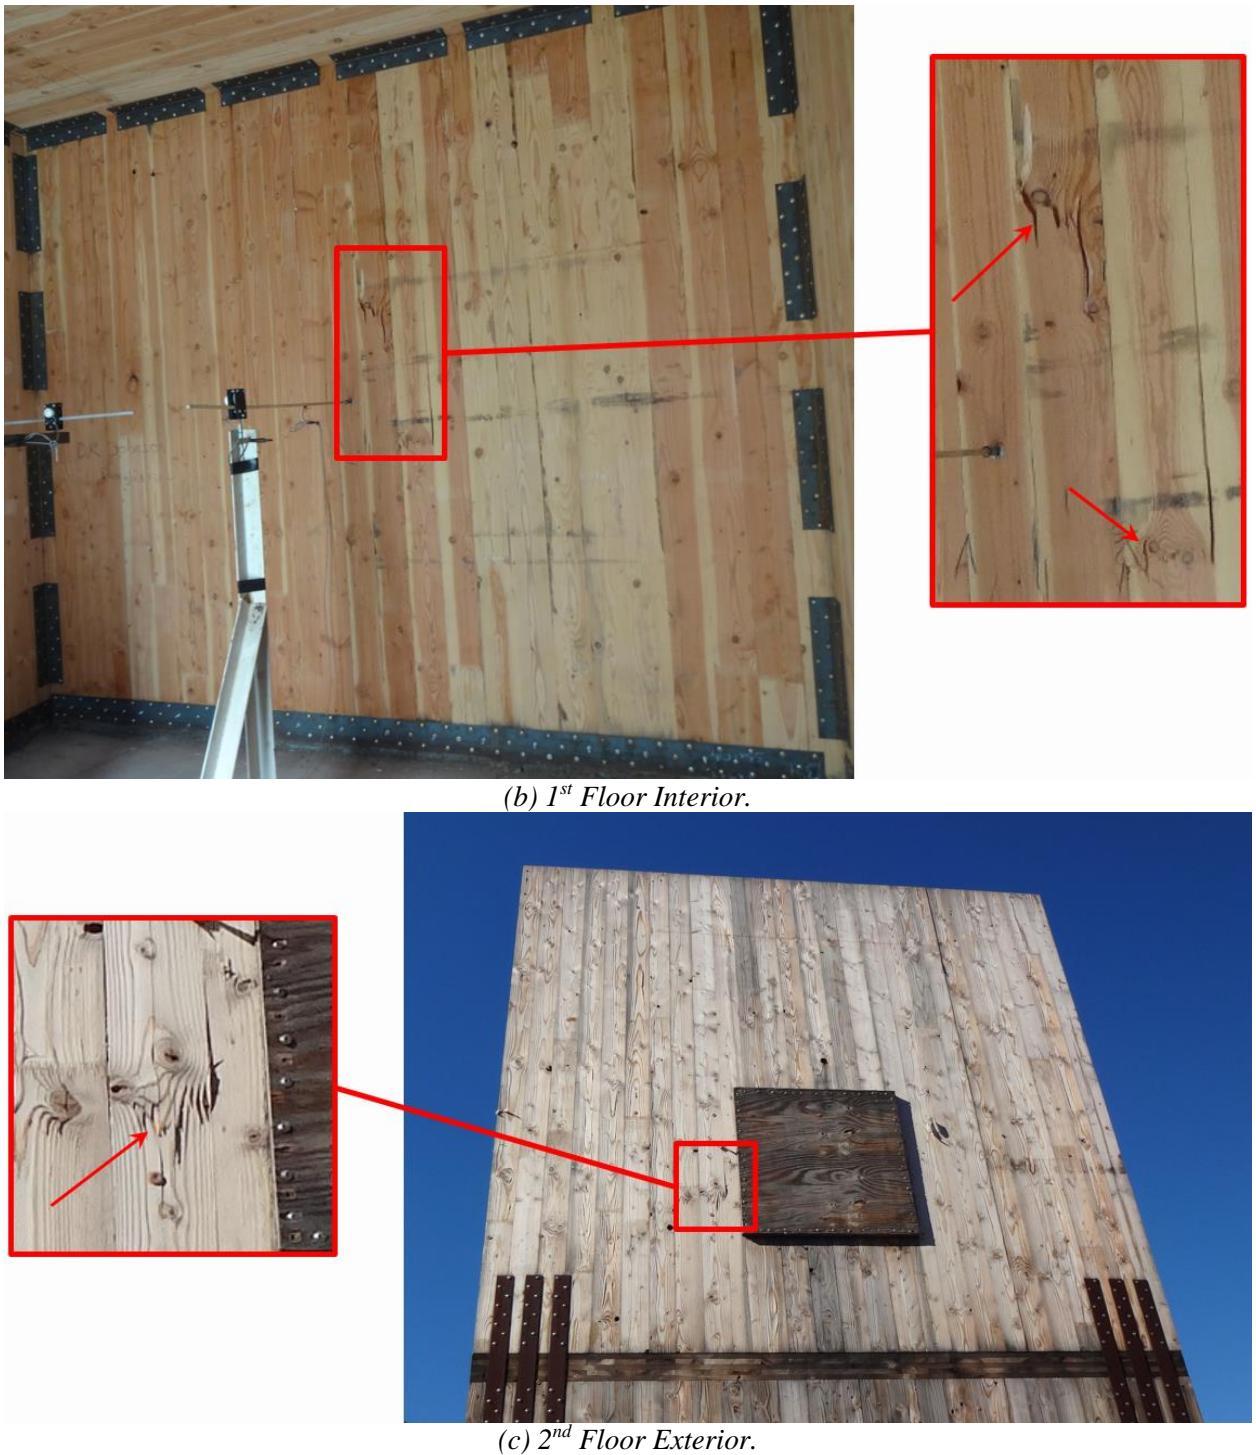
(a) 1<sup>st</sup> Floor Exterior. Figure 4-14. Test 7 Post-Test Photographs of Window-Side Panels in Grade V1 Structure.

Figure 4-14. Test 7 Post-Test Photographs of Window-Side Panels in Grade V1 Structure. (Cont'd)

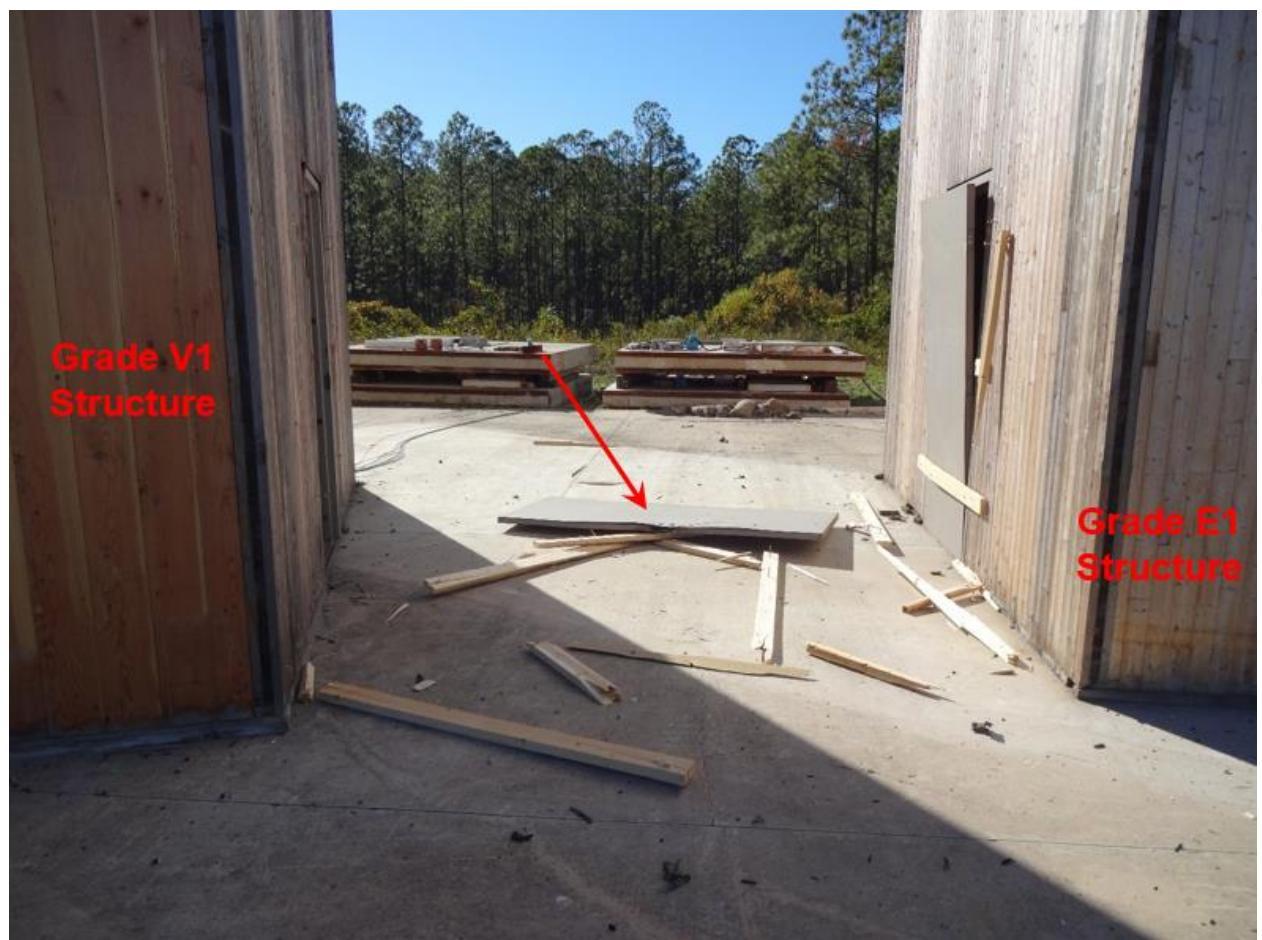
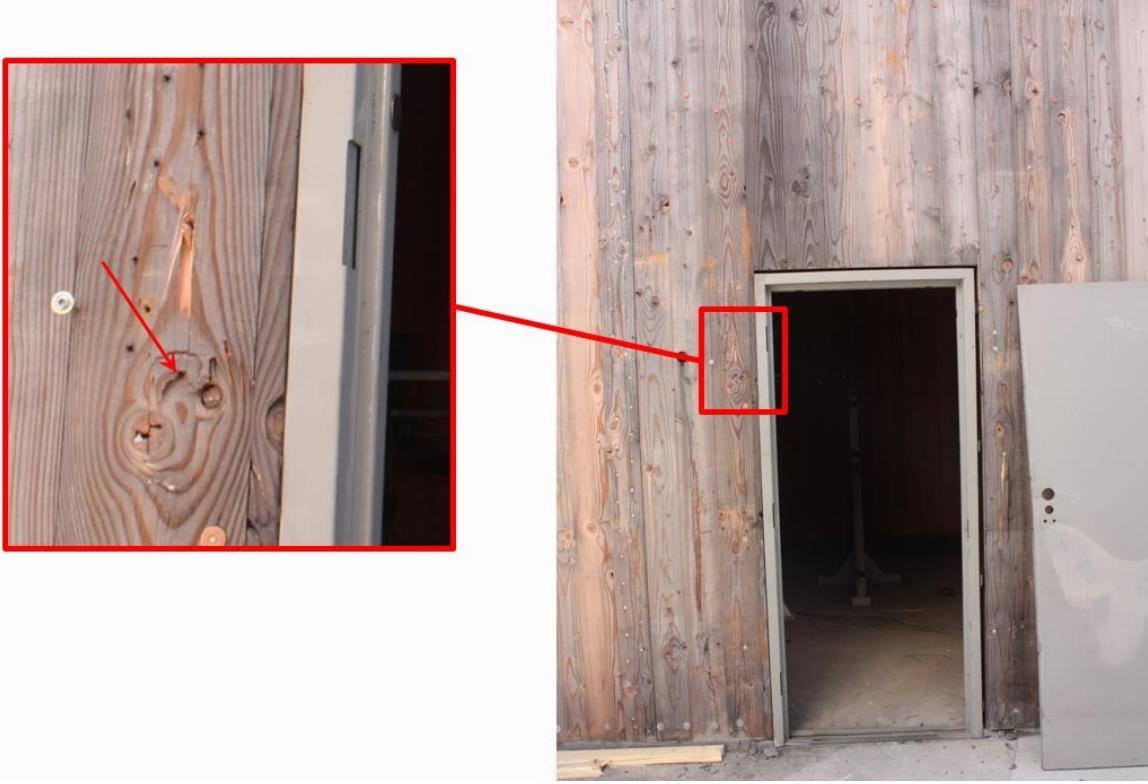
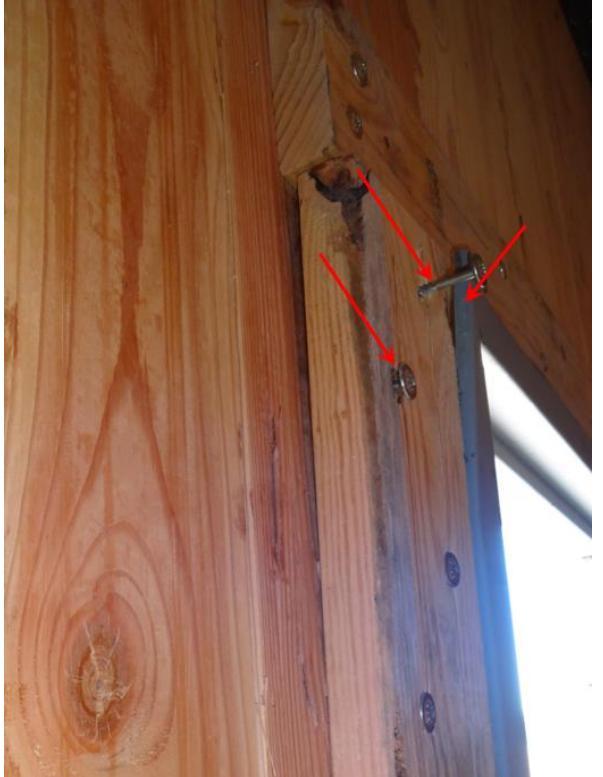
(a) Door Rebounds Out of Frame. Figure 4-15. Test 7 Post-Test Photographs of Door-Side Panels in Grade V1 Structure.

(b) Localized Damage at Door Jamb.

(c) Localized Damage Near Top of Door Frame. Figure 4-15. Test 7 Post-Test Photographs of Door-Side Panels in Grade V1 Structure. (Cont'd)

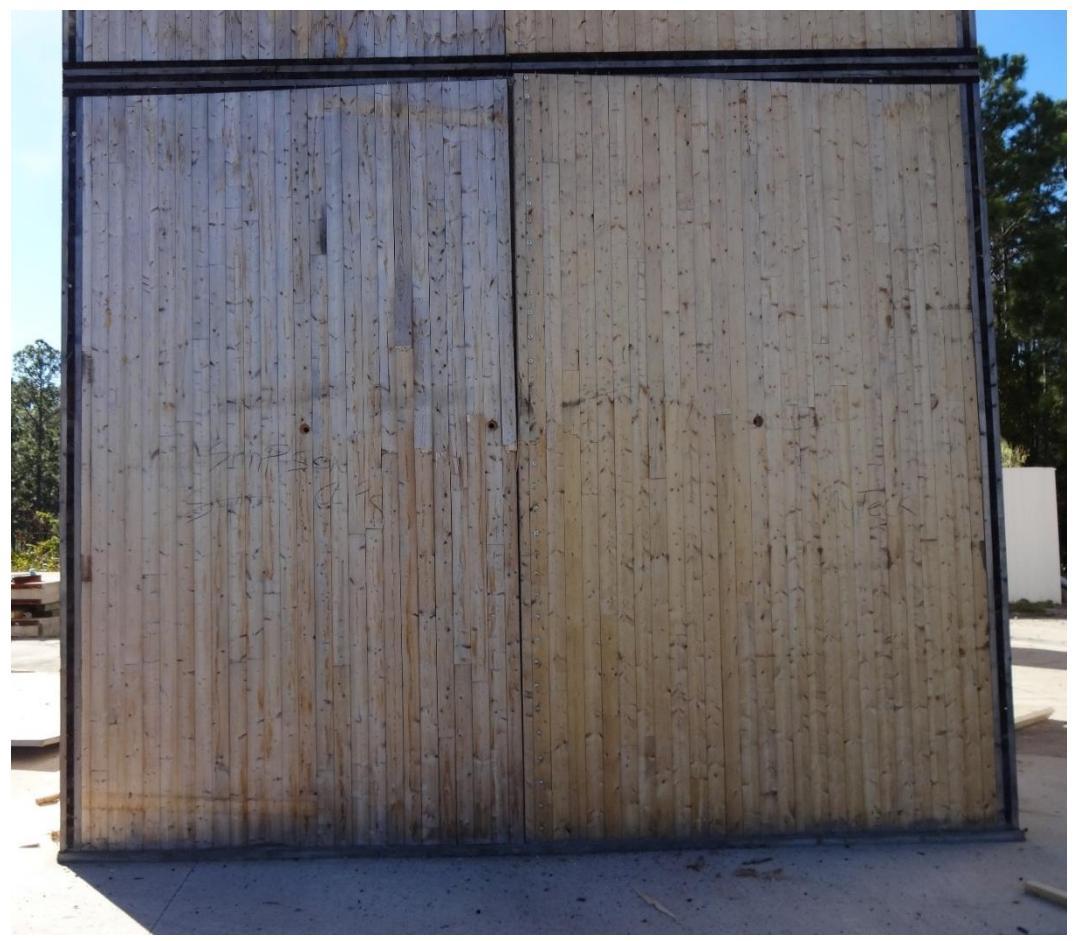
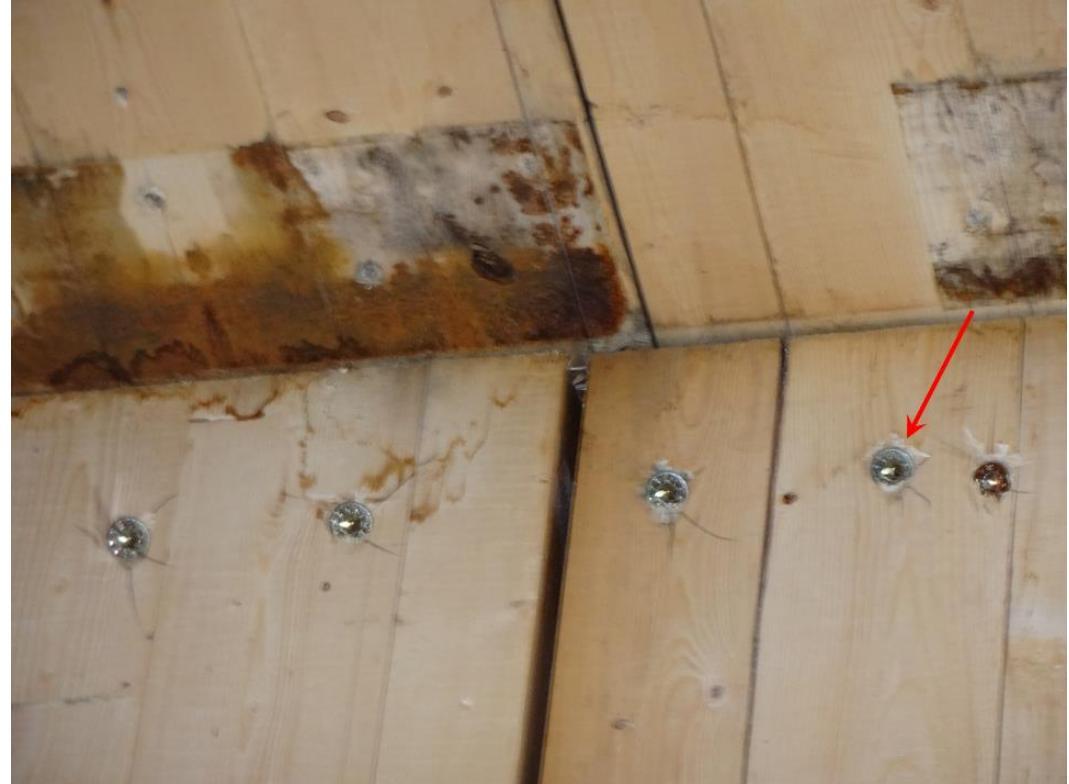
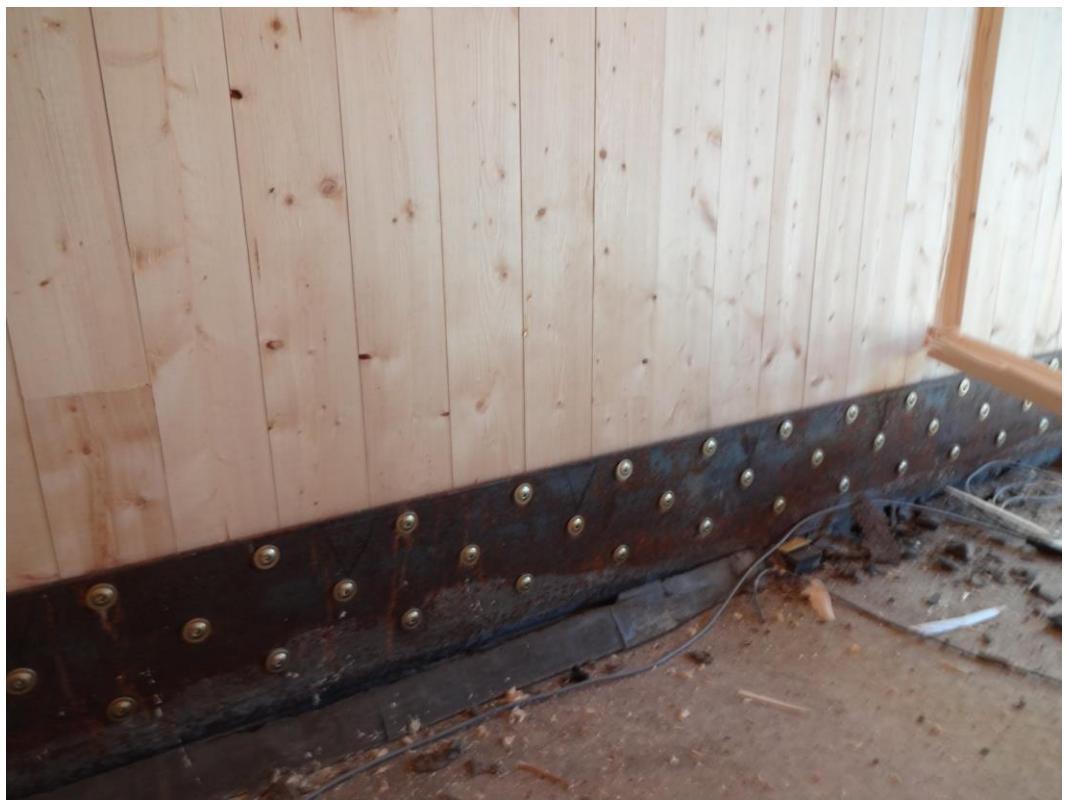
(a) Exterior Face. Figure 4-16. Test 7 Post-Test Photographs of 1<sup>st</sup> Floor Front Wall Panels in Grade E1 Structure.

(e) Pre-Test Condition at Top of Wall Panel. Figure 4-16. Test 7 Post-Test Photographs of 1st Floor Front Wall Panels in Grade E1 Structure. (Cont'd)

(f) Base Angle Connection. Figure 4-16. Test 7 Post-Test Photographs of 1st Floor Front Wall Panels in Grade E1 Structure. (Cont'd)
