# **RESULTS FROM PHASE 2 BLAST TESTS OF FULL-SCALE CROSS-LAMINATED TIMBER STRUCTURES**

Mark K. Weaver, S.E.<sup>1</sup> Charles Newberry, P.E.<sup>2</sup> Casey O'Laughlin, P.E.<sup>3</sup> Lisa Podesto, P.E.<sup>4</sup>

October 9, 2020

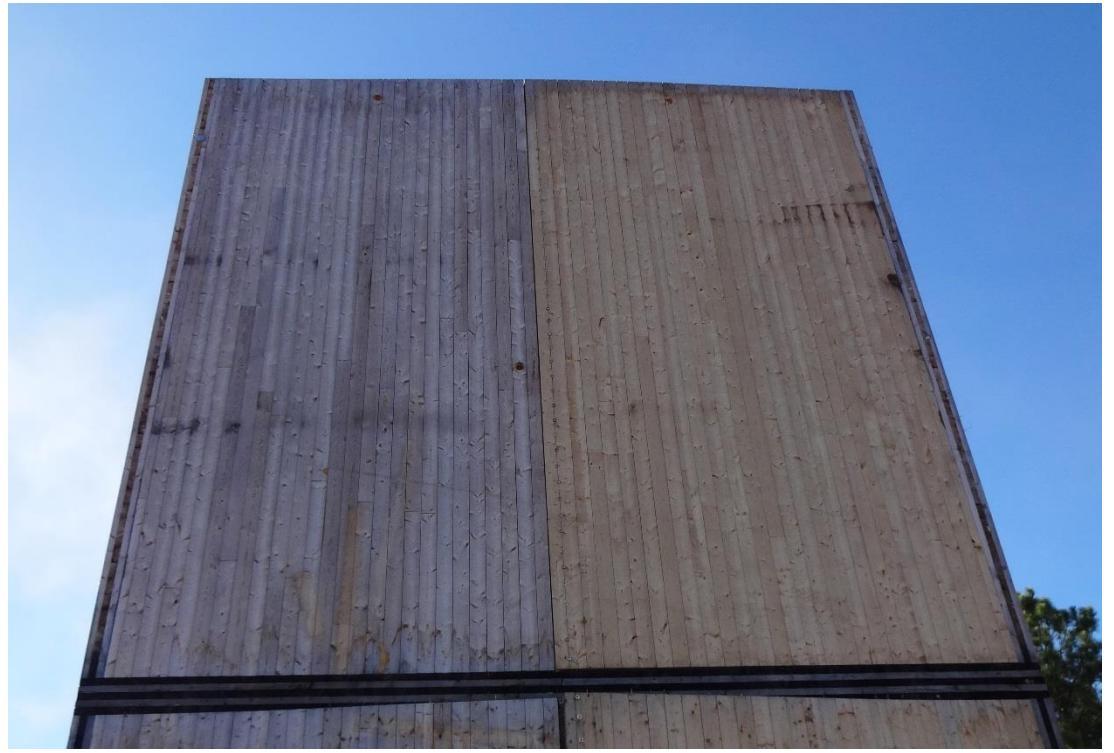
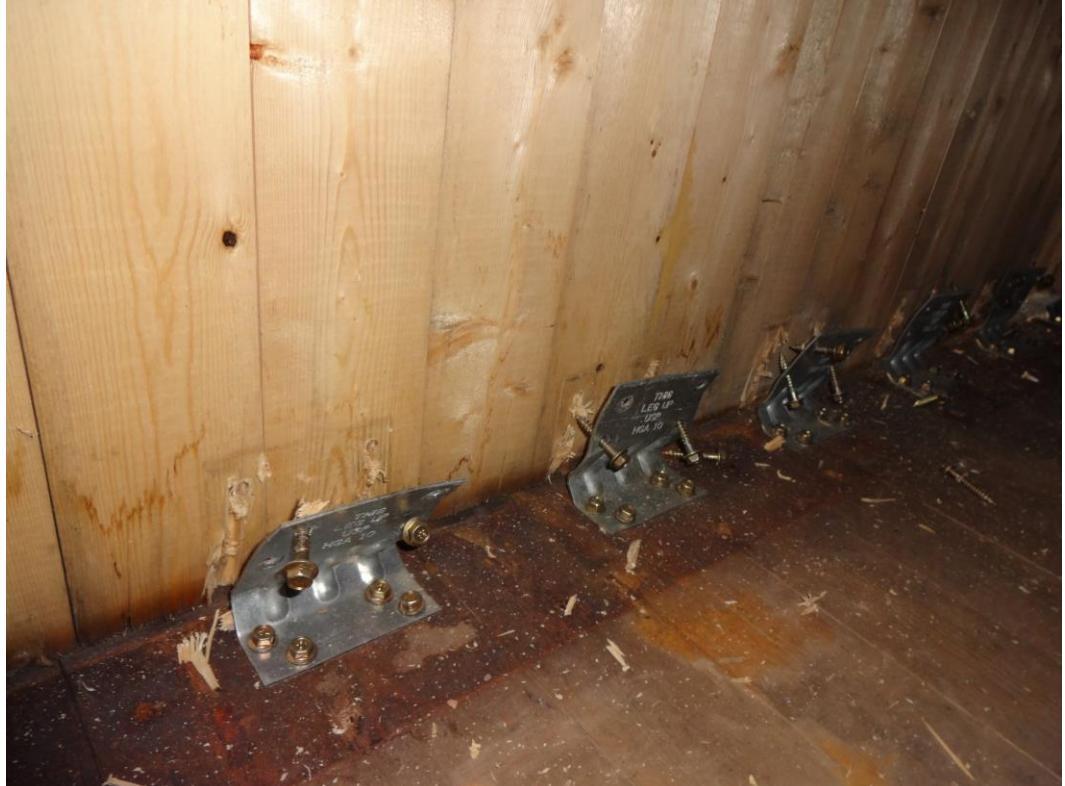
(a) Exterior Face. Figure 4-17. Test 7 Post-Test Photographs of 2<sup>nd</sup> Floor Front Wall Panels in Grade E1 Structure.

(e) MiTek Brackets. Figure 4-17. Test 7 Post-Test Photographs of 2nd Floor Front Wall Panels in Grade E1 Structure. (Cont'd)

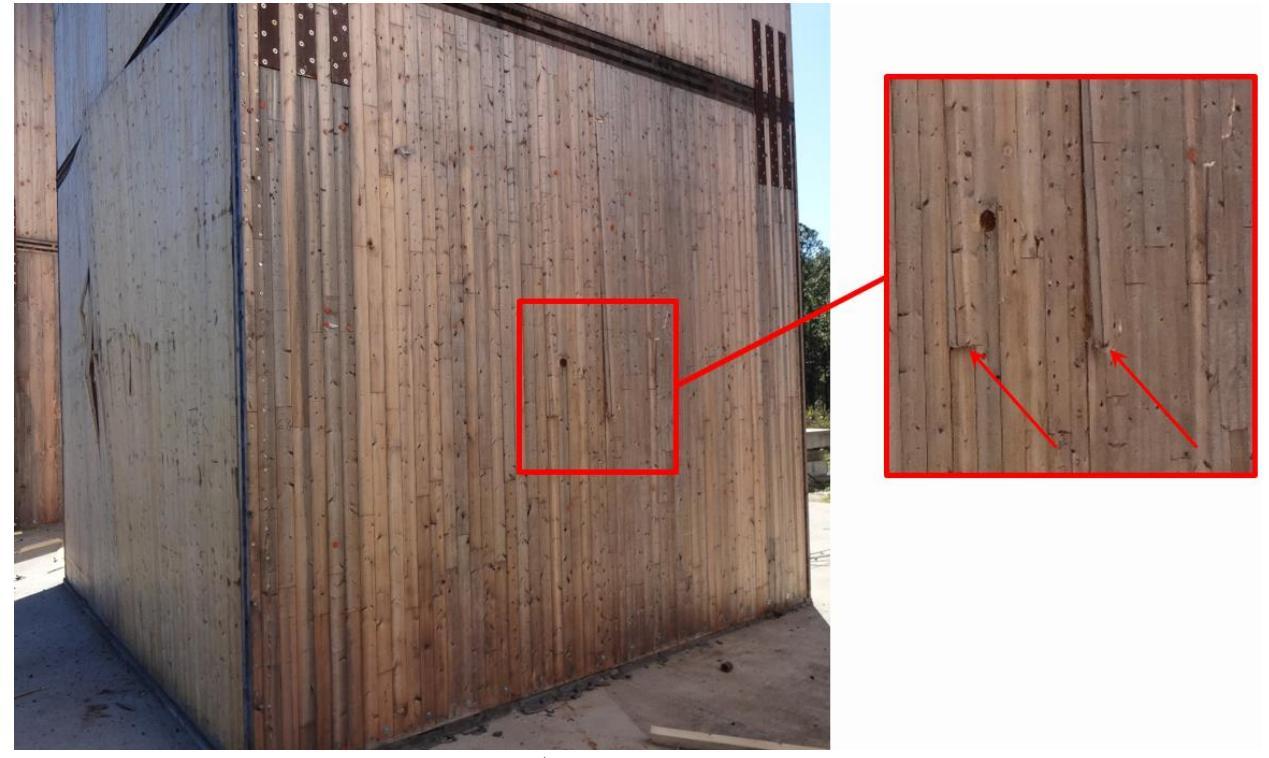
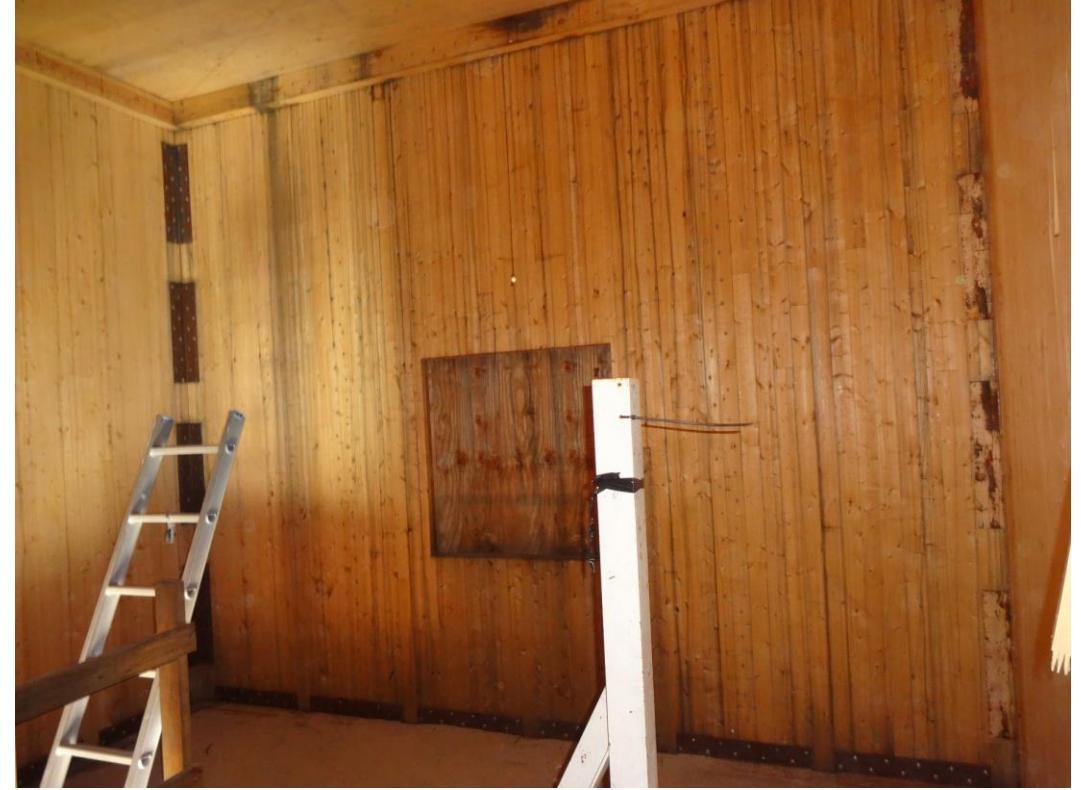
(a) 1<sup>st</sup> Floor Exterior Face. Figure 4-18. Test 7 Post-Test Photographs of Window-Side Panels in Grade E1 Structure.

(c) 2<sup>nd</sup> Floor Interior Face. Figure 4-18. Test 7 Post-Test Photographs of Window-Side Panels in Grade E1 Structure. (Cont'd)

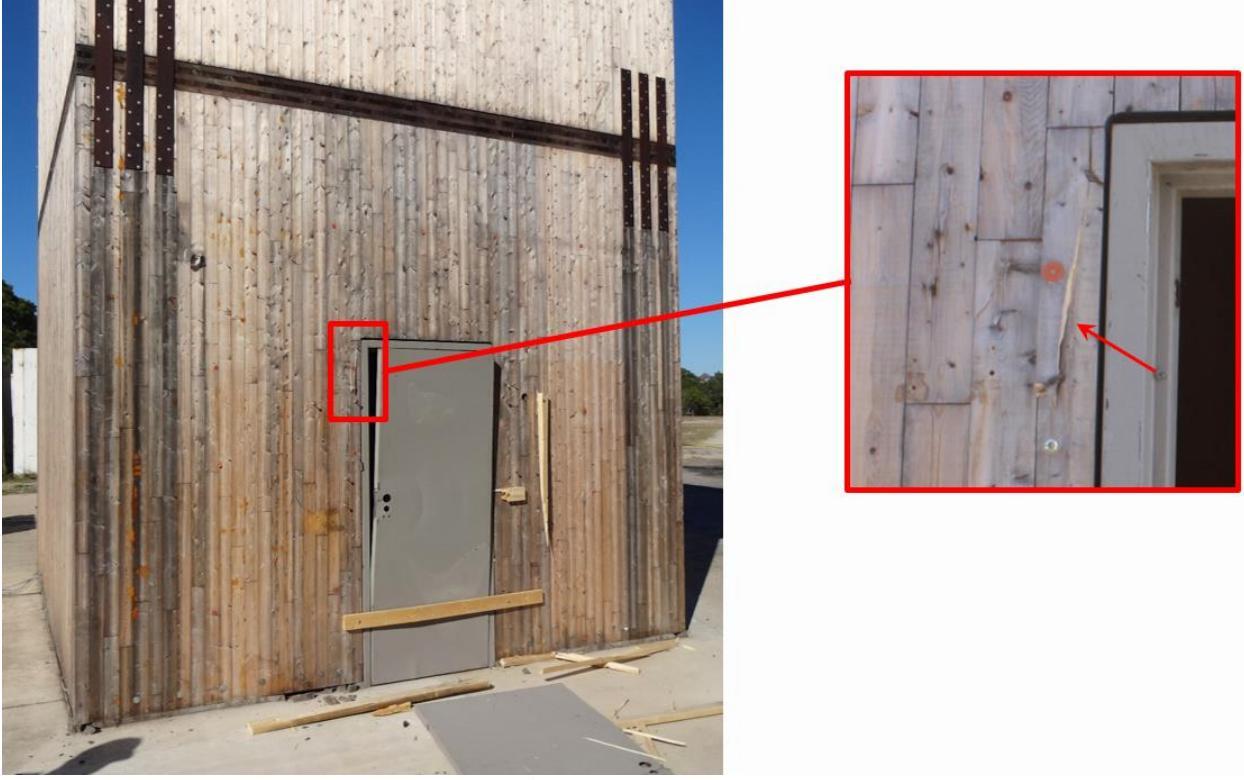
(a) 1<sup>st</sup> Floor Exterior Face. Figure 4-19. Test 7 Post-Test Photographs of Door-Side Panels in Grade E1 Structure.

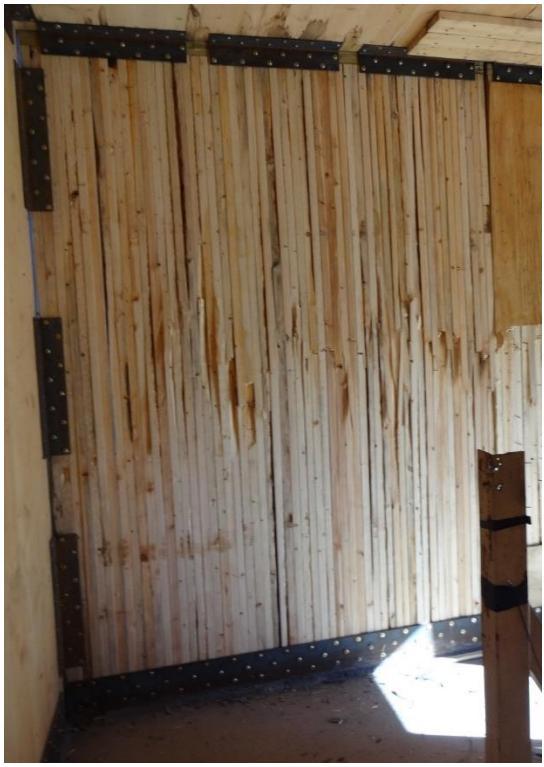
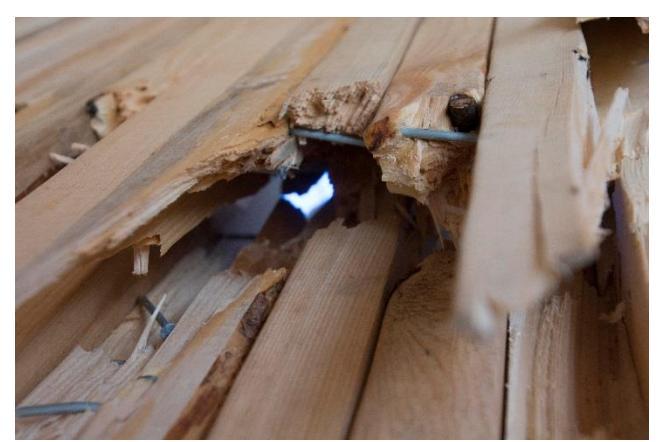
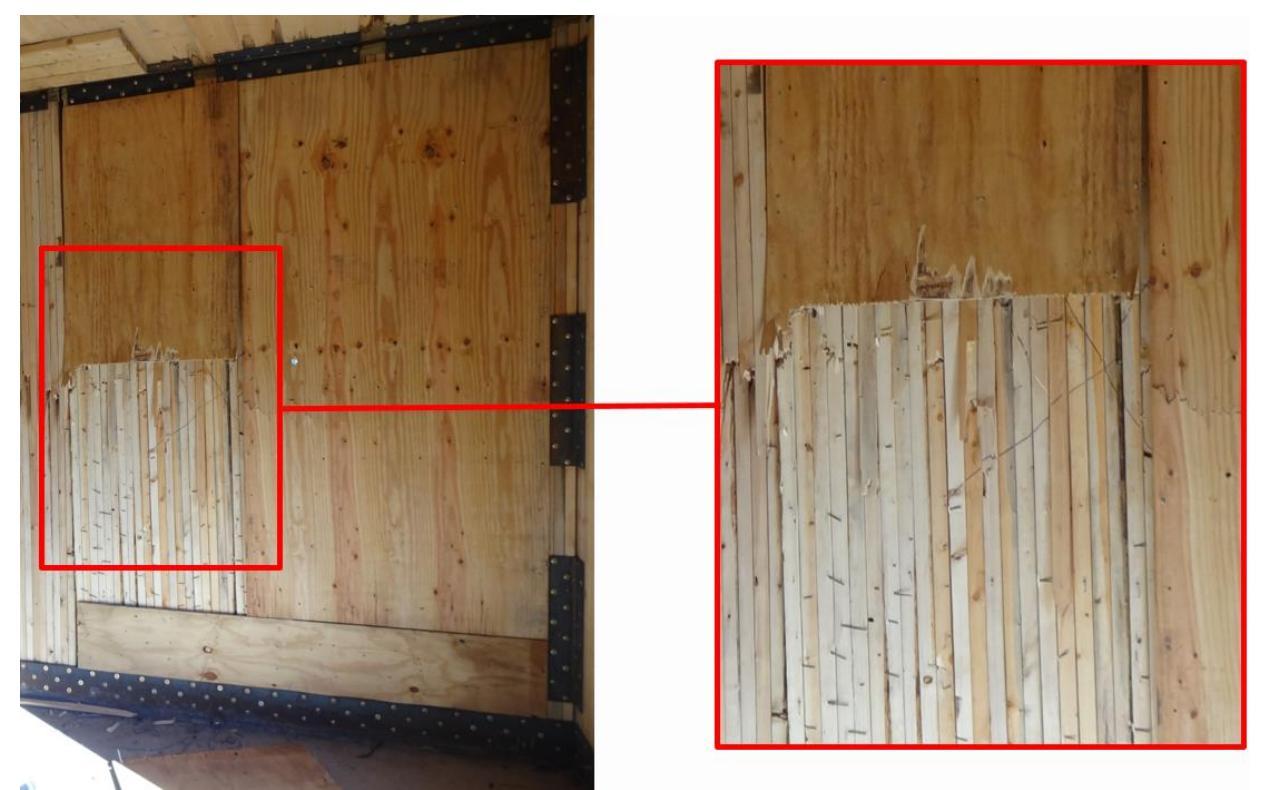
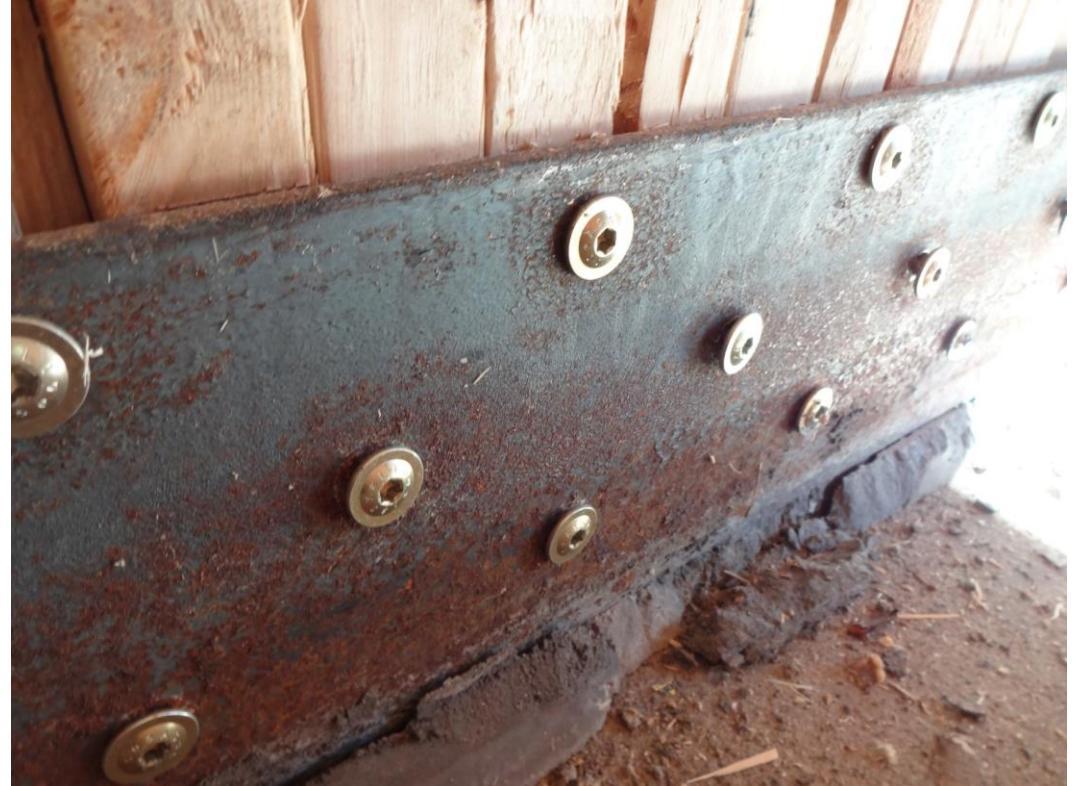
(a) Interior Face w/o Sheathing.
(b) Close-up of Stud Rupture (From Below).
Figure 4-20. Test 7 Post-Test Photographs of Front Panels in Grade V4 Structure.

(c) Interior Face of Portion of NLT Wall with Plywood Sheathing.

(h) Base Angle Connection. Figure 4-20. Test 7 Post-Test Photographs of Front Panels in Grade V4 Structure. (Cont'd) • Side Walls: Photographs documenting the condition of the 3-ply Grade V4 CLT side wall panels are included in Figure 4-21. Figure 4-21a and Figure 4-21b show the first-floor wall panel at the exterior and interior faces, respectively. Similarly, Figure 4-21c and Figure 4-21d show the first-floor wall panel at the exterior and interior faces, respectively. No damage to the side walls, either on the first or second floor, was observed at the conclusion of Test 7.

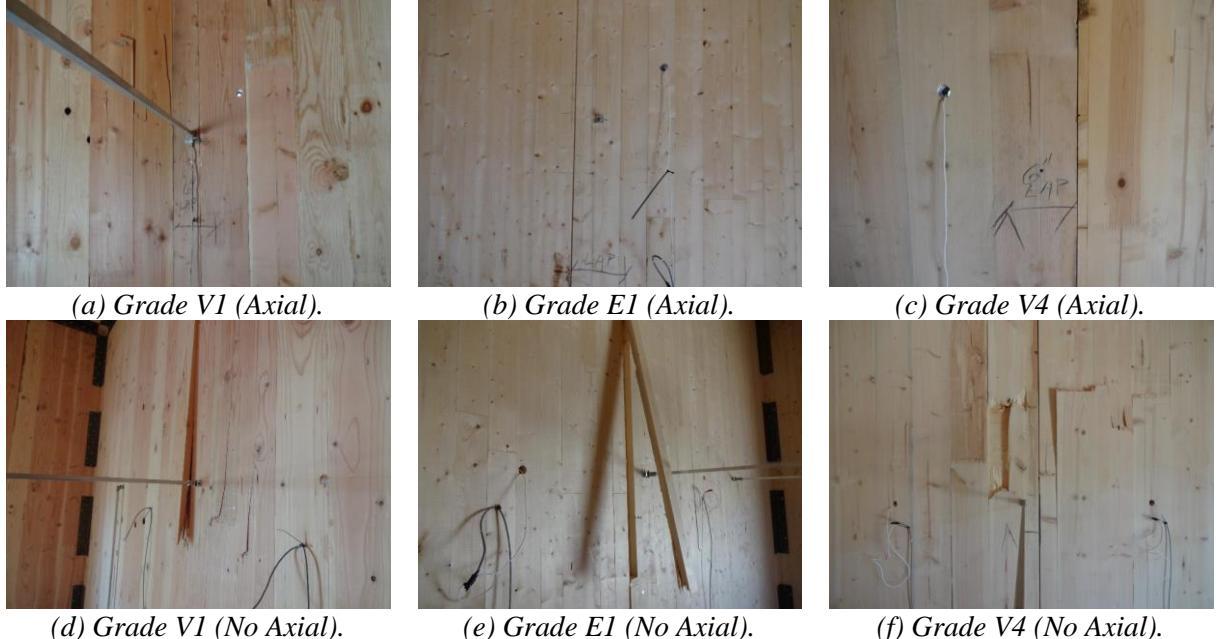
Given roughly the same applied blast load and resulting displacement response of the front wall panels, it might be presumed that the wall panel damage observed following Tests 3 and 5 would be similar. However, comparing the observed damage on the interior face of the first-floor front wall panels between the Tests 3 and 5 (Figure 5-8) indicates greater board rupture and disengagement occurred in the test structures without axial load. This finding was consistently observed across the three CLT grades considered and is consistent with the quasi-static testing documented in Chapter 2.

(d) Grade V1 (No Axial). (e) Grade E1 (No Axial). (f) Grade V4 (No Axial). Figure 5-8. Test 3/5 Damage to the Interior Face of First-Floor Front Panels.
