BLAST-RESISTANT TESTING FOR MASS TIMBER EXTERIOR WALLS: FINAL ACCOMPLISHMENT REPORT

Lisa Podesto, P.E.¹

Mark K. Weaver, S.E.²

October 9, 2017

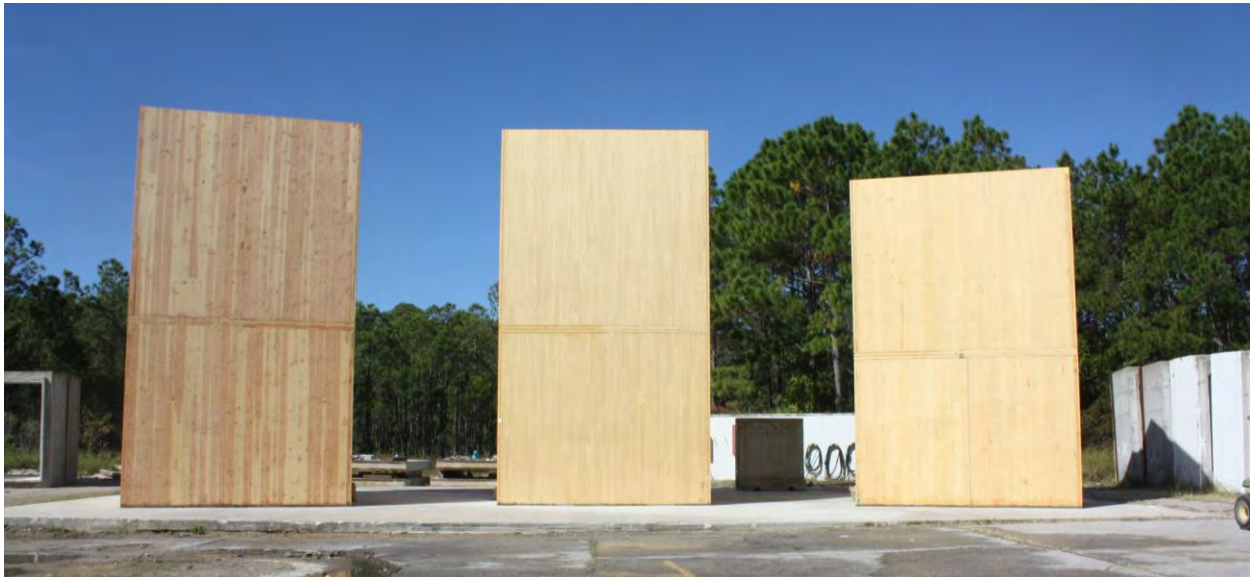
Figure 3-3. CLT Test Structures.

A series of live blast tests was planned for three two-story, single-bay CLT structures at Tyndall AFB. These structures are shown in Figure 3-3. The structures, included anchorage to an existing concrete slab, were constructed in full over a period of eight days by Lend Lease. Each structure was constructed using a different grade of CLT (i.e., grade designations V1, E1, and V4 provided by DR Johnson, Nordic Structures, and SmartLam, respectively) and included window and door openings consistent with an actual building. Actual doors were provided by American Direct and manufactured by Ambico. Self-tapping screws (provided by MyTiCon) and adhesive anchors (provided by Hilti) were utilized in concert with steel angles to connect the constituent panels of each structure.

Three shots were performed to demonstrate the effectiveness of CLT over a spectrum of blast loads. The first two shots were designed to stress the CLT structures within their respective elastic limits. The third shot was designed to push the structures beyond their elastic limits such

that post-peak response could be observed. Reflected pressure and peak deflections were recorded at front, side, and roof faces using a total of sixty-two gages to thoroughly document the response of the structure in time.

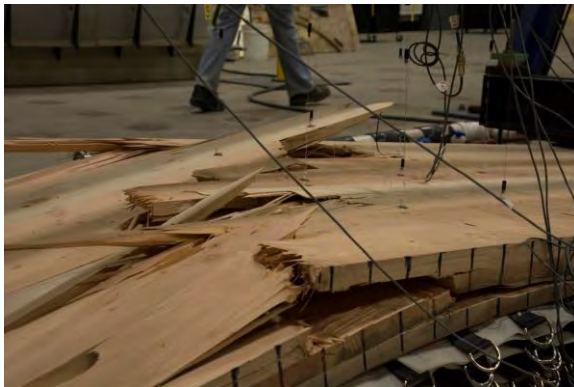
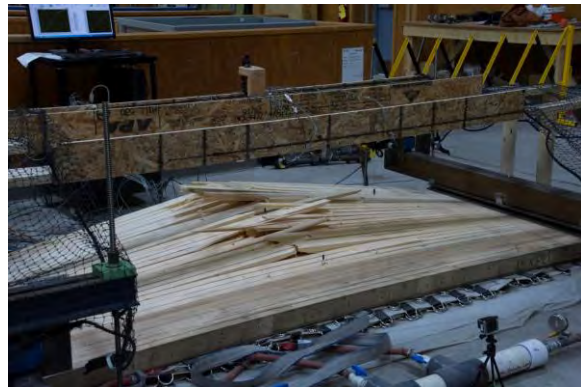
Figure 4-1. Photo of Typical 3-ply CLT Panel at End of Test.

Panel tests without connections typically failed due to rupture of the outermost tension ply at finger joints, knots, or sloped grain. The typical failure pattern observed for a CLT and NLT panel is shown in Figure 4-1.

(a) CLT Panel.

(b) NLT Panel.

- When CLT panels ruptured due to flexure, negligible shear slip between panel plies away from the location of panel rupture was observed. This observation lends credence to a fully-composite panel, at the core of the shear analogy method.
- The shear analogy method can be employed with the characteristic values shown in Table 1 of PRG 320 to faithfully reproduce the observed elastic bending stiffness for the grades and ply numbers tested. Figure 4-2 shows this computed stiffness as a dark gray line. As can be observed from Figure 4-2, CLT panel response was essentially linear elastic prior to panel rupture.
- The shear analogy method, with the 0.85 reduction factor included in PRG 320, can be used with the characteristic values shown in Table 1 of PRG 320 to generate a lower-bound

- The NLT panels failed in flexure near panel mid-span at values very close to that predicted by SBEDS. Typically, one stud would rupture first and then its neighbors would fail in a zipper fashion. This response led to highly unbalanced panels where one half was nearly intact and showed minimal deflection while the other half would be completely ruptured and have a mid-span deflection upwards of 10 inches. This result is in direct contrast with the failure observed in CLT panels, which was not localized in one portion of the panel. This observation indicates there is not a high distribution of load in NLT panels as compared to CLT panels.

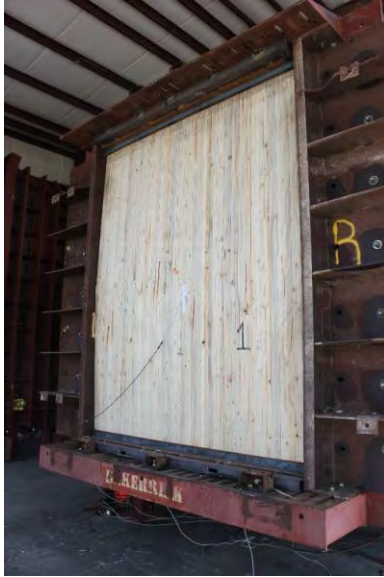
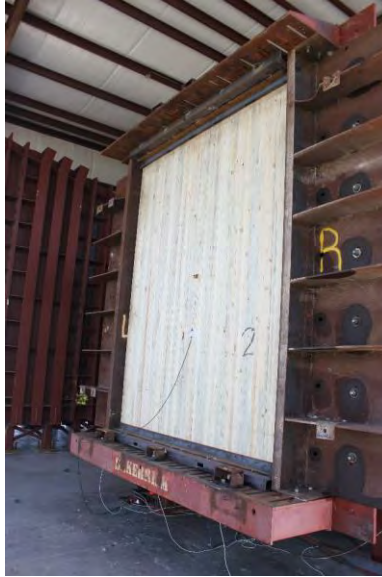
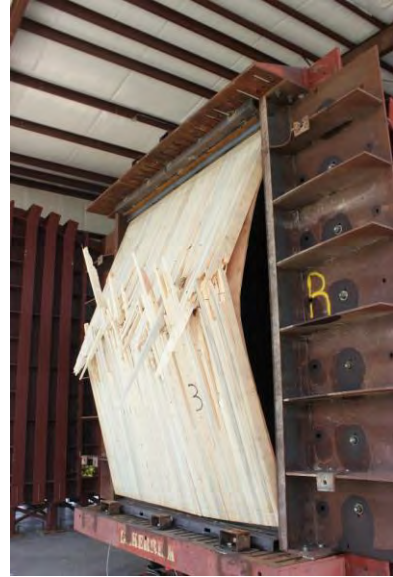
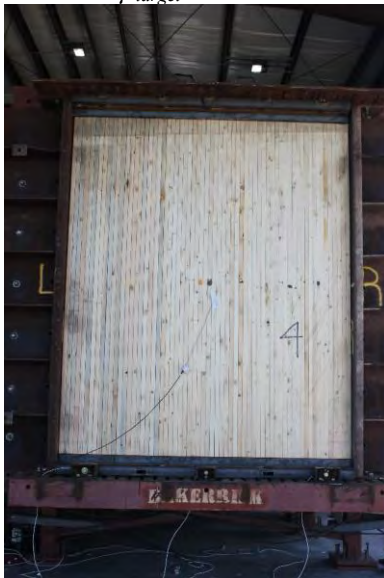
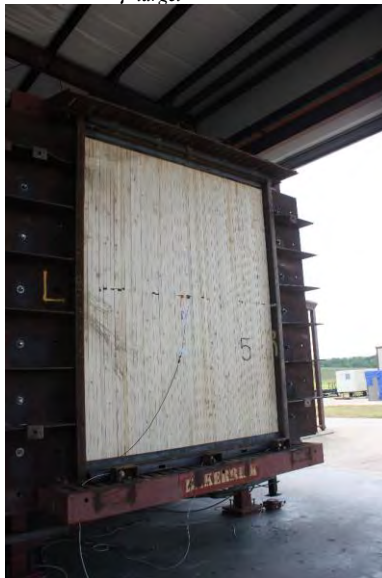
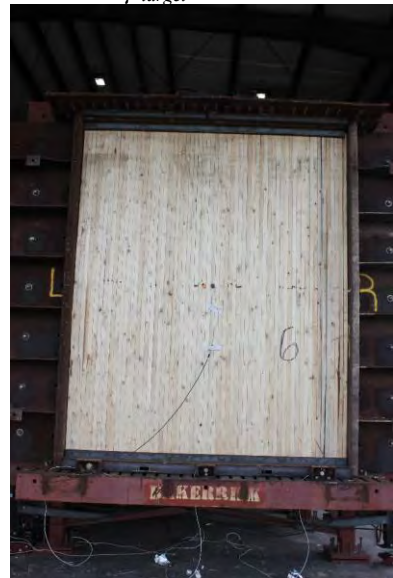
Figure 4-3. Post-Test Photographs of NLT Shock Tube Testing.

A summary of the shock tube testing results is included as Table 4-1. Also, photographs of the panels following each test is included as Figure 4-3.

(a) Test 2: 2x4 NLT
 $\mu_{\text{target}} = 0.75$.

(b) Test 1: 2x4 NLT
 $\mu_{\text{target}} = 1.00$.

(c) Test 3: 2x4 NLT
 $\mu_{\text{target}} = 1.25$.

(d) Test 4: 2x6 NLT
 $\mu_{\text{target}} = 0.75$.

(e) Test 5: 2x6 NLT
 $\mu_{\text{target}} = 1.00$.

(f) Test 6: 2x6 NLT
 $\mu_{\text{target}} = 1.25$.

- Significantly different qualitative responses were observed between the 2x4 and 2x6 NLT panels for the same target displacement ductility. This result is most clearly illustrated when target ductility was set equal to 1.25 (i.e., tests 3 and 6) where the 2x4 NLT panel completely was blown out while the 2x6 NLT panel simply exhibited minimal rupture and remained completely supported by the frame. This result calls into question the use of ductility as the sole factor in dictating response limit.

- Blow out occurred at a ductility response limit of 1.25 for the 2x4 NLT. As the blowout response limit for non-load bearing wood studs is displacement ductility of 4 according to PDC-TR 06-08 [33], these shock tube tests indicate that the ductility response limits for wood may require modification but more testing would be required to verify this.
- The analytical model for 2x6 NLT in SBEDS consistently underpredicted (by as much as 30 percent) the peak response observed in the shock tube testing. As these panels generally exhibited elastic response (except for Test 6), it is possible that the either the computed panel stiffness was underestimated or the assumed panel weight was overestimated.

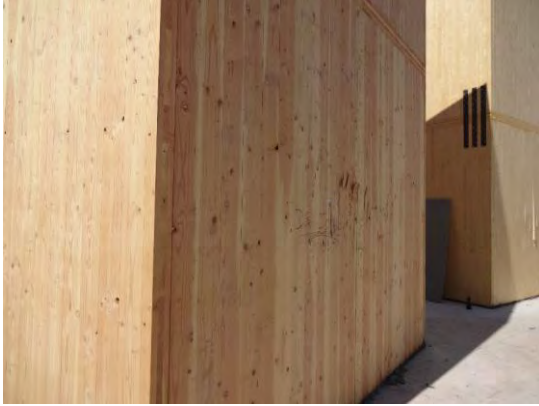
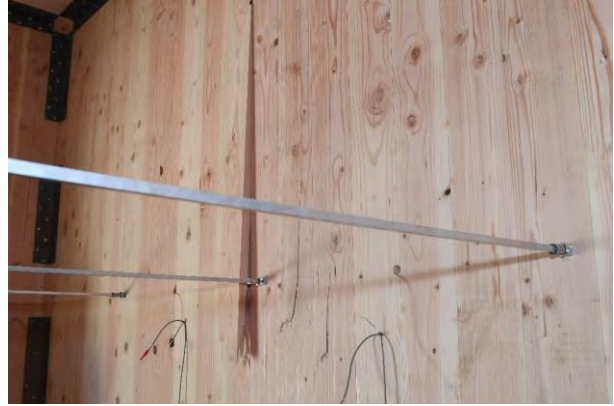
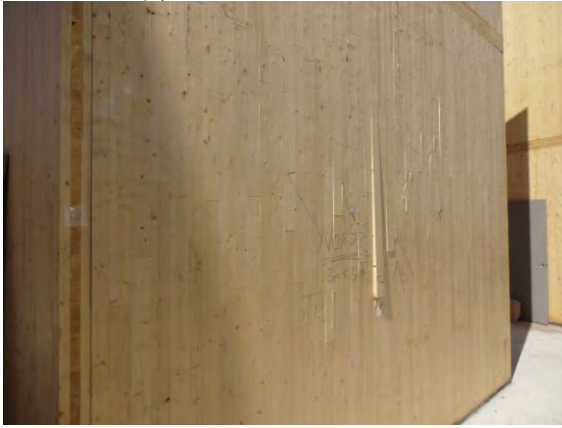
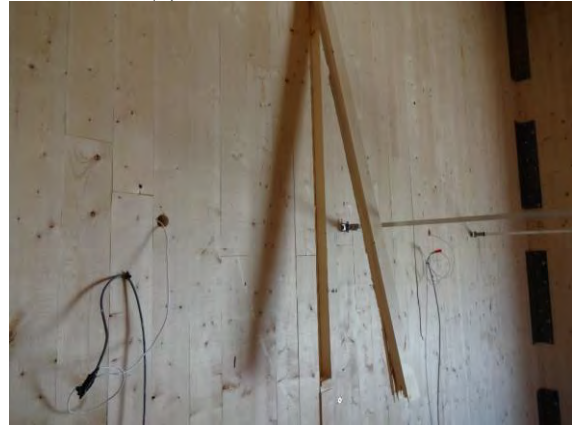
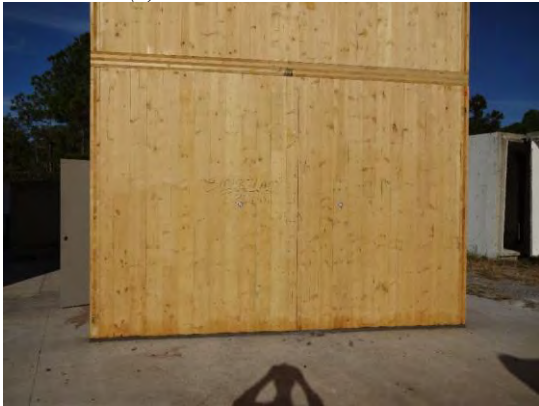
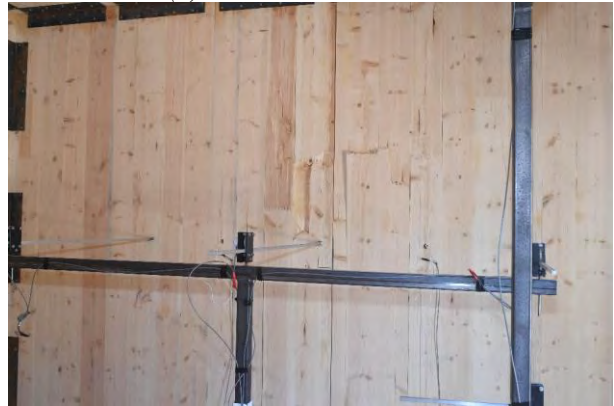
Figure 4-4. Shot 3 Post-Test Photographs of 1st Floor Front Panel.

The tests proceeded as planned and the CLT structures responded as expected. For the first two tests, peak recorded deflections were consistent with pre-test predictions indicating the efficacy of the design assumptions and methodology in predicting elastic response of CLT to dynamic loads. Furthermore, results from the third test indicated a controlled response in which localized panel rupture was observed but connection integrity and load carrying ability were not compromised for each of the three structures tested. Photographs showing the front and back face of the first-floor panel that ruptured in all three test structures is included as Figure 4-4.

(a) Grade VI – Exterior.

(b) Grade VI – Interior.

(c) Grade E1 – Exterior.

(d) Grade E1 – Interior.

(e) Grade V4 – Exterior.

(f) Grade V4 – Interior.

- Localized CLT panel rupture can be sustained without adverse consequences to the CLT system's connections and load carrying ability. Further testing can be used to investigate the impact of localized CLT panel rupture for different conditions (e.g., different in-plane axial loads, different connection configurations, etc.).

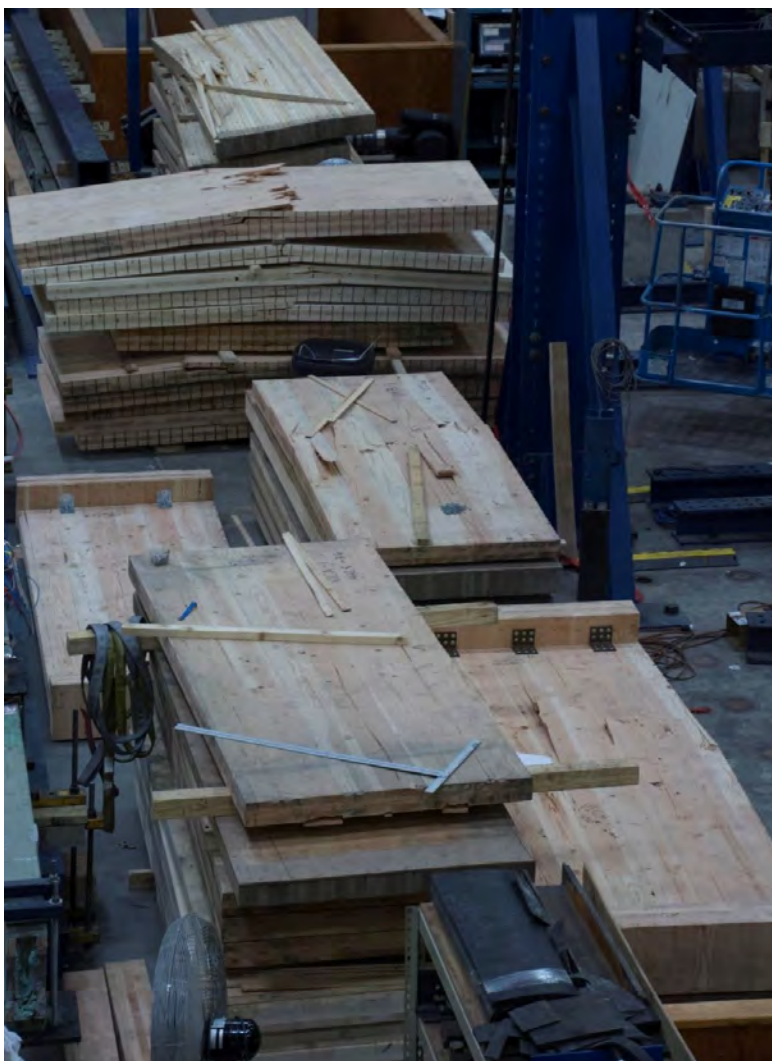
Figure 1-1. Panels Following Testing.

The University of Maine (UMaine) in conjunction with WoodWorks and Karagozian & Case, Inc. (K&C) performed a testing program aimed at investigating the bending response of cross-laminated timber (CLT) and nail laminated timber (NLT) panels in their major strength direction under a uniformly-applied quasi-static load. The apparatus utilized for the testing was developed by UMaine and consisted of a series of rubber bladders filled with water capable of applying a uniform quasi-static pressure in a controlled fashion. Applied pressure, out-of-plane deflection, and total resisted load were measured and recorded as panels were displaced well beyond the deflection associated with peak panel strength. While most of the panels were tested with end conditions that did not restrain panel rotation, six were tested with connections meant to represent those that might be used to attach a wall to a floor and ceiling in a building designed to resist significant out-of-plane wall loading. Panels following testing are shown in Figure 1-1.

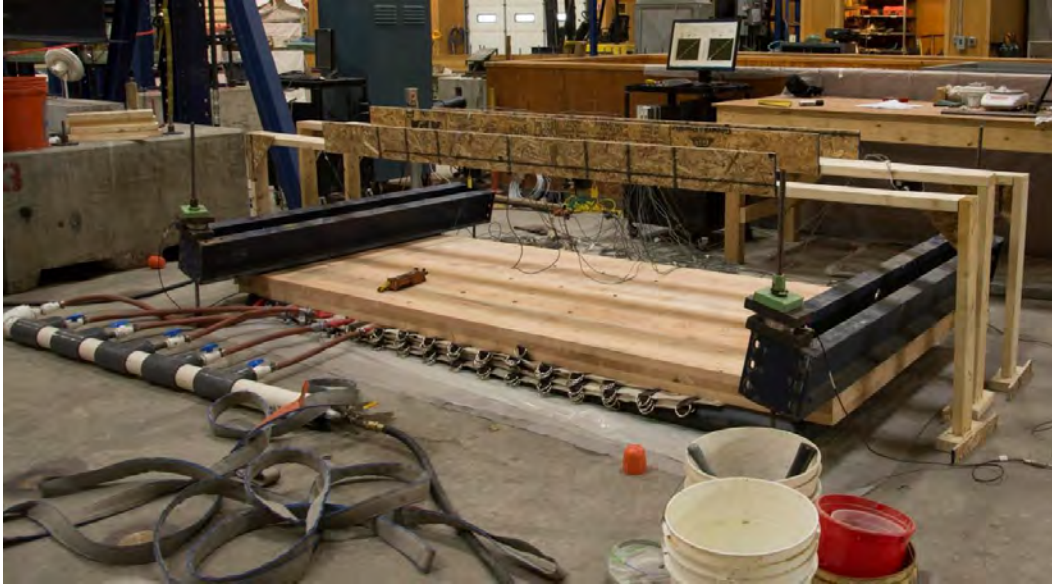
panel end was applied with a large enough eccentricity (i.e., with respect to the channels' shear center) to cause the channels to rotate and the tension rods to yield (see Figure 3-2). As such, the back-to-back channels were replaced with a tube with two tension rods at each end of each crossbar early in the testing program.

Figure 3-2. Failure of Initial Crossbar.

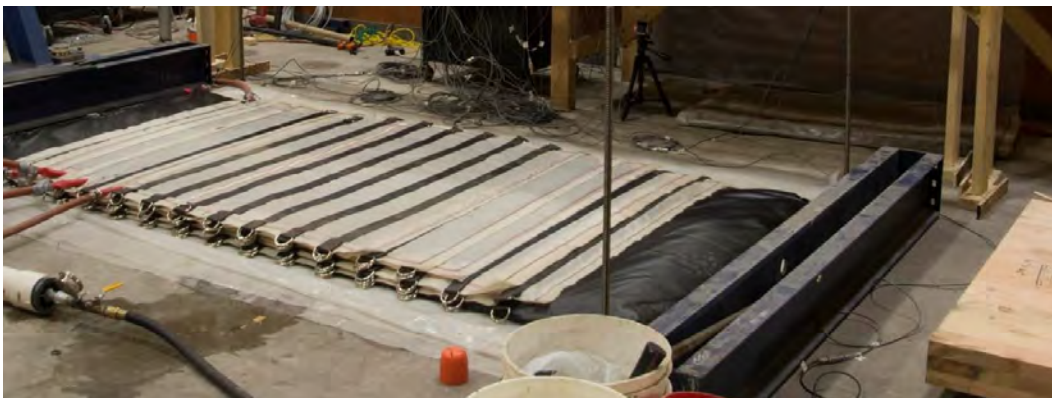
Prior to each test, a series of rubber bladders were placed on the concrete reaction floor directly underneath the panel. The bladders were centered on the panel and piled on top of each other in order of decreasing length (i.e., the longest was placed on the reaction floor and the shortest was placed on the top). Bladders were 3'-6", 5'-0", 5'-10", 6'-2", 7'-4" and 10'-0" long and 4'-0" wide in all circumstances. After the 10'-0" bladder burst (see test 5V1-2 in Table 2-2), it was replaced with 3'-6" and 7'-4" long bladders at the lowest level. Each bladder was encased in a woven bag to minimize outward deformation. The bladders in place prior to panel placement can be seen in Figure 3-3.

Figure 3-3. Bladders in Place Prior to Panel Placement.

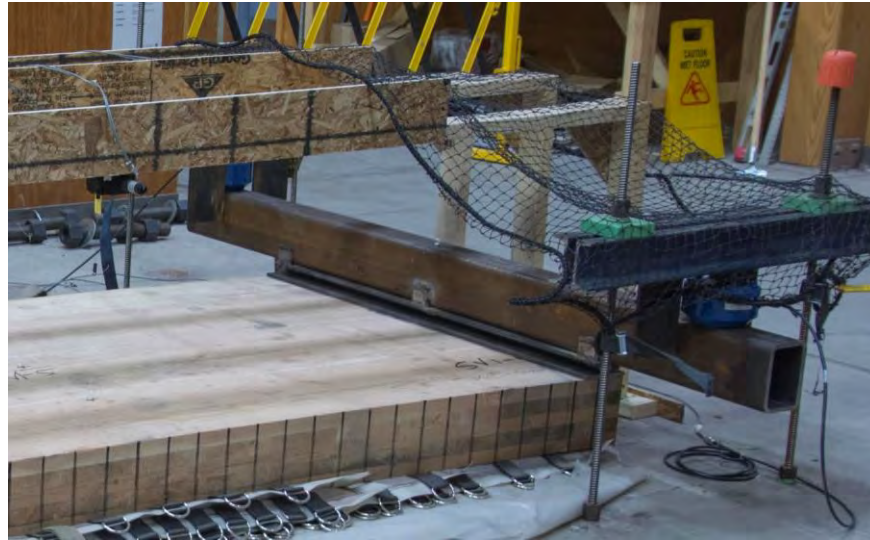
Filling the bladders with water caused the panels to deflect upwards. The bladders were filled with tap water from a 3-inch diameter PVC distributor that ensured that the water in all of them had the same pressure. Pressure was measured via a pressure transducer (PT 1) at one bladder away from the water flow and with an analog meter where the hose enters the distributor. The ends were free to rotate due to a 48-inch-long, 1.25-inch-diameter steel cylindrical bar between the crossbar and the panel. The simply supported panels had a structural span of 10'-0" from roller to roller. A photograph of the final configuration for the “simple” test setup configuration is included as Figure 3-4.

Figure 3-4. “Simple” Test Setup Configuration.

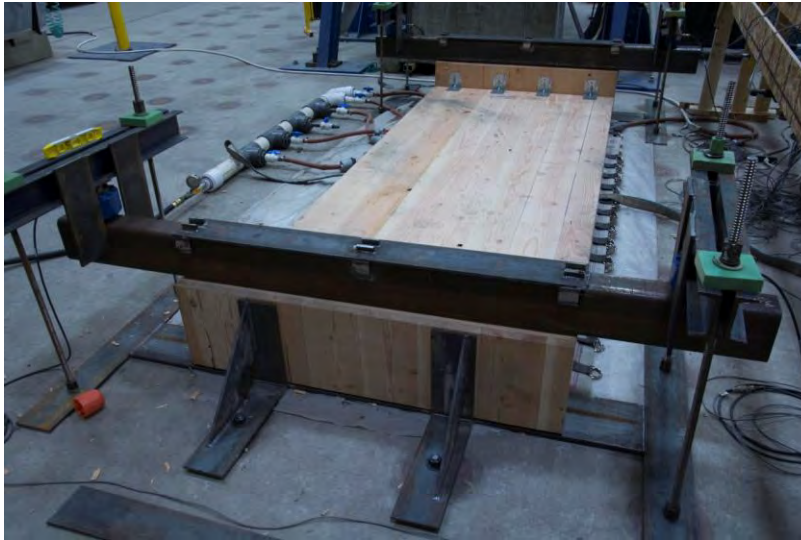
The “semi-rigid” configuration utilized the crossbar and tension rod system of the “simple” configuration, but replaced the cylindrical bar with stub end pieces of a 5-ply CLT panel to which angle brackets were secured. The resulting span from inside of end piece to inside of end piece was 9'-6" (i.e., the length of the panel). To prevent the end pieces from sliding or rotating during testing, a steel brace was installed on the back side of the end pieces and the tension bars were wrench-tightened to provide a pretension force of between one and two thousand pounds. A photograph of the “semi-rigid” test setup configuration is included as Figure 3-6.

Figure 3-6. “Semi-Rigid” Test Setup Configuration.

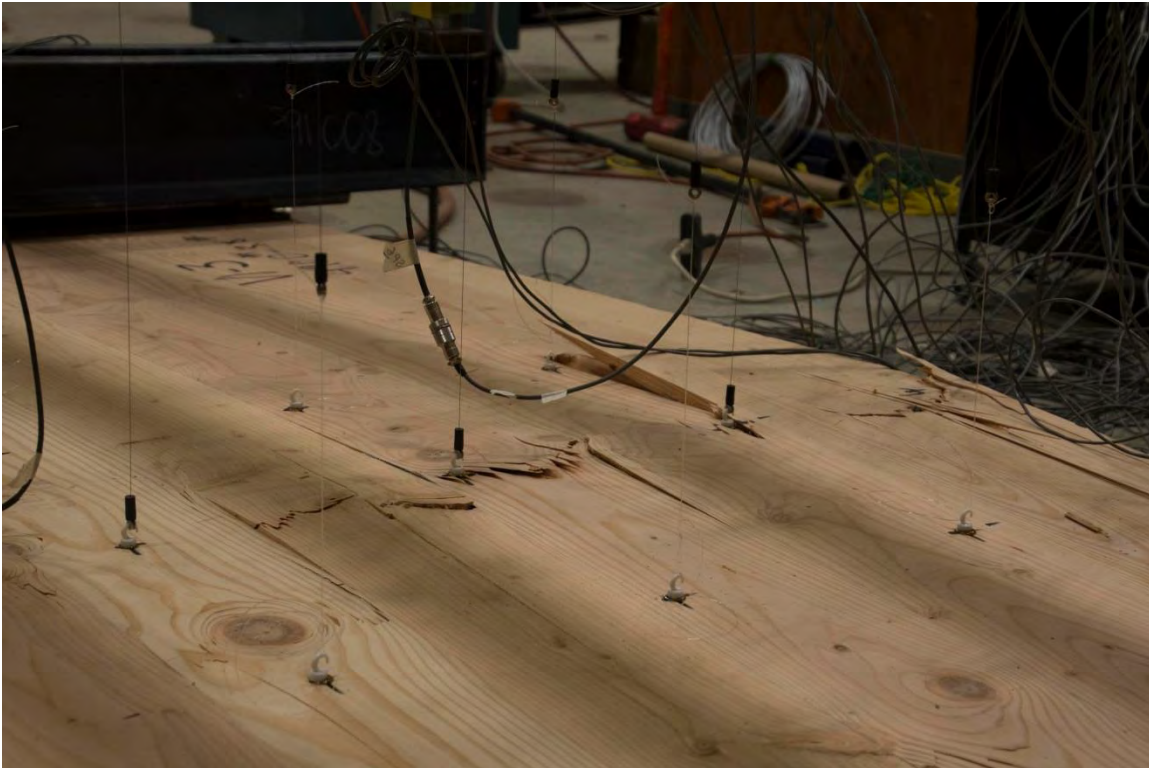
Figure 3-9. Connection of String Potentiometers to Panels.

- The string potentiometers were hung from a timber frame that was supported by legs resting directly on the concrete reaction floor. There was no connection between the test fixture and the timber frame other than the concrete floor.
- Hooks were glued to the panels and a loop at the end the string was pulled over the hook (see Figure 3-9).

- String potentiometer (see Figure 3-8 for location in plan)
 - Panel deflection was measured at eleven locations using string potentiometers (SPs) with 10-inch and 25-inch strokes. One 10-inch SP was attached at the mid-span of each crossbar to measure crossbar displacement (i.e., SP 4 and SP 8). The remaining SPs were placed in a 3×3 grid centered at panel mid-span. SP 5, 6, and 7 had a 25-inch stroke and SP 1, 2, 3, 9, 10, and 11 had a 10-inch stroke.

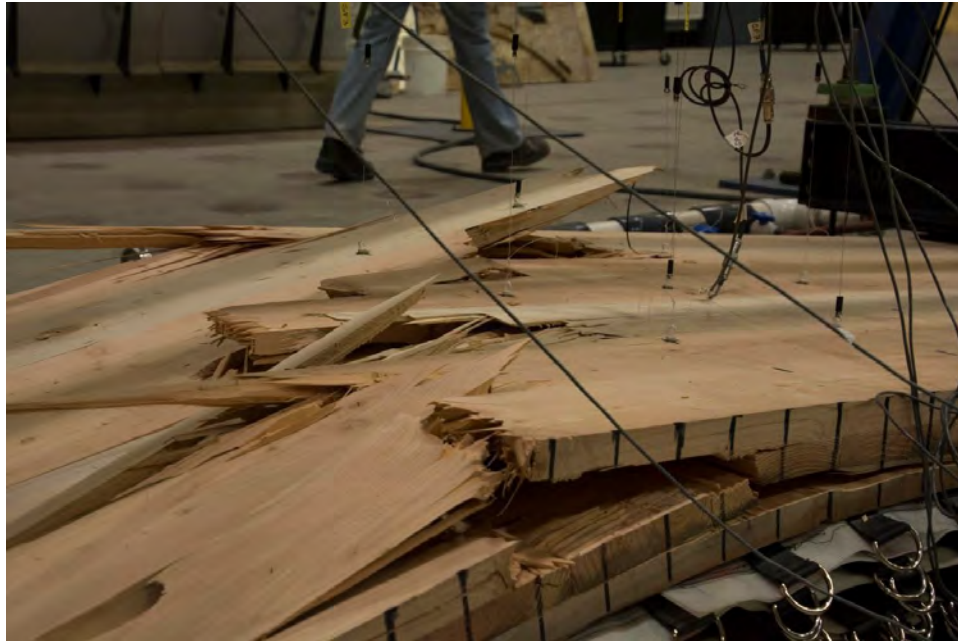
Typically, one or more SP would detach during the initial violent failure, occasionally more would come off in subsequent failures, and eventually, in general, the remaining 10-inch SP would reach the end of their stroke. Testing was typically complete within ten minutes. Figure 3-10 shows a typical 3-ply CLT panel near the end of its test.

Figure 3-10. Photo of Typical 3-ply CLT Panel at End of Test.

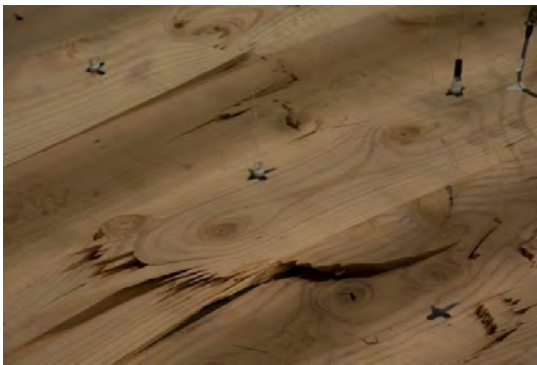
Figure 4-1. Typical Panel Failure Locations.

Table 4-1 records the observed limit state and the peak panel strength for each test. With one notable exception, all CLT panels without connections (i.e., “simple” test setup configuration) failed near panel mid-span, presumably due to flexural stress. The location of panel rupture typically centered on knots, sloped grain, and finger joints (see Figure 4-1). No shear slip between panel plies away from the location of panel rupture was observed.

(a) Sloped Grain.

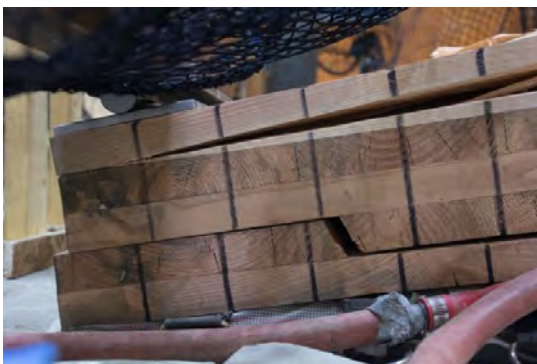
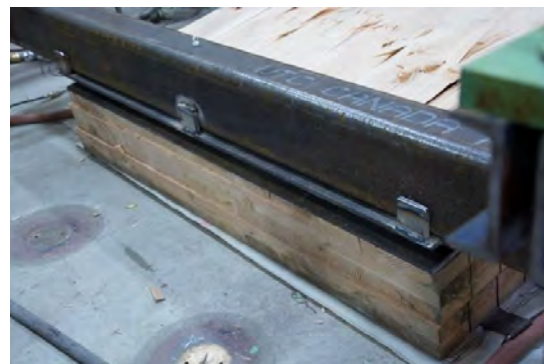
Figure 4-2. CLT Panel with Shear Failure at Support.

One 5-ply Grade V1 CLT panel failed in shear near the supports. Failure was initiated at a point internal to the panel, thus making it difficult to observe failure progression in time. Figure 4-2 shows photographs of the 5-ply panel that failed in shear.

(a) Side View.

(b) Top View.

Excluding the Grade V4 panels, which arrived to the lab much later, it is worth noting that the 5-ply CLT panel that failed in shear was the final CLT panel tested in the “simple” test setup configuration, and thus had the lowest moisture content (see Table 2-2). It was noted that as panels dried, significant inter-layer stresses developed leading to checking and some joint failure along the panel edges (see Figure 4-3). Thus, the different limit state observed for the final 5-ply test could be related to panel moisture content and the imperfections that resulted, but in the absence of further testing this theory is conjecture.

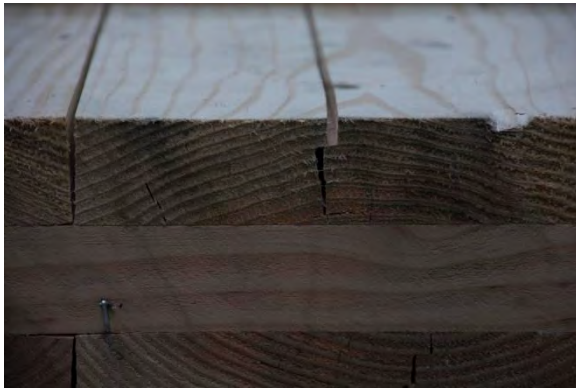
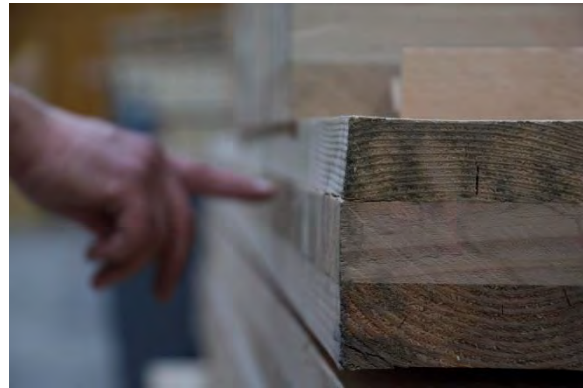
Figure 4-3. Localized Deformation in CLT Panels.

(a) *Checking.*

(b) *Bond Failure.*

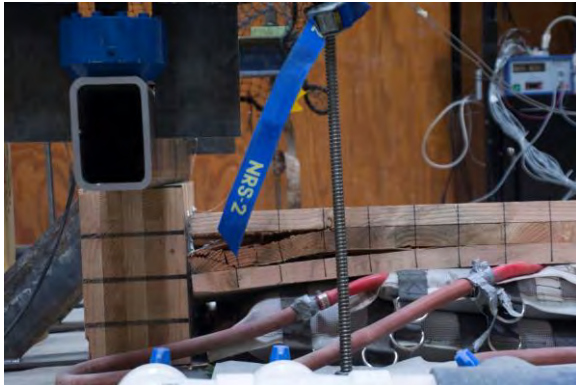
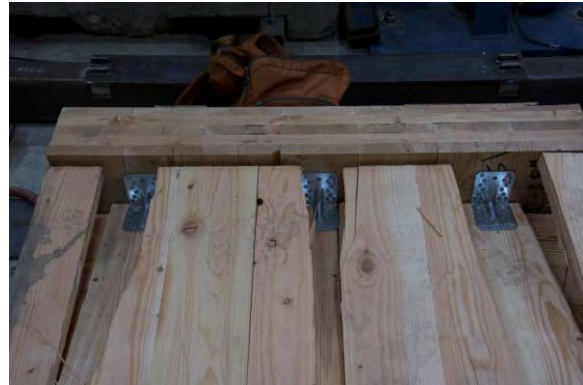
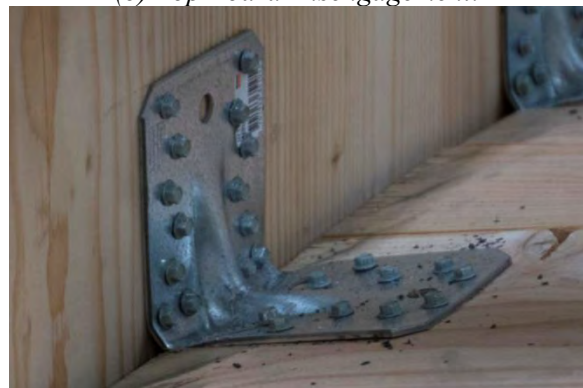
Figure 4-5. Failure Modes Associated with Simpson Brackets.

The panels with the Simpson Strong-Tie (SST) angle brackets (i.e., V1CA-2 through V1CA-4) typically exhibited shear failures near one end of the panel (see Figure 4-5(a)). For the test in which four SST brackets were installed at each end (i.e., V1CA-2), the shear failure precipitated a flexural failure near panel mid-span. For the tests in which two and three SST brackets were installed at each end (i.e., V1CA-3 and V1CA-4), top boards not directly supported by angle brackets pulled away from those that were (see Figure 4-5(b)). In general, the SST brackets were capable of deforming significantly while still being able to support their respective loads (see Figure 4-5(c)). Additionally, both a small amount of wood crushing beneath the SST angle brackets and fastener pullout was observed (see Figure 4-5(d)).

(a) Shear Failure.

(b) Top Board Disengagement.

(d) Wood Crushing & Fastener Pullout.

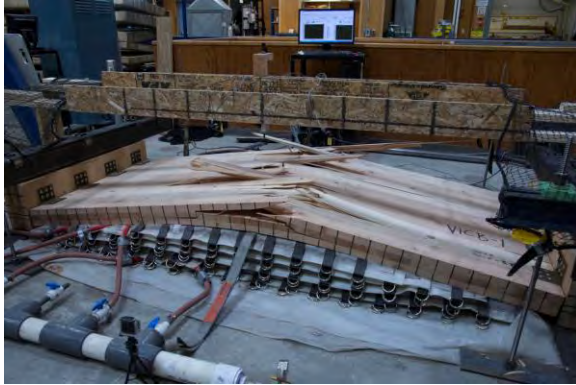
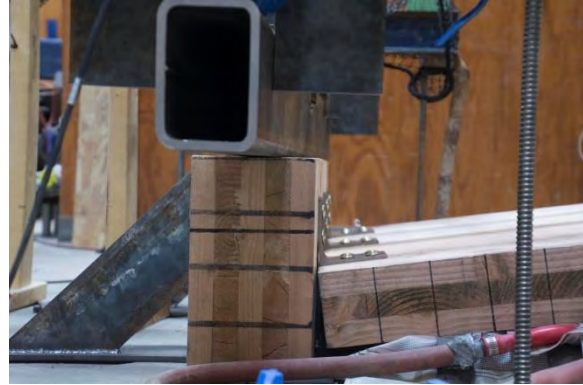
Figure 4-6. Failure Modes Associated with L4x4x1/4 Brackets.

By contrast, the panels with L4x4x1/4 angle brackets typically exhibited a flexural failure response near mid-span (see Figure 4-6(a)) similar to the predominant failure mode observed for panels tested in the “simple” test setup configuration. For the tests in which two brackets were installed at each end (i.e., V1CB-4), a few of the top boards not directly supported by angle brackets pulled away from those that were. As with the SST brackets, the L4x4x1/4 brackets yielded (see Figure 4-6(b)), but unlike the SST brackets, no fastener pullout or wood crushing was observed.

(a) *Flexural Failure.*

(b) *Bracket Deformation.*

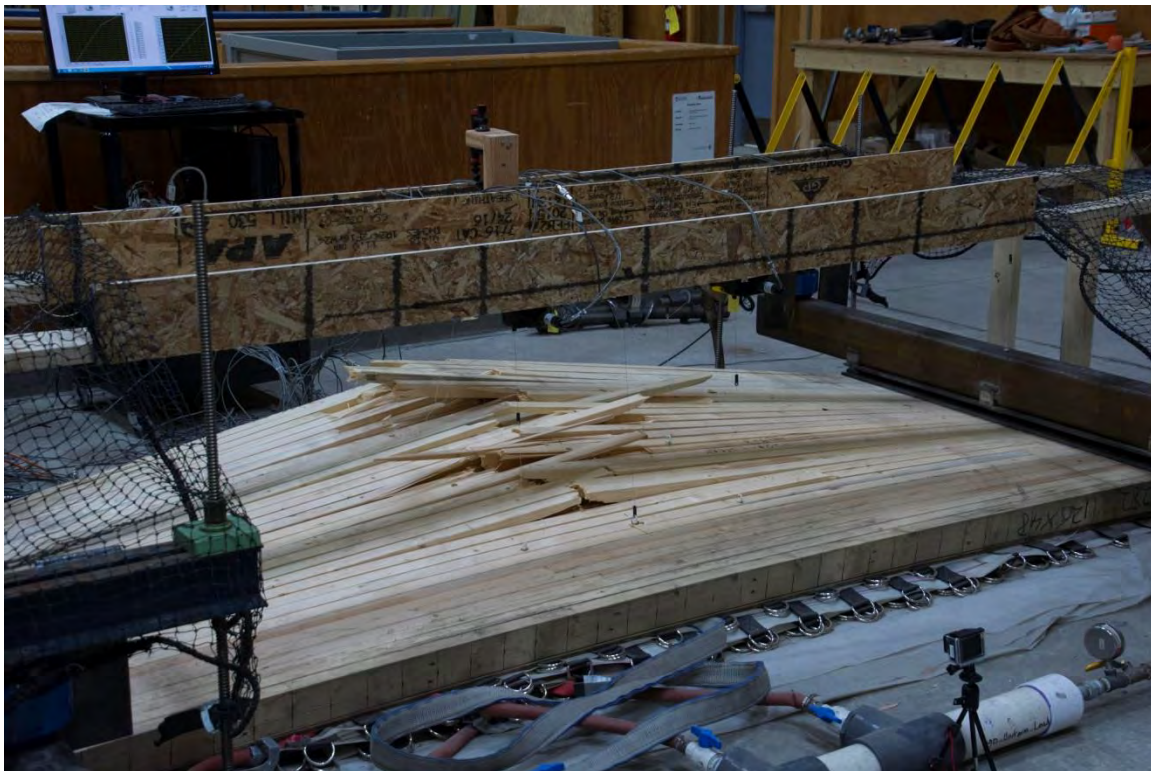
The NLT panels failed in flexure near panel mid-span. Typically, one stud would rupture first and then its neighbors would fail in a zippering fashion. This response led to highly unbalanced panels where one half was nearly intact and showed minimal deflection while the other half would be completely ruptured and have a mid-span deflection upwards of 10 inches. Figure 4-7 shows a typical example of this response.

Figure 4-7. Asymmetric Flexural Failure of NLT Panel.

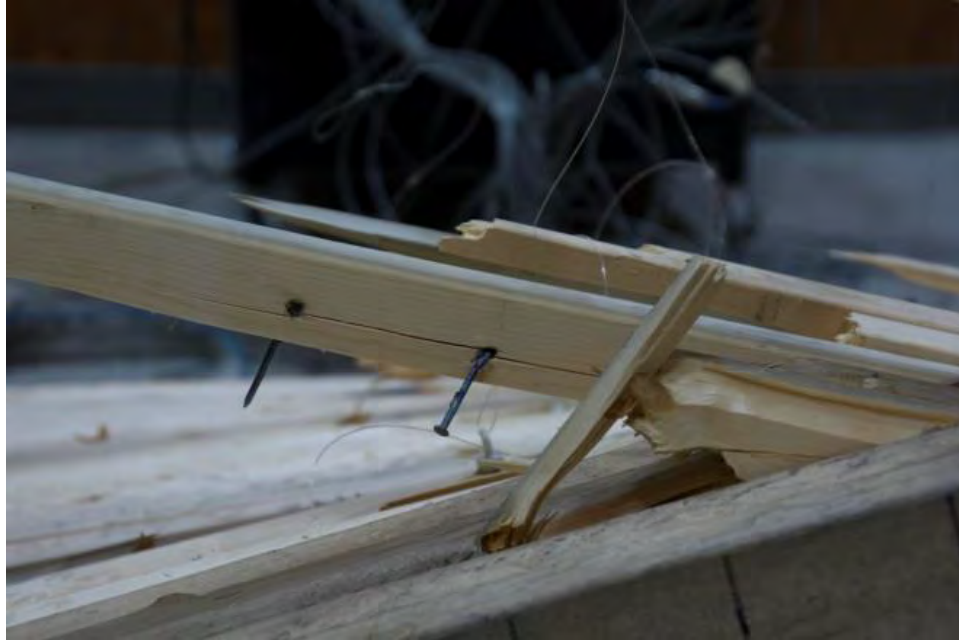
Significant rotation of the boards relative to one another occurred due to the asymmetric deformation. Nail pullout and yielding was observed as well (see Figure 4-8). Prior to failure, panels were uniformly deflected. As some of the boards broke, the others rebounded as the pressure diminished and the water shifted to the failed portions of the panel.

Figure 4-8. Details of NLT Panel Failure.

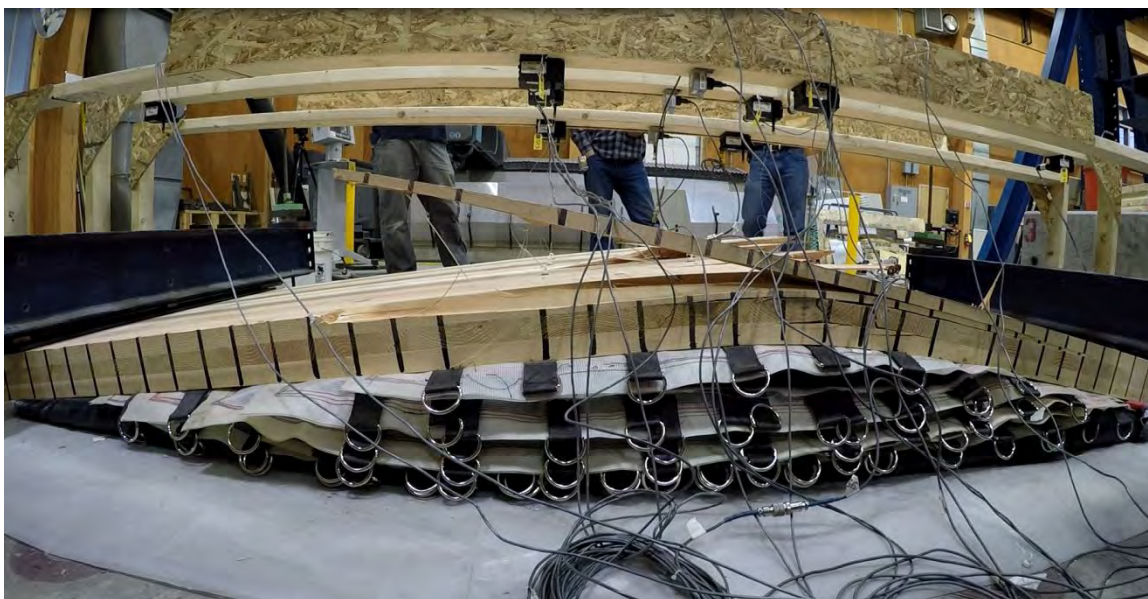
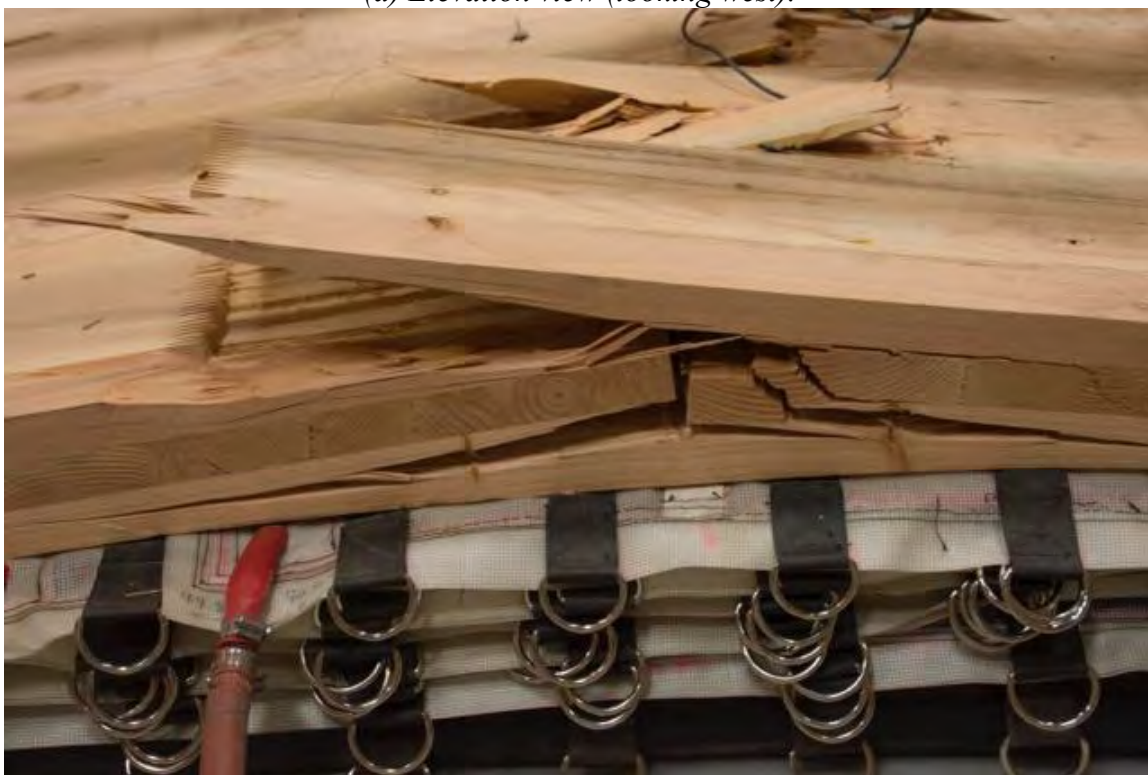
Figure A-1. 3-Ply Grade V1 CLT – Test 1 (V1-1).

(a) Elevation view (looking west).

(b) Detail view (looking east).

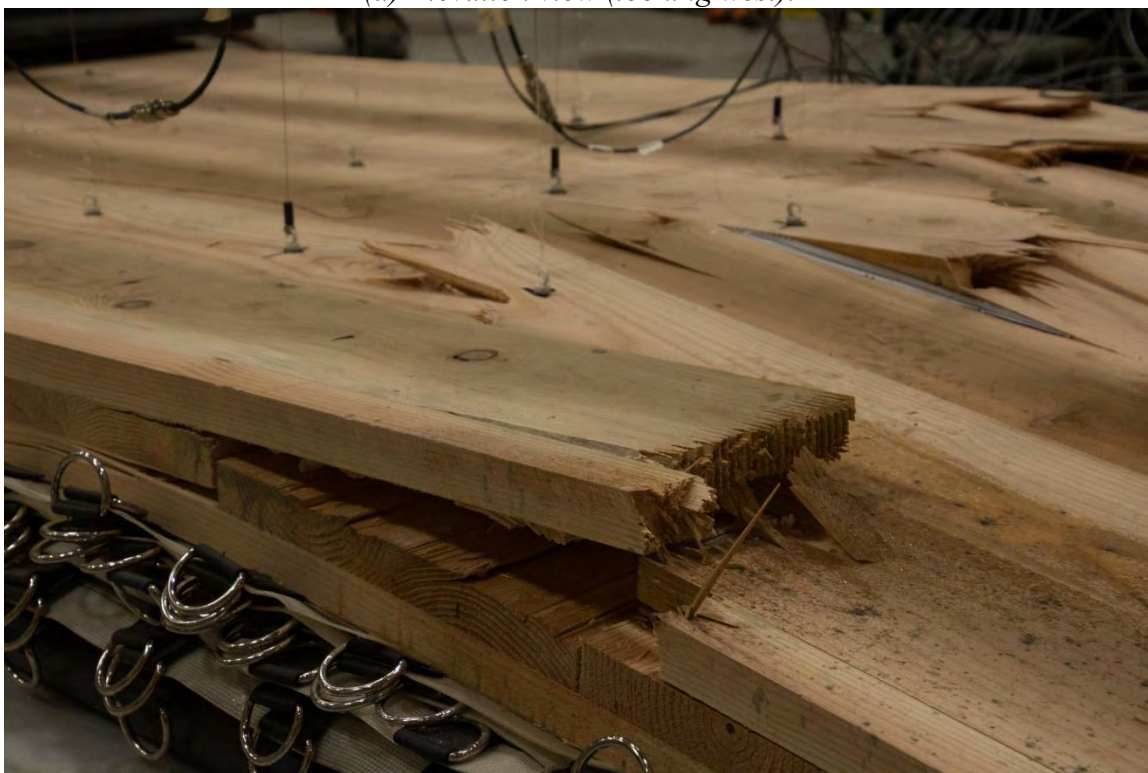
Figure A-2. 3-Ply Grade V1 CLT – Test 2 (V1-2).

(b) Detail view (looking east). (Note white plastic between adjacent boards.)

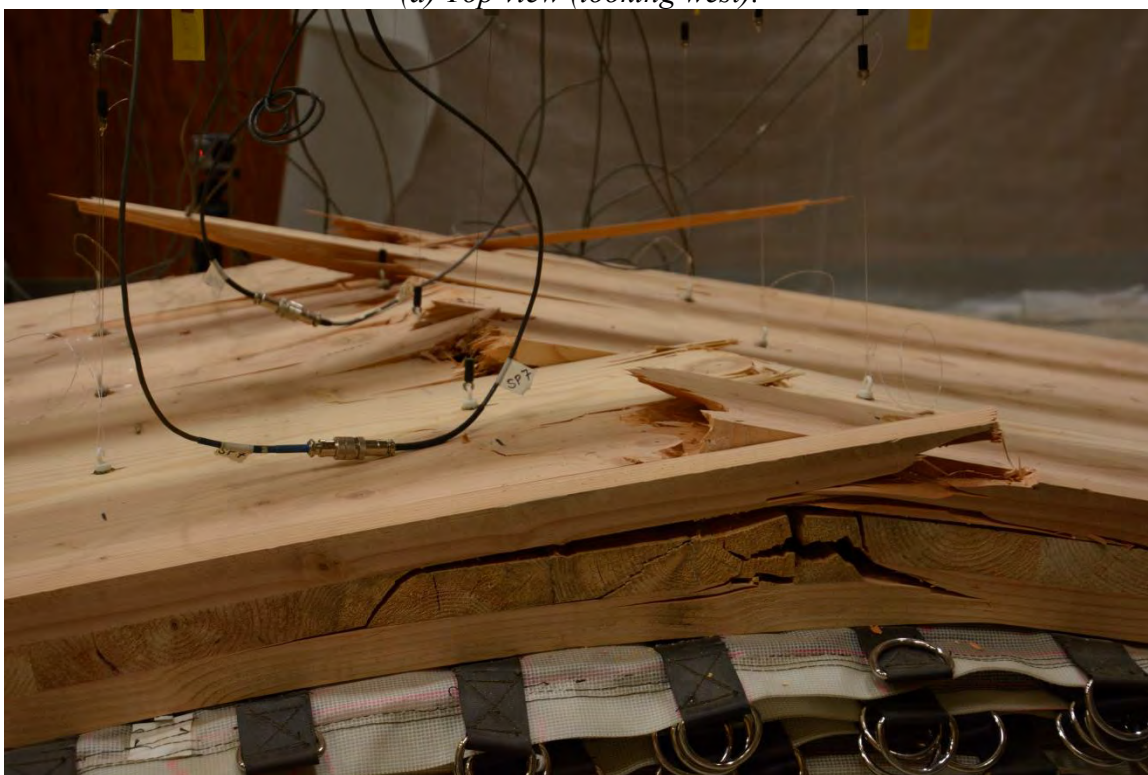
Figure A-3. 3-Ply Grade V1 CLT – Test 3 (V1-3).

(b) Detail view (looking east).

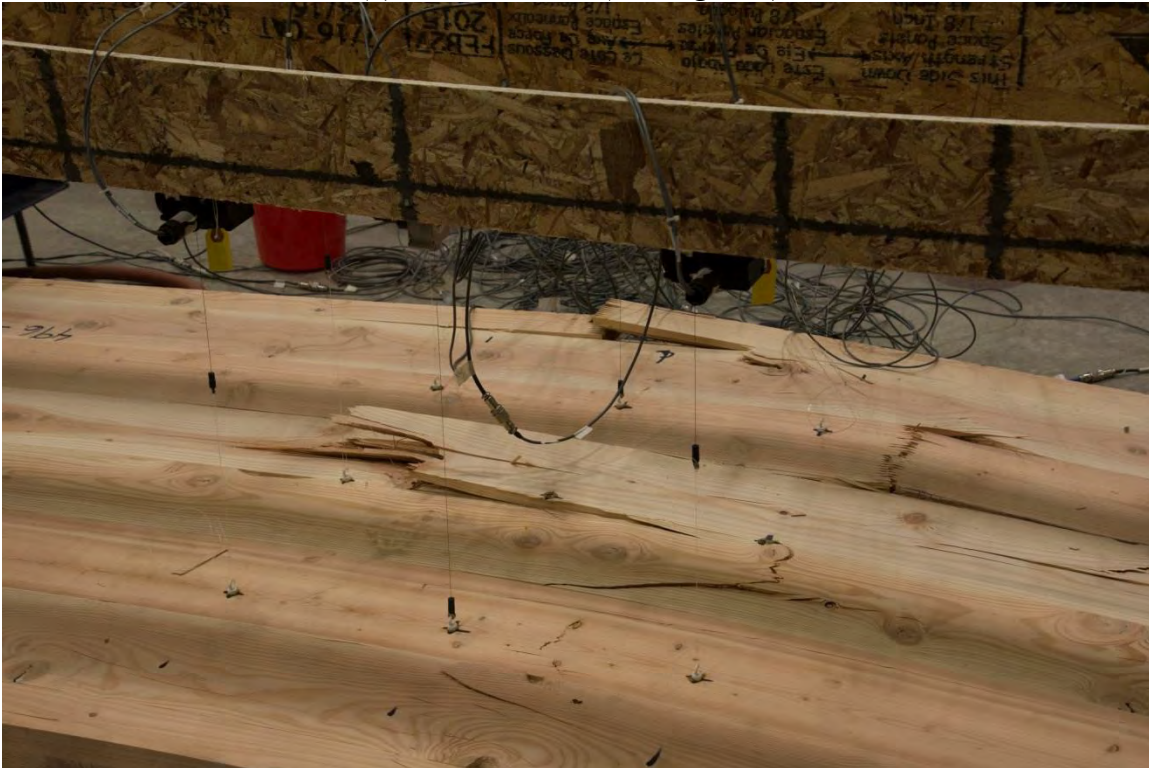
(b) Initiation of failure (looking east). (Note failure at finger joint outside middle two feet.)

Figure A-4. 3-Ply Grade V1 CLT – Test 4 (V1-4).

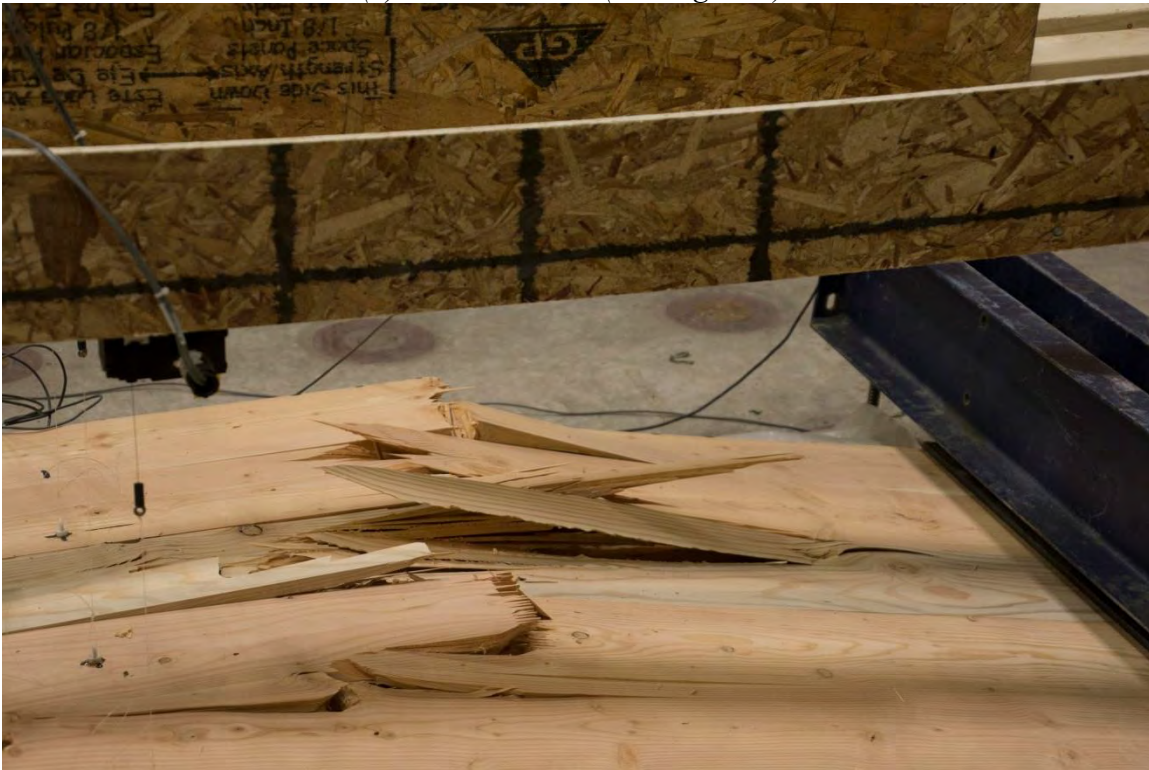
Figure A-5. 3-Ply Grade V1 CLT – Test 5 (V1-5).

(a) Elevation view (looking west).

(b) Top view (looking east). (Note failure at finger joints near support, no finger joints located near panel mid-span.)

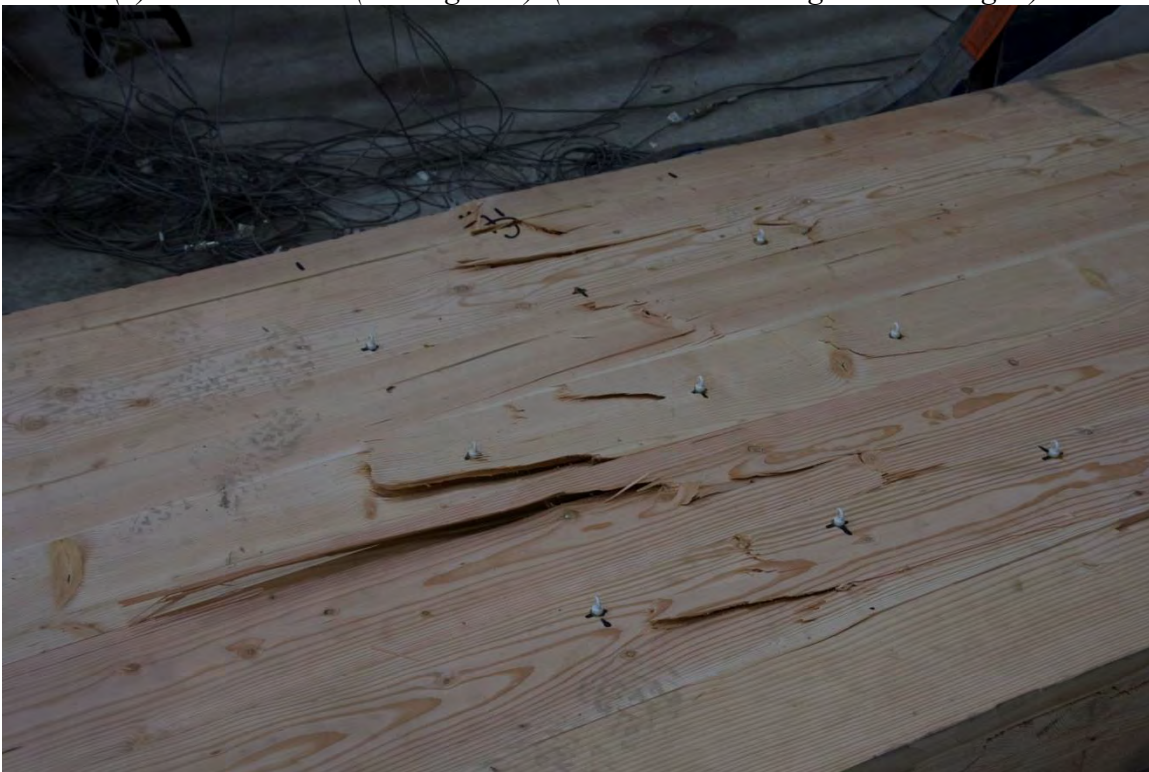
Figure A-6. 5-Ply Grade V1 CLT – Test 1 (5V1-1).

(a) Elevation view (looking west). (Note bladder leakage at lower right.)

(b) Top view (looking east).
