BLAST-RESISTANT TESTING FOR MASS TIMBER EXTERIOR WALLS: FINAL ACCOMPLISHMENT REPORT

Lisa Podesto, P.E.¹

Mark K. Weaver, S.E.²

October 9, 2017

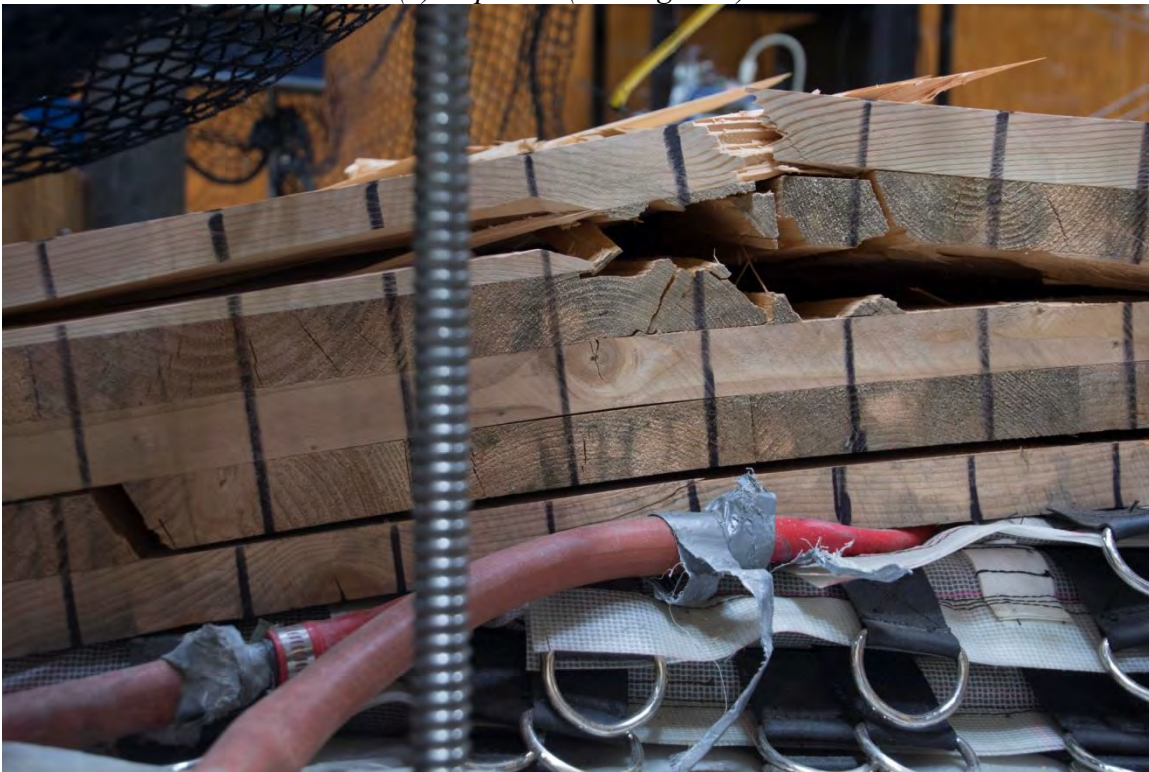
Figure A-10. 5-Ply Grade V1 CLT – Test 5 (5V1-5).

(b) Detail view (looking west). (Note slip between individual CLT plies.)

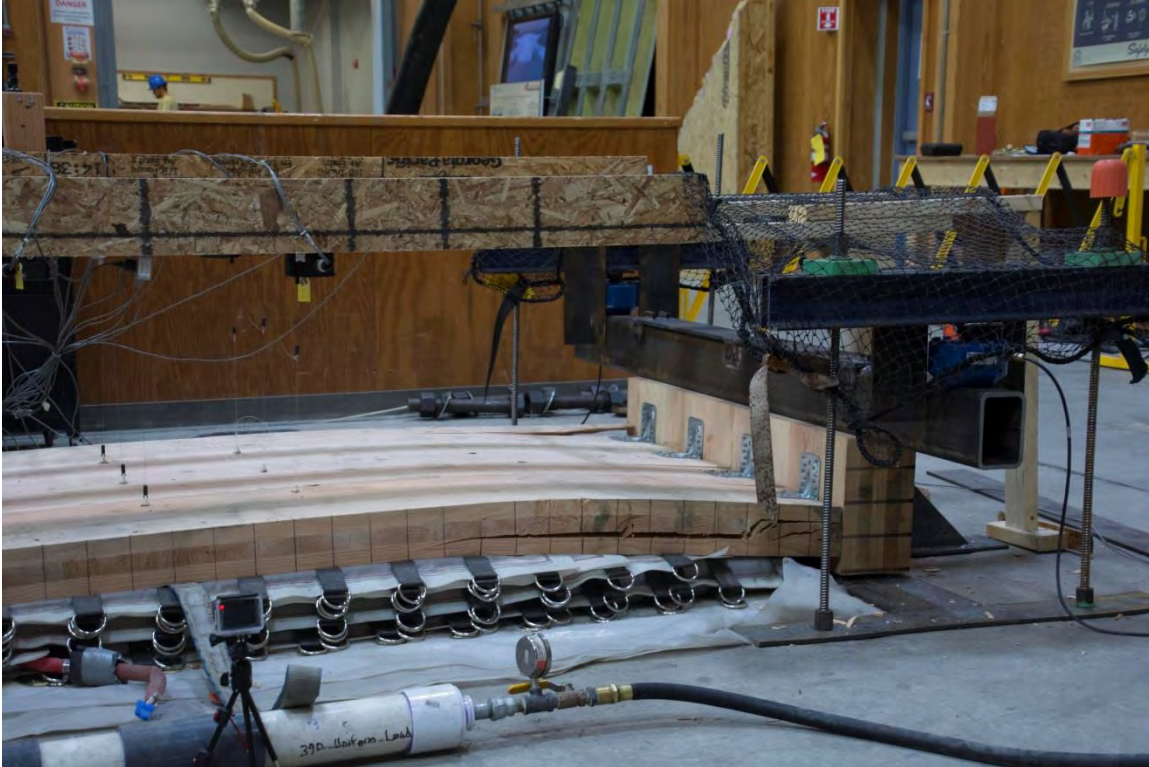
Figure A-12. 3-Ply Grade V1 CLT w/ SST Brackets at Each End – Test 2 (V1CA-2).

(a) Initial shear failure (looking west).

(b) Subsequent flexural failure (looking west).

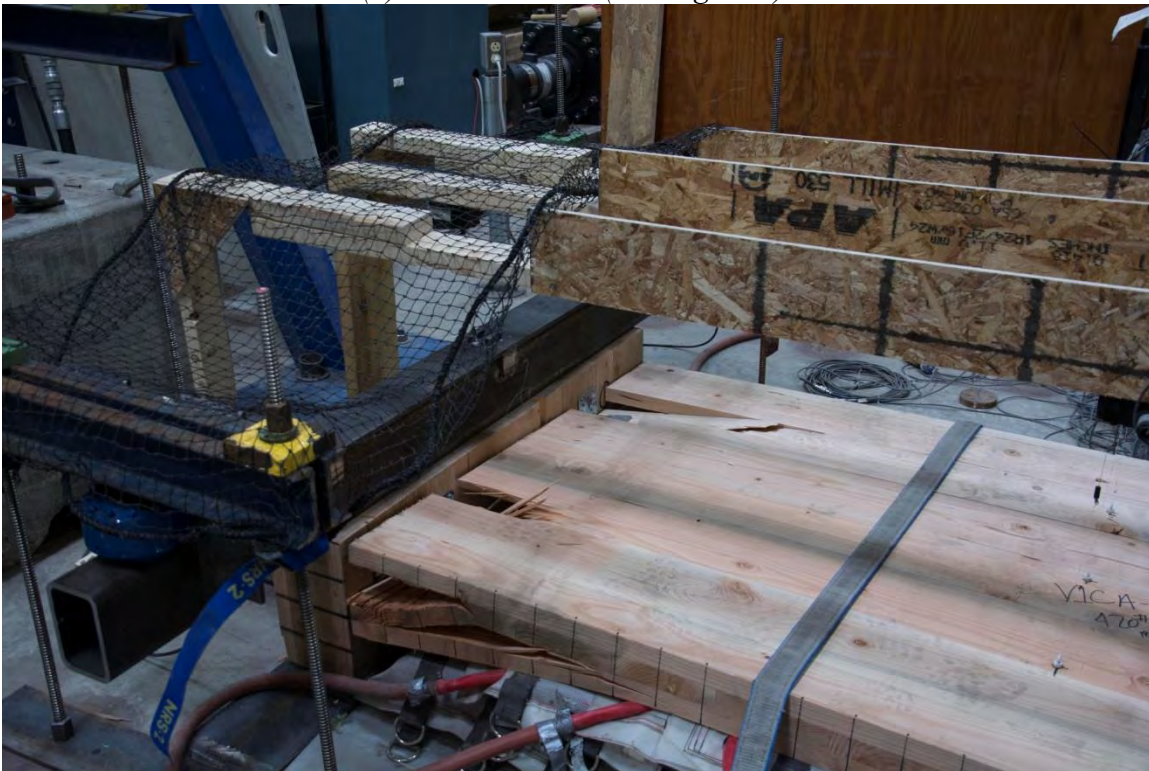
Figure A-14. 3-Ply Grade V1 CLT w/ SST Brackets at Each End – Test 4 (V1CA-4).

(b) Top view (looking west).

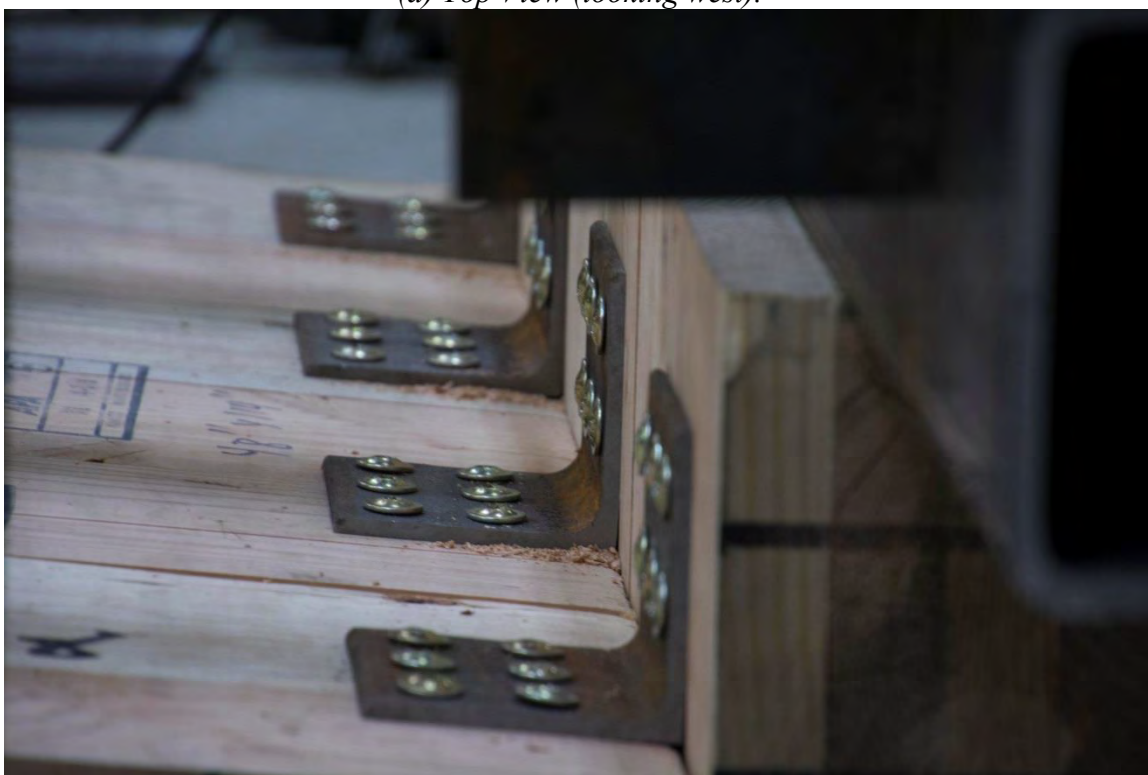
Figure A-15. 3-Ply Grade V1 CLT w/ L4x4x1/4 Brackets at Each End – Test 1 (VICB-1).

(b) Detail view – bracket deformation (looking west).

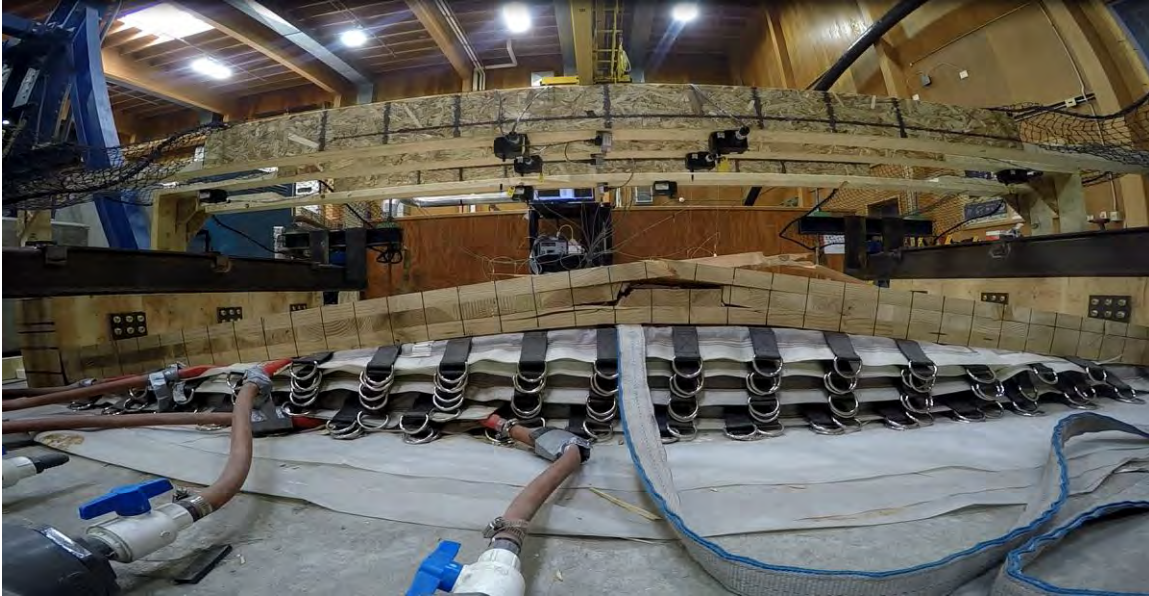
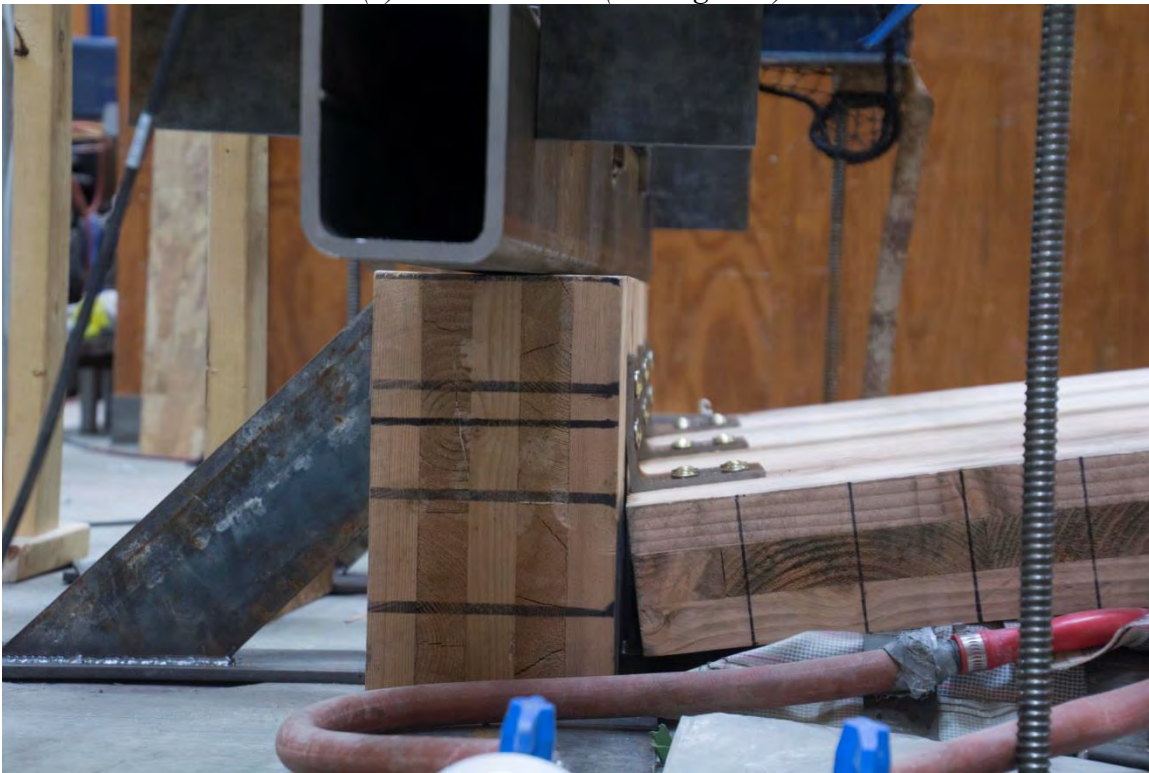
Figure A-16. 3-Ply Grade V1 CLT w/ L4x4x1/4 Brackets at Each End – Test 2 (V1CB-2).

(a) Elevation view (looking west).

(b) Detail view – bracket deformation (looking west).

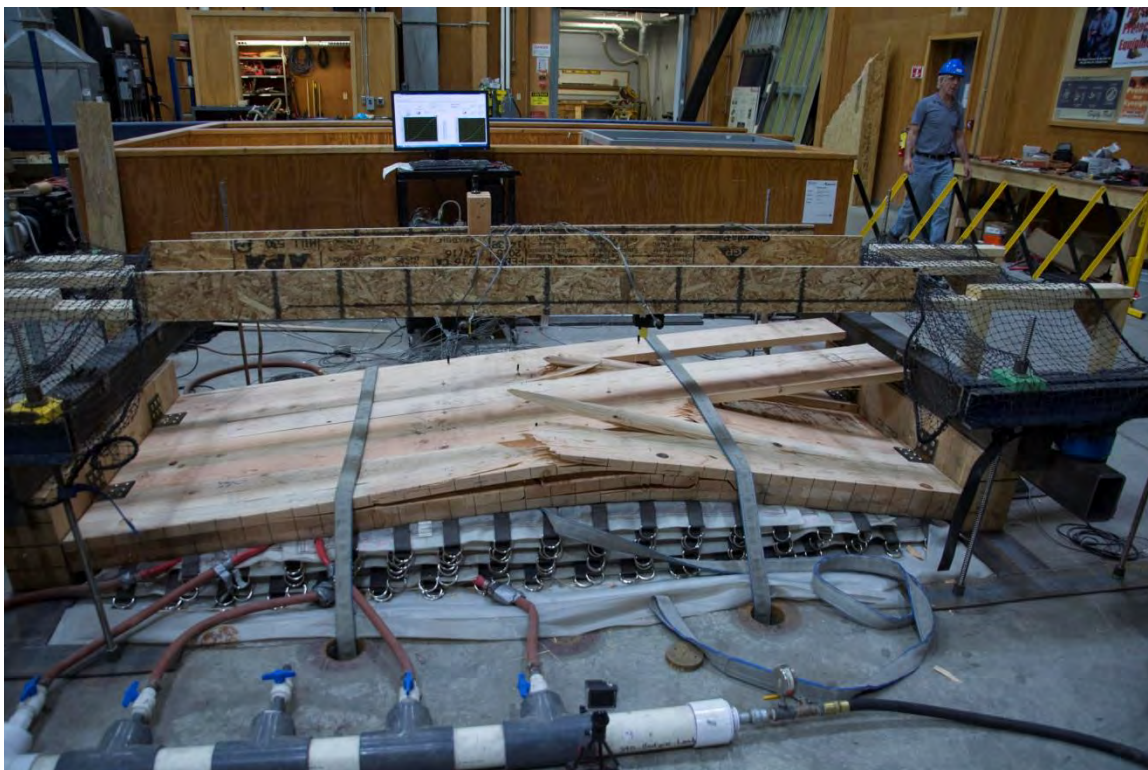
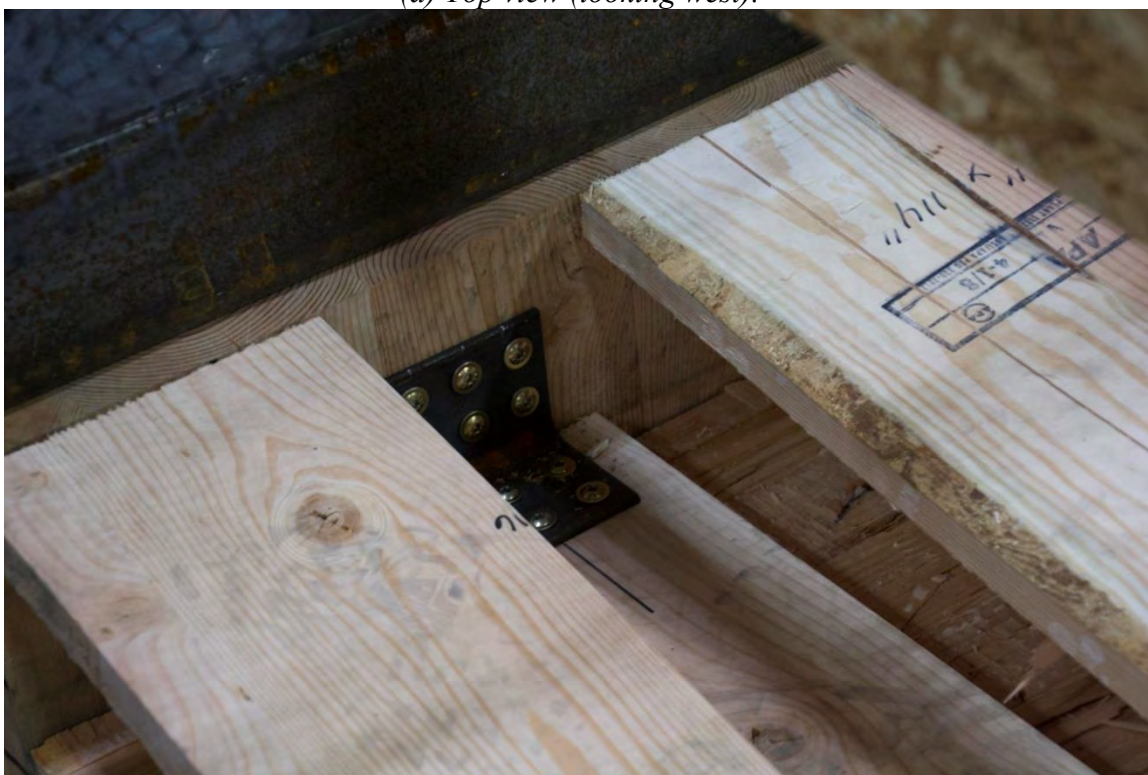
Figure A-17. 3-Ply Grade V1 CLT w/ L4x4x1/4 Brackets at Each End – Test 3 (V1CB-3).

(a) Top view (looking west).

(b) Detail view.

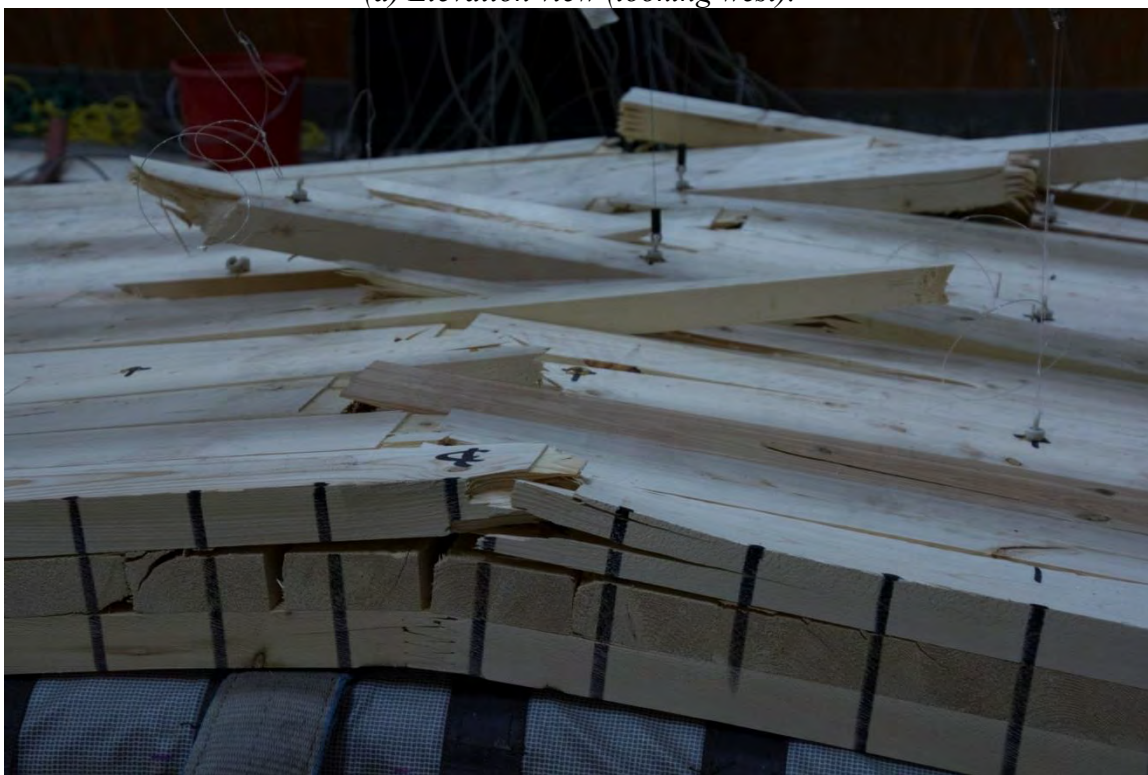
Figure A-18. 3-Ply Grade E1 CLT – Test 1 (E1-1).

(b) Detail view (looking west).

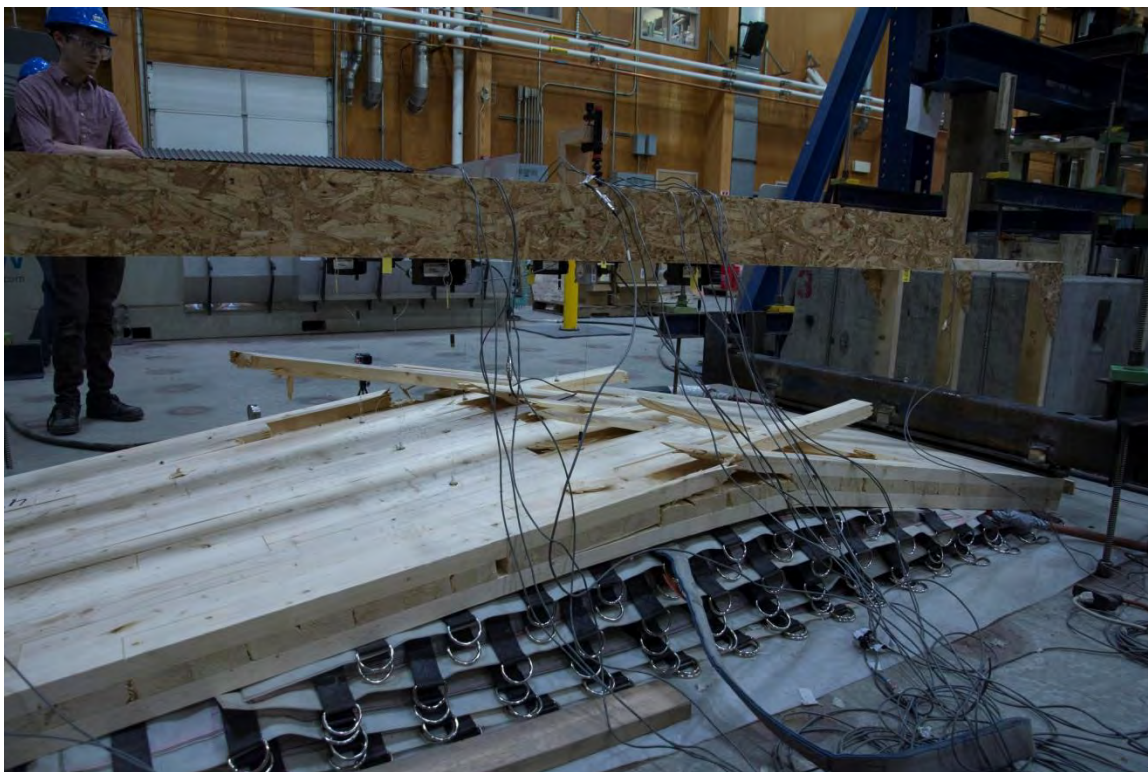
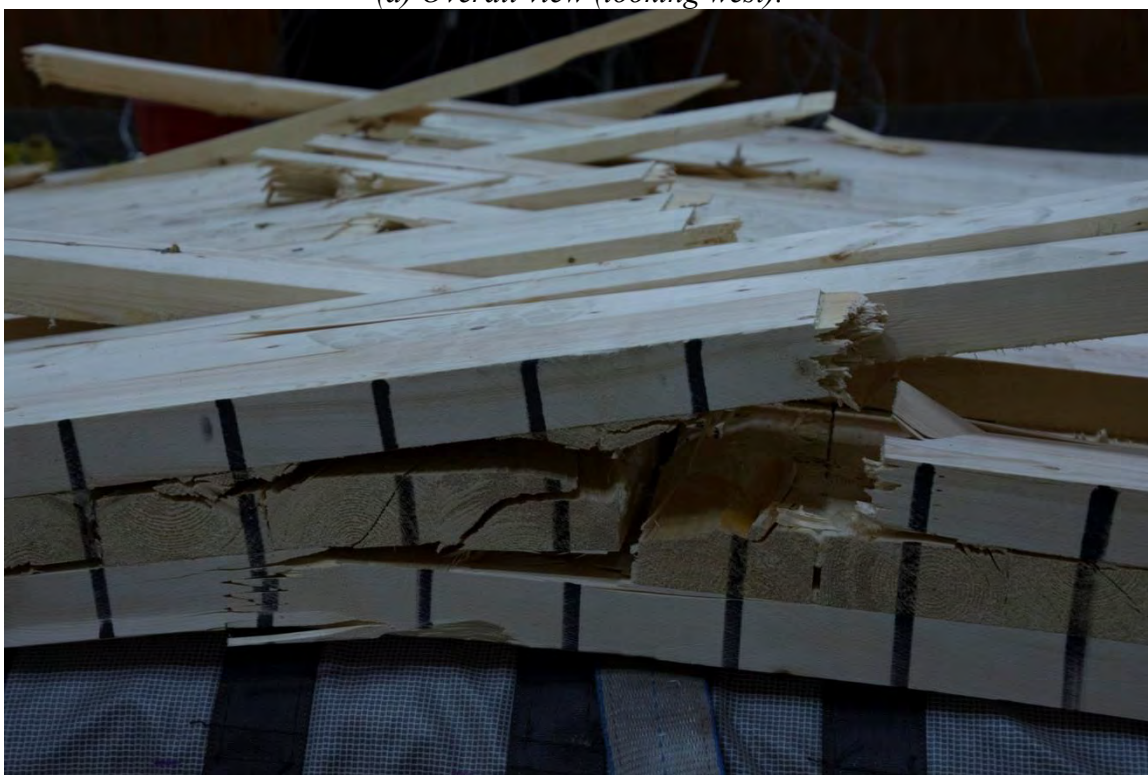
Figure A-20. 3-Ply Grade E1 CLT – Test 3 (E1-3).

(a) Overall view (looking west).

(b) Detail view (looking east).

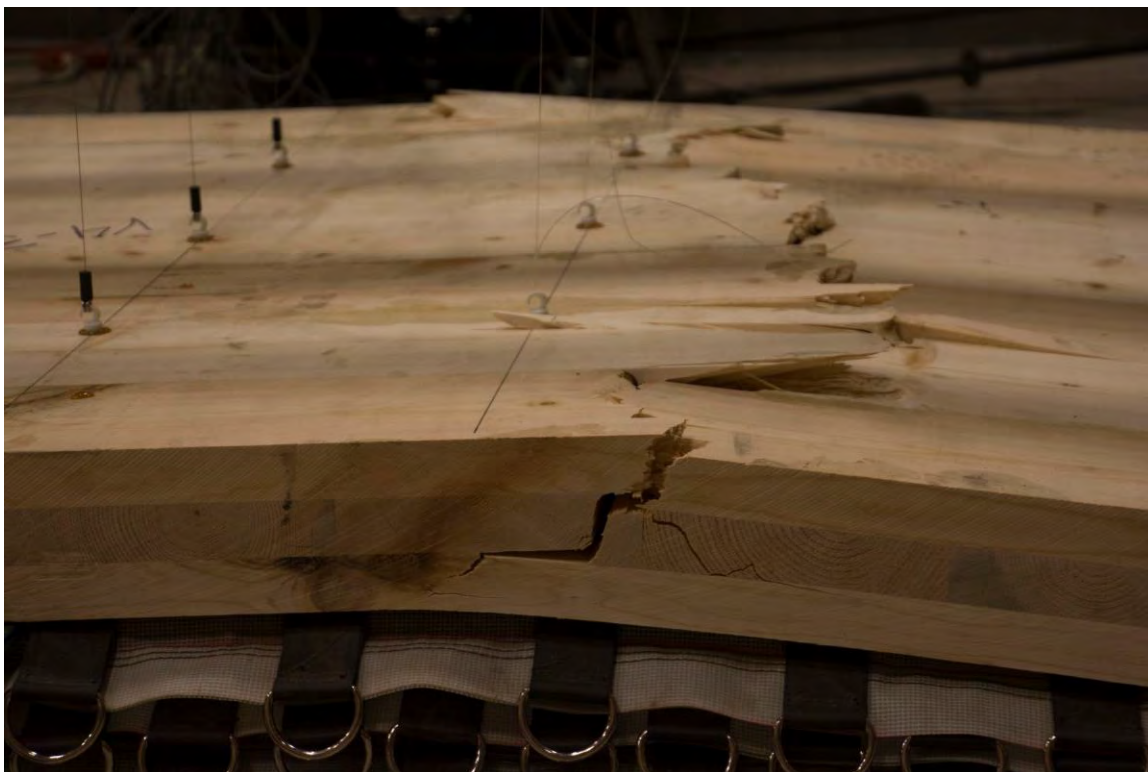
Figure A-24. 3-Ply Grade V4 CLT – Test 3 (V4-3).

(a) Initial failure.

(b) Subsequent failure.

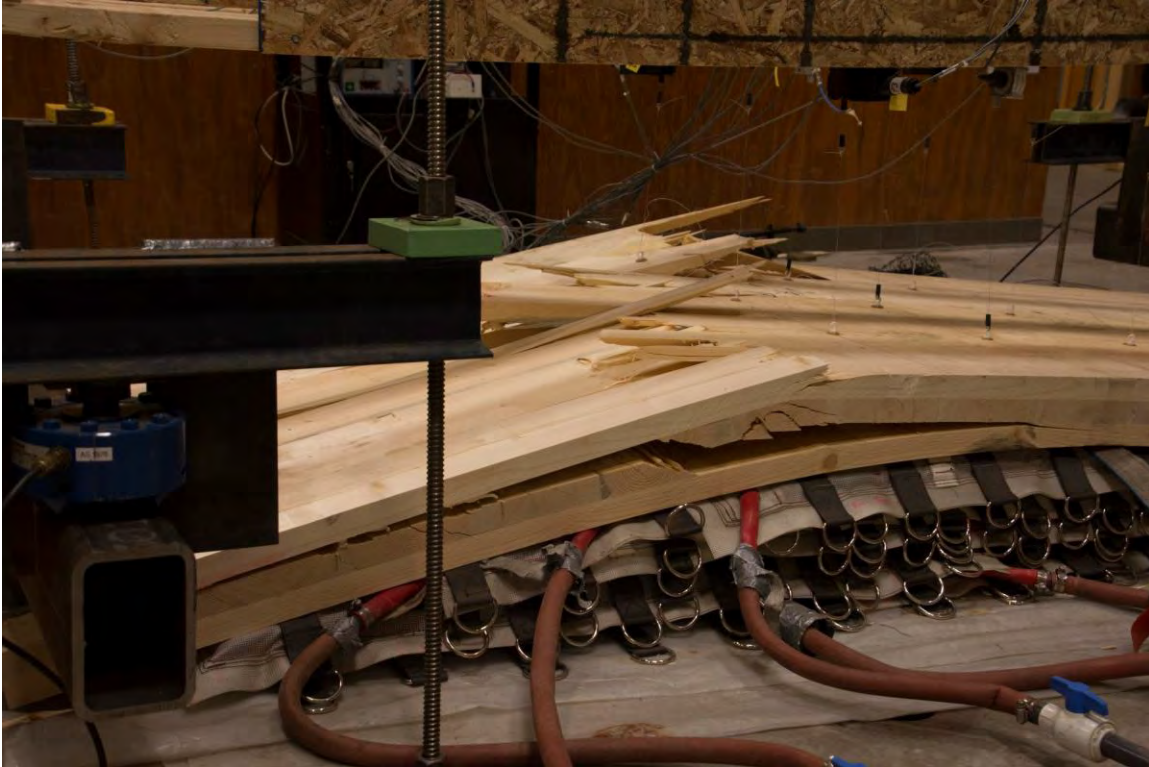
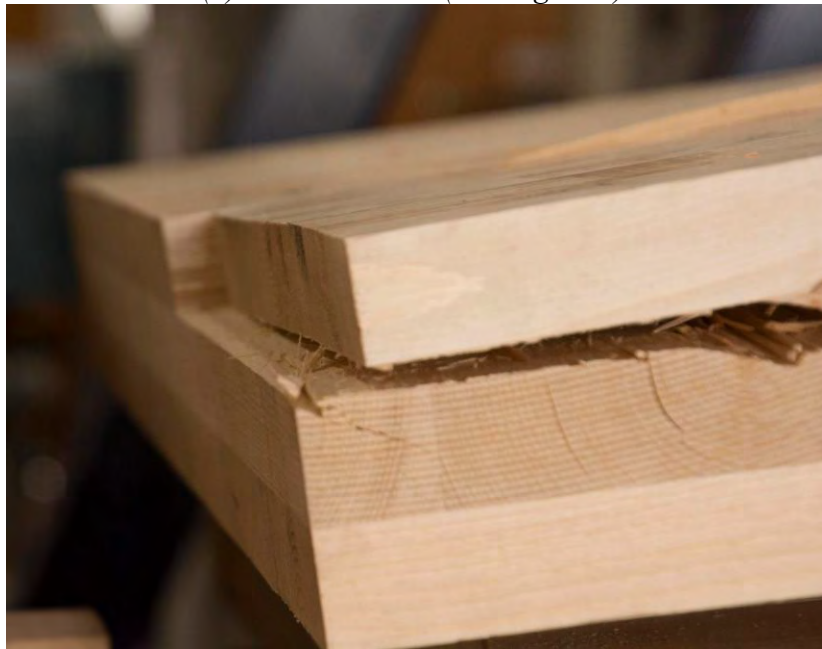
Figure A-25. 3-Ply Grade V4 CLT – Test 4 (V4-4).

(a) Elevation view (looking west).

(b) Shear slip at end.

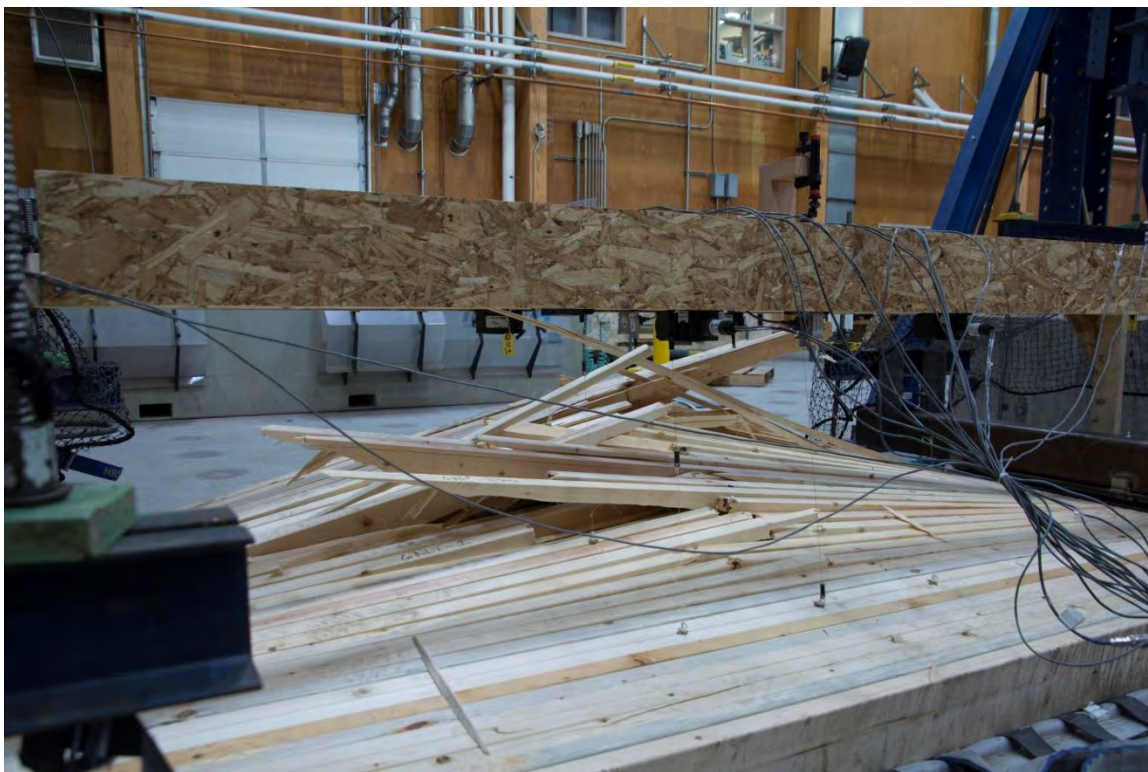
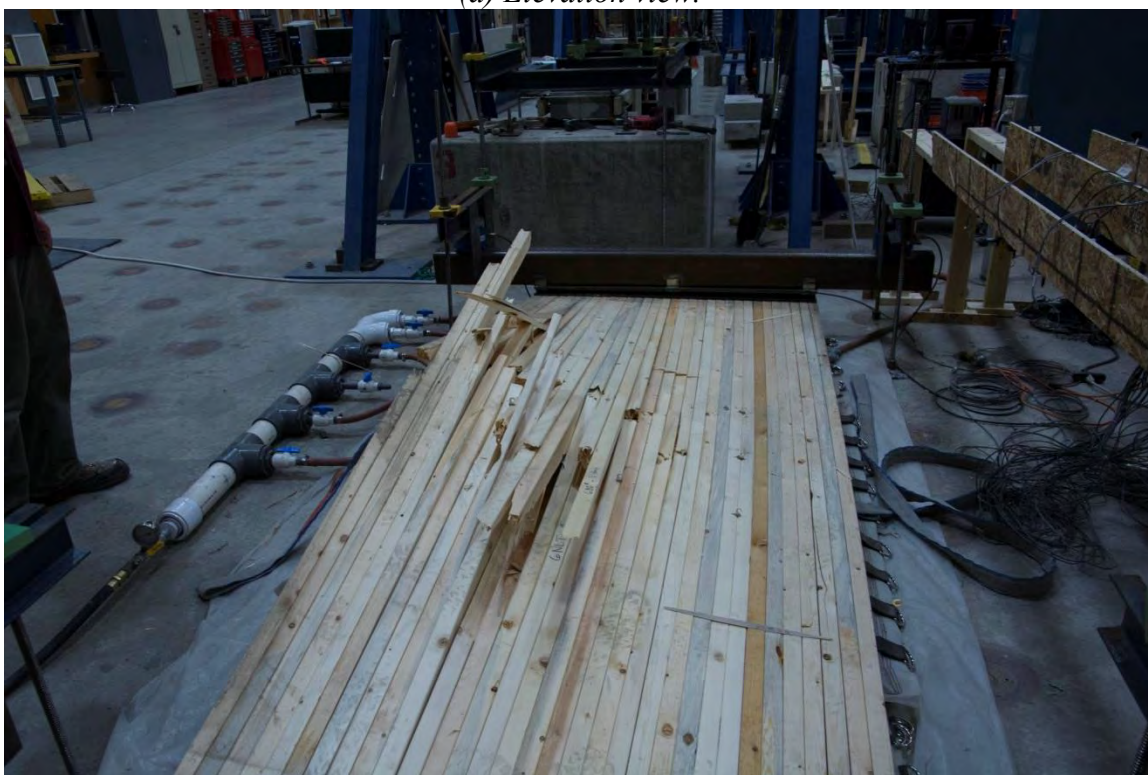
Figure A-29. 2x6 NLT – Test 1 (6NLT-1).

(a) Elevation view.

(b) Top view.

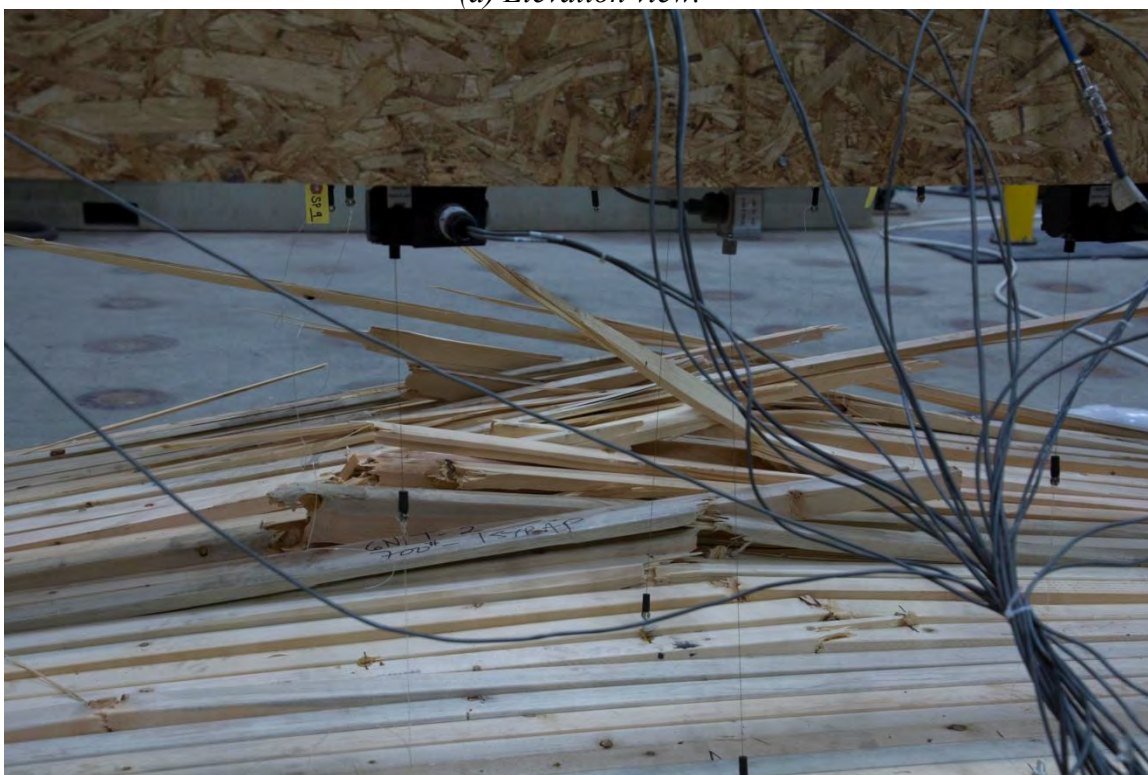
Figure A-30. 2x6 NLT – Test 2 (6NLT-2).

(b) Detail view.

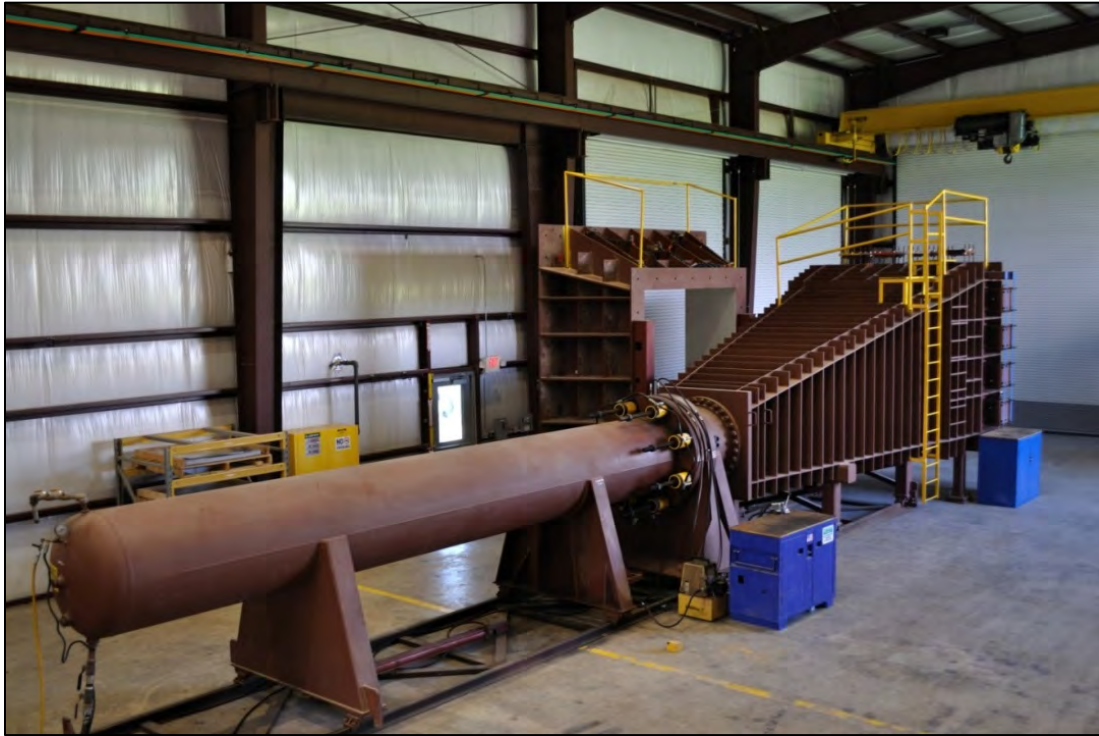
Dynamic testing of the prepared specimens was conducted in the BakerRisk shock tube facility. The shock tube is a test apparatus that consists of two major sections: a driver section and an expansion section. Blast pressures are generated when an aluminum rupture disk placed between the two sections fails due to pressure in the driver section. A shock wave then travels down the expansion section and loads the test specimen(s) mounted at the end of the expansion section. In this testing series, as is customary, the driver was baffled to reduce the effects of reloading by the reflections that exist in the shock tube. The shock tube is shown in Figure 4.

Figure 4. BakerRisk Shock Tube

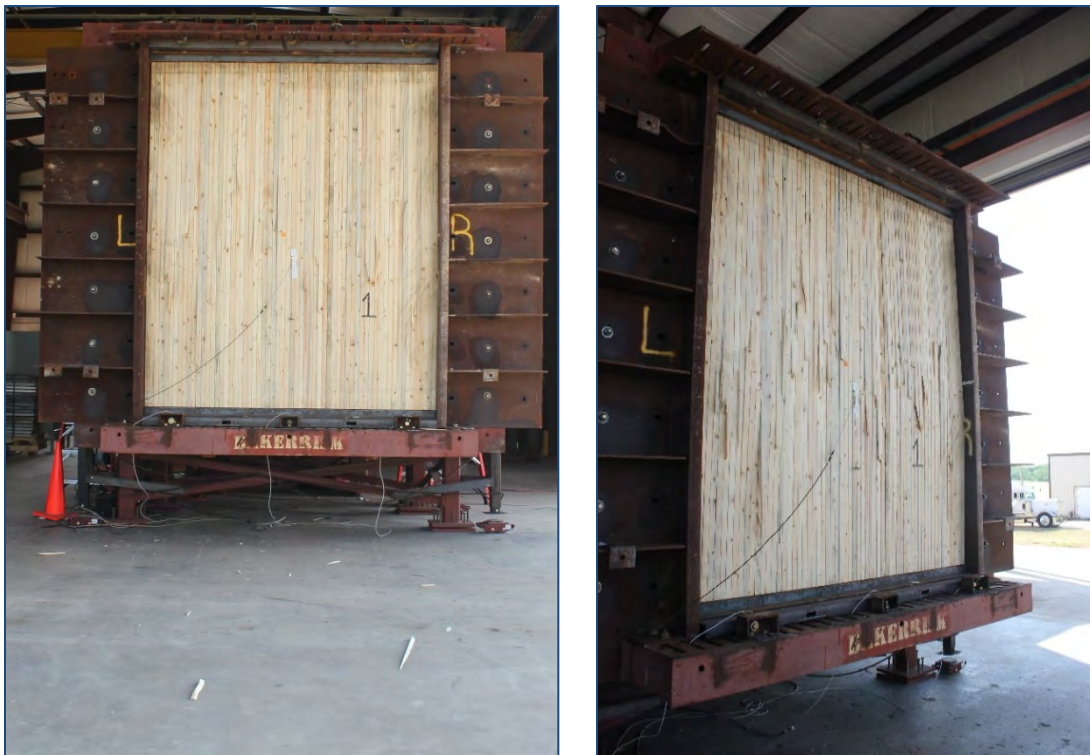
The accelerometer gauge became detached from the test specimen due to specimen damage. The specimen was measured to have a peak deflection of 4" at a time of 18 ms, as observed on the post-test high speed video displacement grid. The non-loaded face of the specimen was observed to have significant cracking and wood spalling accompanied by wood fragment debris throw down range (Figure 6). The 2×4 wood members exhibited cracking at midspan through the majority of their cross-section as observed at the end members after removal of the specimen from the test frame.

Figure 6. Test 1 Debris Field (Left) and Damage View (Right)

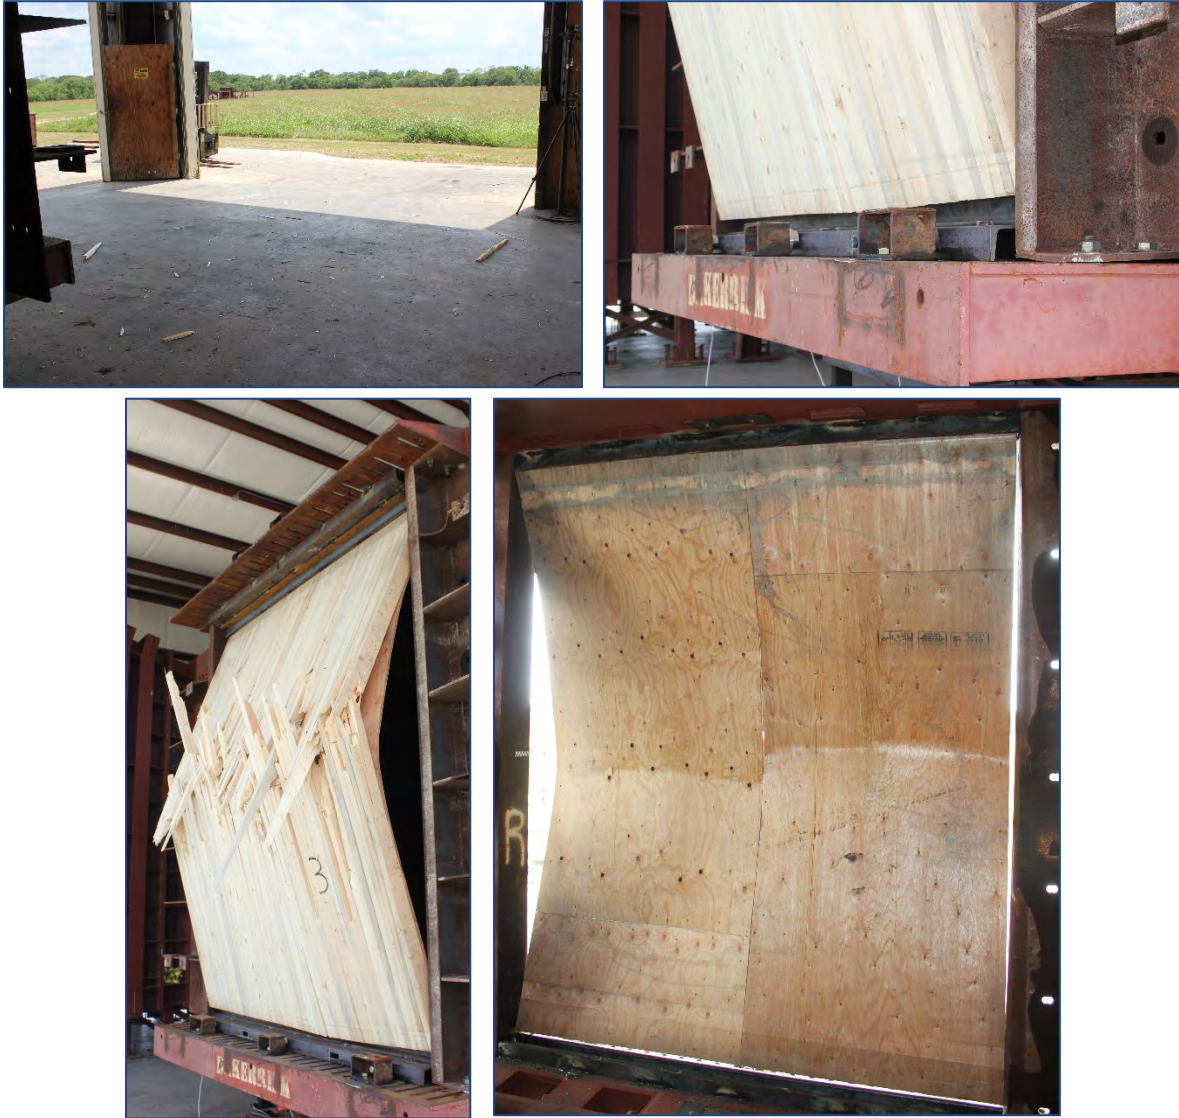
The non-loaded face of the specimen was observed to have significant cracking and wood spalling accompanied by wood fragment debris throw down range (Figure 7). The 2×4 wood members exhibited cracking at midspan through the majority of their cross-section as observed from both the non-loaded face and at the end members after removal of the specimen from the test frame. The loaded plywood face of the specimen also exhibited significant cracking and permanent deformation. The specimen exhibited significant shortening as the result of the high displacement and disengaged from the bottom support.

Figure 7. Test 3 Debris Field and Support Disengagement (Top) and Damage Views (Bottom)

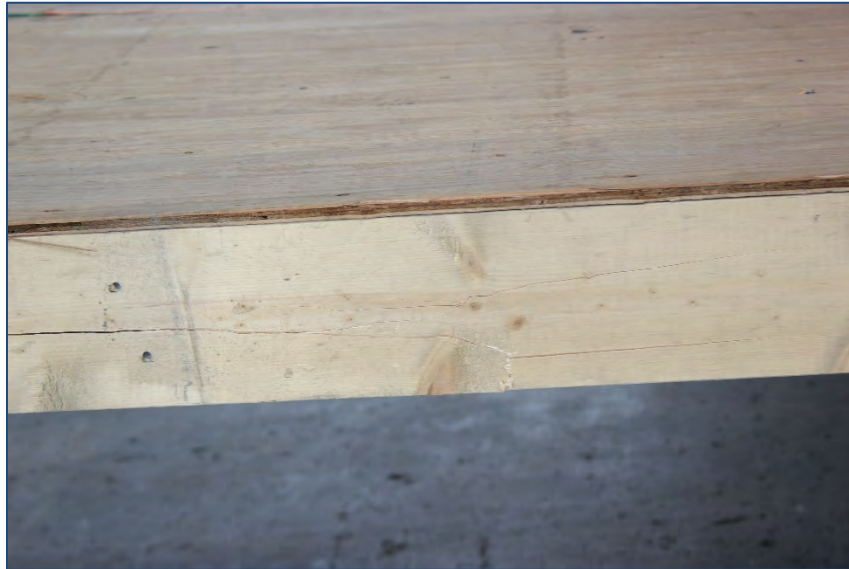
The test specimen was measured to have a peak deflection of 2.5" at a time of 14.5 ms. The non-loaded face of the specimen was observed to exhibit cracking during the test with the wood members returning to their original position and cracks closing post-test. Cracking was observed through the cross-section of the 2×4 wood members after removal of the specimen from the test frame (Figure 8).

Figure 8. Test 5 Specimen Post-Test Cracking of Edge Member at Mid-Span

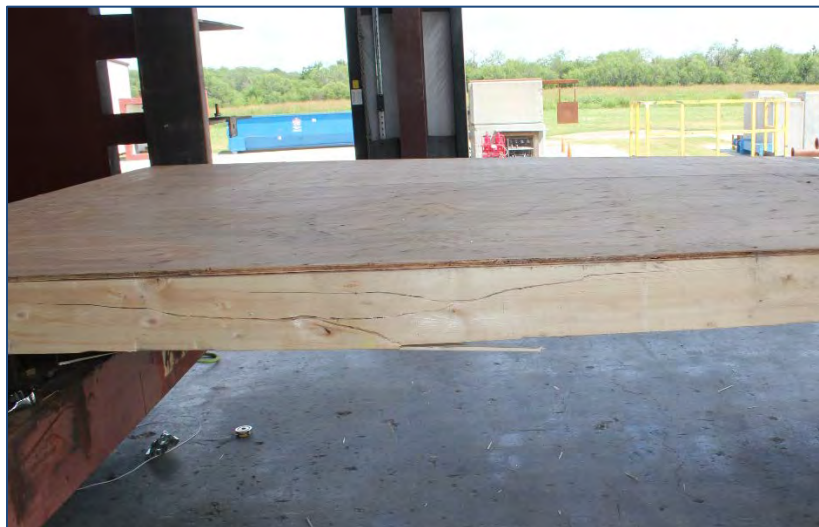
The specimen was measured to have a peak deflection of 2.7" at a time of 16.3 ms. The non-loaded face of the specimen was observed to have significant cracking and wood spalling accompanied by wood fragment debris throw down range. The 2×4 wood members exhibited cracking at midspan through the majority of their cross-section as observed at the end members after removal of the specimen from the test frame (Figure 9).

Figure 9. Test 6 Specimen Post-Test Cracking of Edge Member at Mid-Span

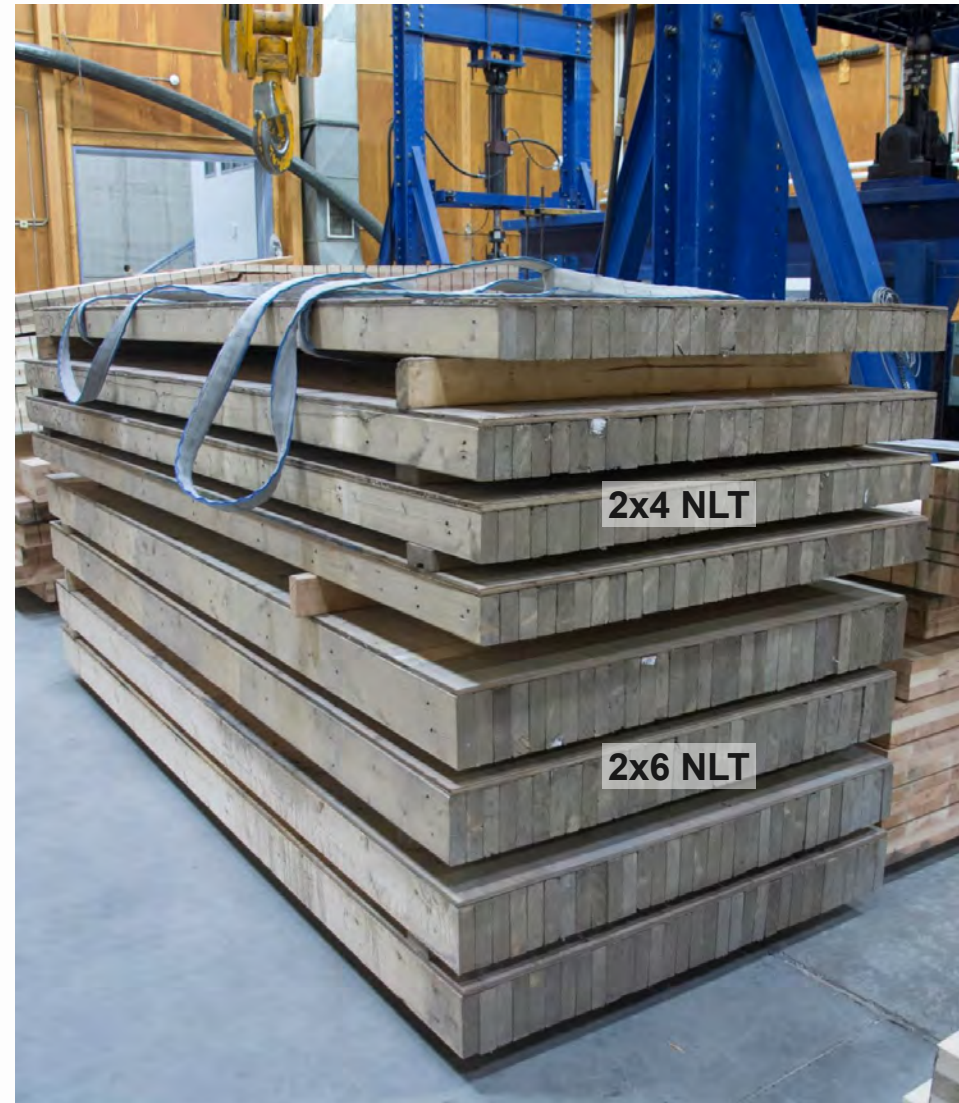
What is NLT?

- **Massive timber panel system.**
- **Use**
 - *In use for more than a century.*
 - *Used for floor, roof, & wall panels.*
- **Construction**
 - *Consists of dimensional lumber (typically 2x members) side-nailed together.*
 - *Plywood sheathing typically provided for structural diaphragm.*

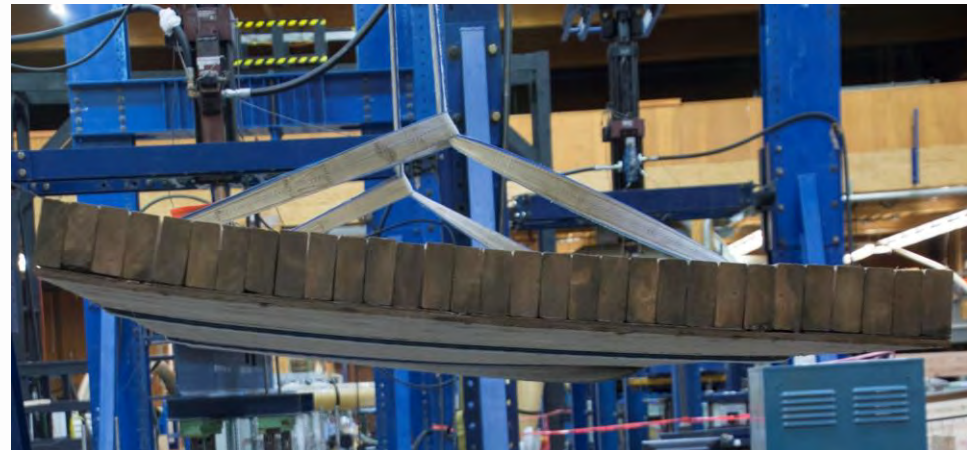
- All panels donated by StructureCraft.
- 4'(W) x 10'(L) panels w/ 2x members running in 10' direction.
- No. 2 or better Spruce Pine Fir 2x members.
- 1/2" plywood nailed to compression face of specimen.
 - *Edge nailing @ 12" O.C.*
 - *Interior nailing*
 - ✦ 16" O.C. in 10' direction.
 - ✦ 12" O.C. in 8' direction.

ID	2x Size	No. of Specimens
4NLT	2x4	3
6NLT	2x6	3

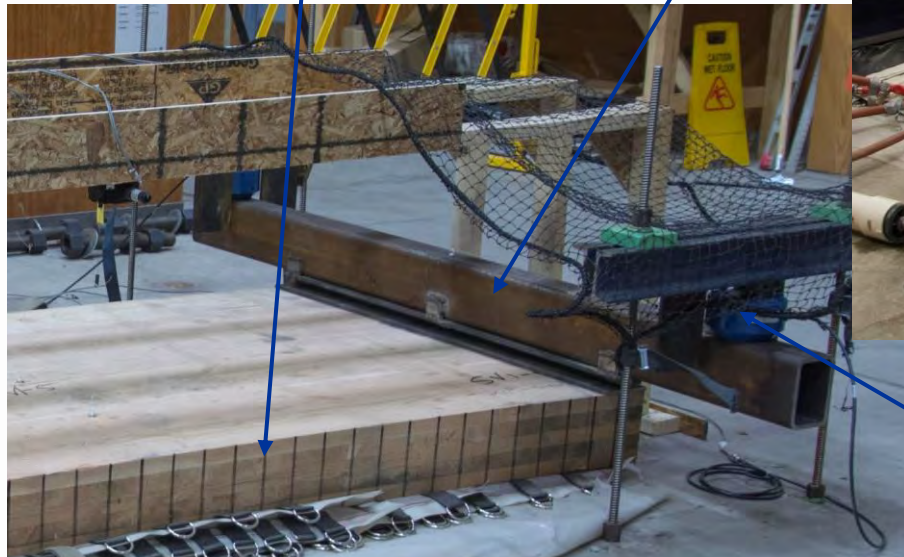
Quasi-Static Testing Test Setup

Vertical Lines to Track Shear
Slippage @ Ply Interface

Crossbar

Bladders stacked used to
apply uniform pressure

Load Cell

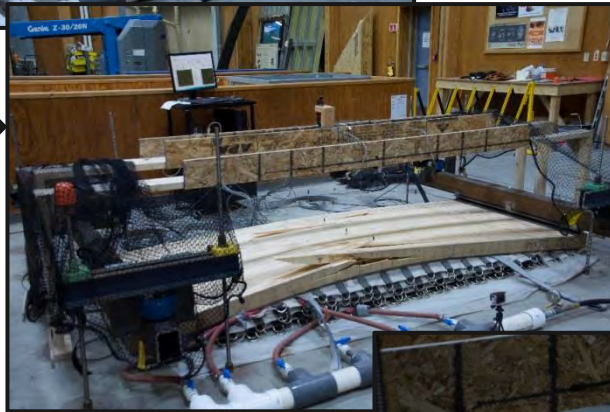
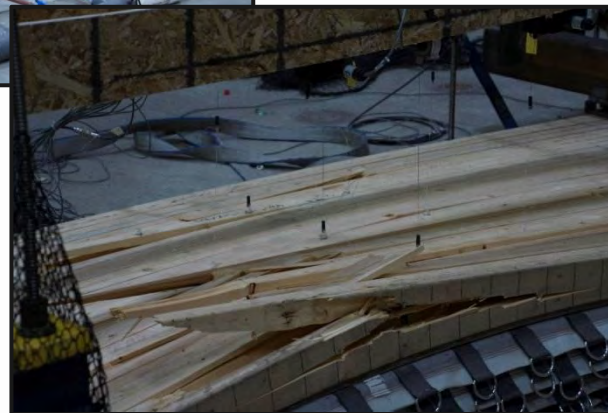
2x4 Specimen Results

Values Computed Using SBEDS

(r_u multiplied by 0.8 (i.e., 1.6 / 2.0) to account for 10 min. vs impact load duration)
