BLAST-RESISTANT TESTING FOR MASS TIMBER EXTERIOR WALLS: FINAL ACCOMPLISHMENT REPORT

Lisa Podesto, P.E.¹

Mark K. Weaver, S.E.²

October 9, 2017

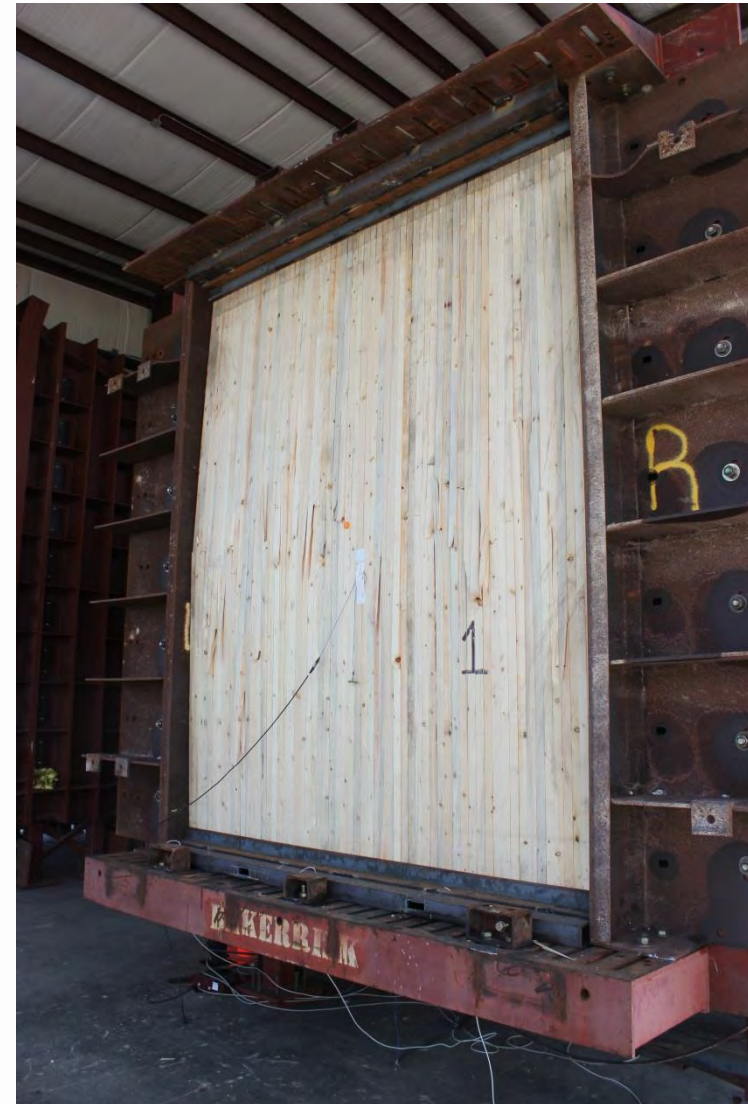
- Same type / number of test specimens as quasi-static tests except 8' wide panels were used instead 4' wide panels.
 - No. 2 or better SPF.
 - 9.5' clear span.
 - Same nailing.
- Blast load: Selected to achieve 0.75, 1.00, and 1.25 ductility ratio response based on SBEDS wood model.
 - Pressure held constant while impulse varied.

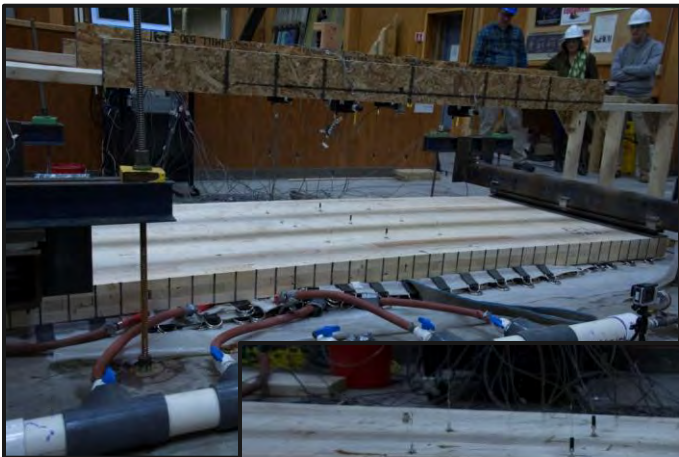
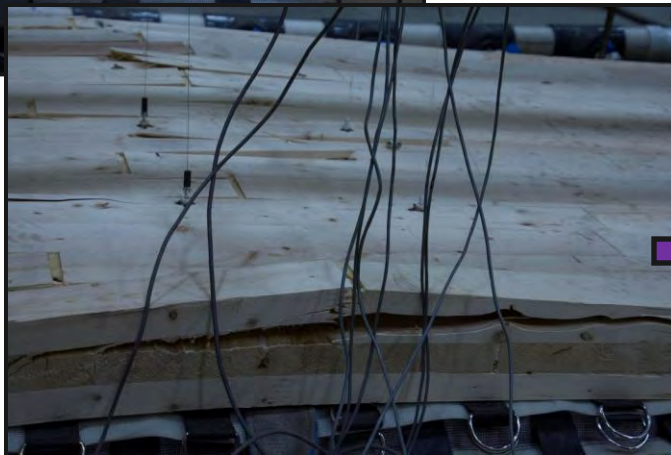
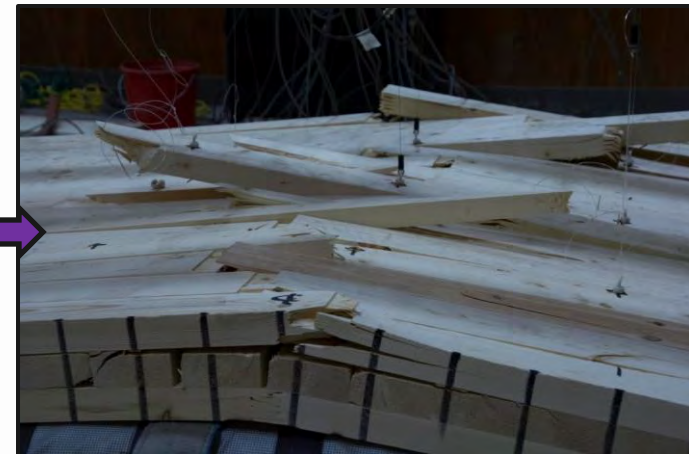
3-Ply Grade E1

ANSI/APA PRG
320-2012
Computed Values

- $k = 2.96\text{-psi/inch}$,
- $r_u = 5.29\text{-psi}$
- CLT-E1-1 Avg of SP5, 6
- CLT-E1-2 Avg of SP5, 6
- CLT-E1-3 Avg of SP5, 7
- CLT-E1-4 Avg of SP5, 6

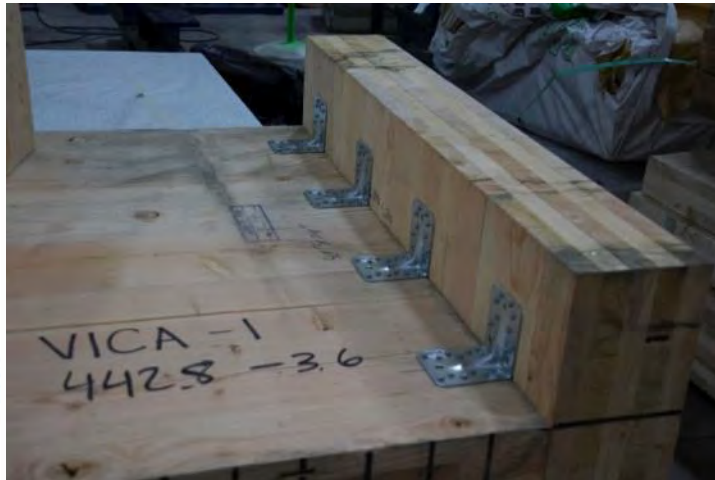
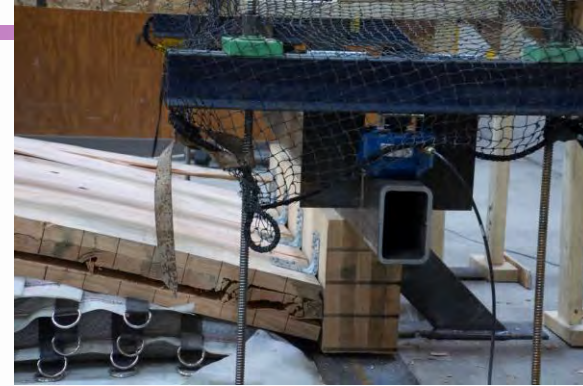
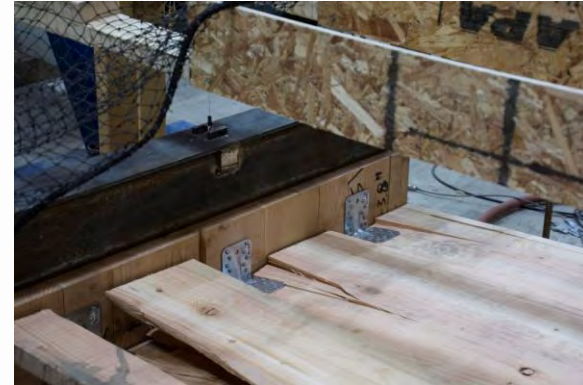
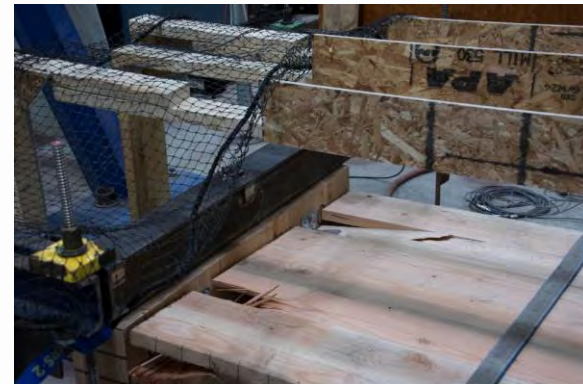
Quasi-Static Testing

Grade V1 Panel w/ ABR105 Bracket

V1CA-2
4 Brackets

V1CA-3
3 Brackets

V1CA-4
2 Brackets

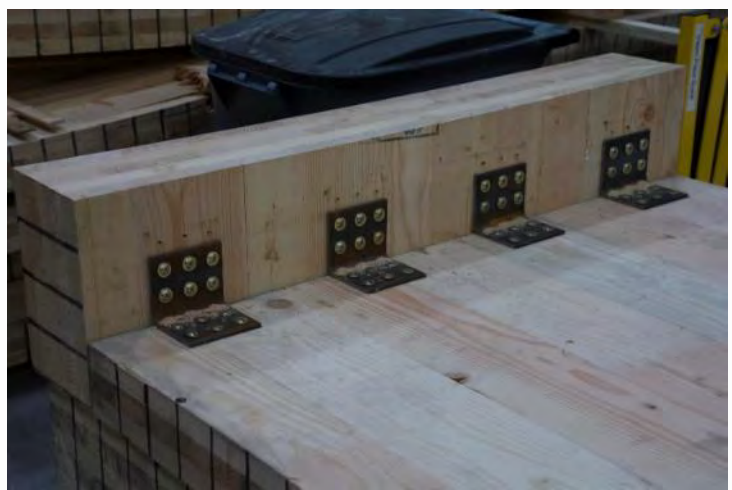
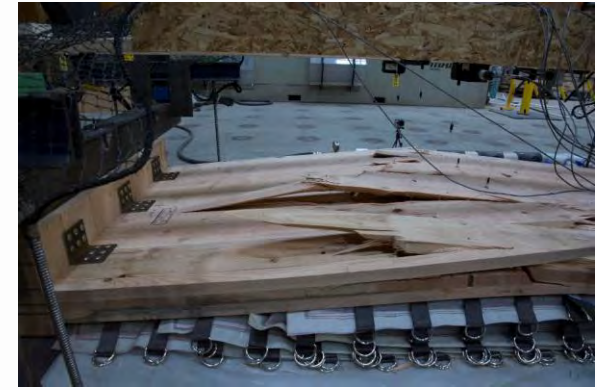
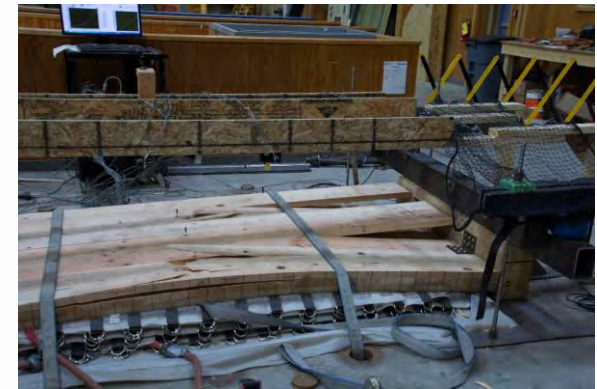
Quasi-Static Testing

Grade V1 Panel w/ L4x4x1/4 Bracket

Charac Value:
 $k = 2.87\text{-psi/inch}$,
 $r_u = 2.44\text{-psi}$

CLT-V1CB-1 Avg of SP5, 6
 CLT-V1CB-2 Avg of SP6, 7
 CLT-V1CB-3 Avg of SP5, 6, 7

V1CB-2
3 Brackets

V1CB-3
2 Brackets

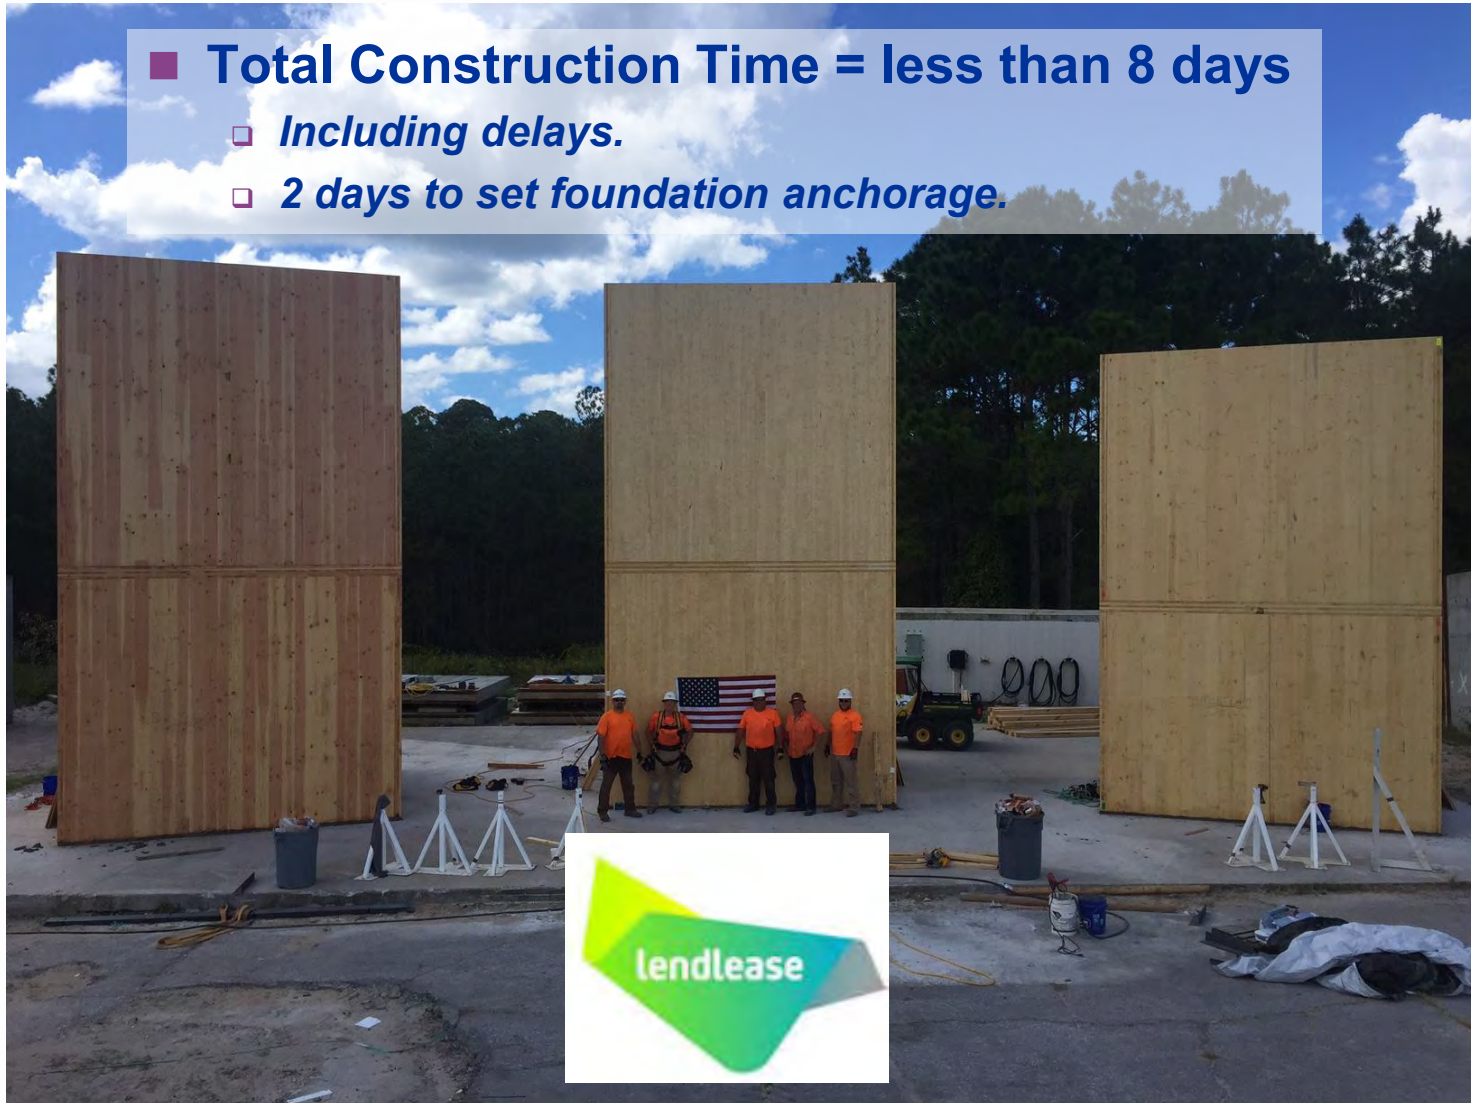
Live Blast Test Construction

- Total Construction Time = less than 8 days
 - Including delays.
 - 2 days to set foundation anchorage.

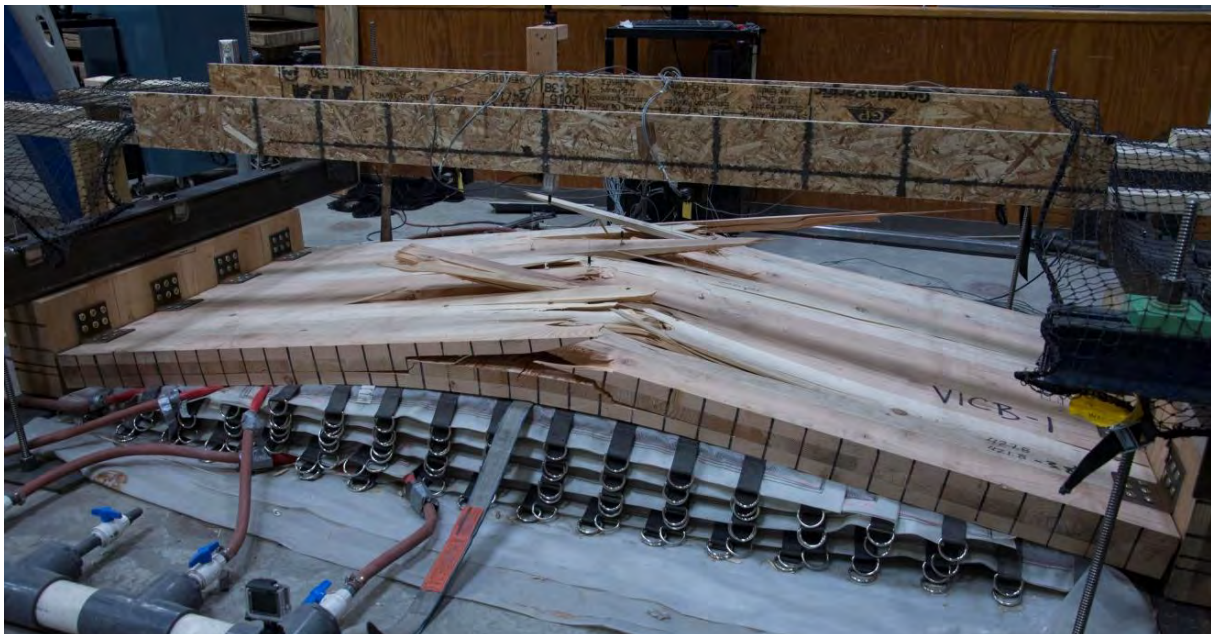
Figure 2-1. UMaine Test Apparatus with CLT Panel at Conclusion of Test.

The University of Maine (UMaine) in conjunction with WW and K&C performed a testing program aimed at investigating the bending response of Grade V1 (3-ply and 5-ply), Grade E1, and Grade V4 CLT panels in their major strength direction under a uniformly-applied quasi-static load [3]. The apparatus utilized for the testing was developed by UMaine and consisted of a series of rubber bladders filled with water capable of applying a uniform quasi-static pressure in a controlled fashion. This apparatus is shown with a CLT panel at the end of a test in Figure 2-1.

- When CLT panels ruptured due to flexure, negligible shear slip between panel plies away from the location of panel rupture was observed (i.e., see black lines on side of panel in Figure 2-1). This observation lends credence to a fully-composite panel, at the core of the shear analogy model [4].

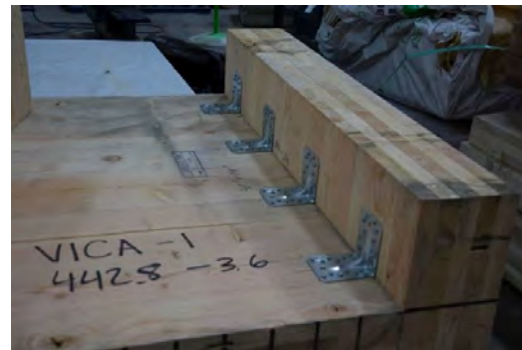
(a) SST ABR 105 Bracket (4 bracket test shown).

- An 11-gauge Simpson Strong-Tie (SST) ABR105 bracket (Figure 2-4a). The SST brackets were secured using SD10212 (i.e., #10 x 2-1/2") self-tapping screws manufactured by SST.
- A 4.5-inch length of pre-drilled ASTM A36 L4×4×1/4 angle (Figure 2-4b). The L4x4 brackets were secured using SWG ASSY® SK 5/16x4 self-tapping screws manufactured by MyTiCon.

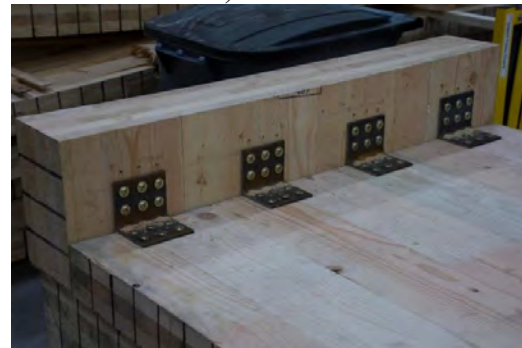
(b) L4x4x1/4 Bracket (4 bracket test shown).

Figure 2-4. Quasi-Static Testing Connection Types.

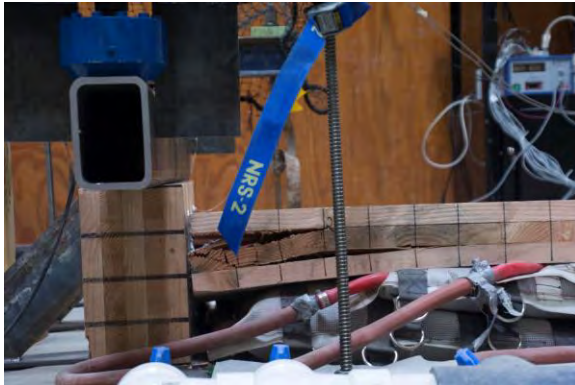
(a) Shear Failure Associated w/ SST Brackets.

The panels with SST brackets typically exhibited shear failures near one end of the panel (Figure 2-5a) while the panels with the L4x4 brackets typically exhibited a flexural failure near mid-span (i.e., similar to panel-without-connection tests) (Figure 2-5b). For both brackets, top boards not directly supported by angle brackets pulled away from those that were (Figure 2-5c). In general, both brackets were capable of deforming significantly while still being able to support their respective loads (Figure 2-5d). The measured peak strength of the CLT panel was independent of the number of angle brackets.

- Upon panel rupture, there was a relatively sudden drop in panel strength to a residual panel strength plateau. The value of this residual strength plateau always exceeded the strength computed using the shear analogy model and ignoring the ruptured ply. For example, the residual strength plateau value of a 5-ply panel was greater than the characteristic bending strength of a 3-ply panel in all circumstances (Figure 2-2).
- Fastener length and the corresponding number of plies that are engaged can impact the ultimate failure mode observed. Although more testing would be needed to corroborate this conclusion, it appears where the fasteners were long enough to engage all panel plies, the fasteners served to act as shear reinforcement and resist the augmented shearing forces associated with discrete support points (Figure 2-5a and b).

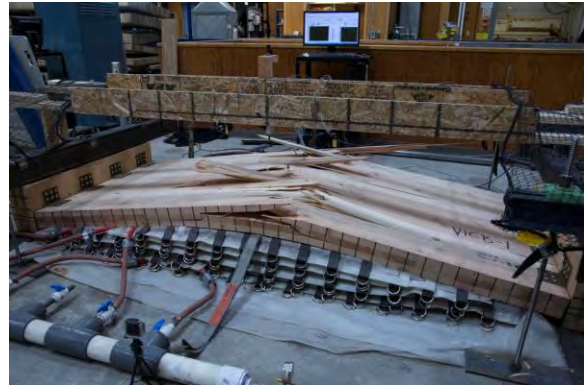
(b) Flexural Failure Associated w/ L4x4 Brackets.

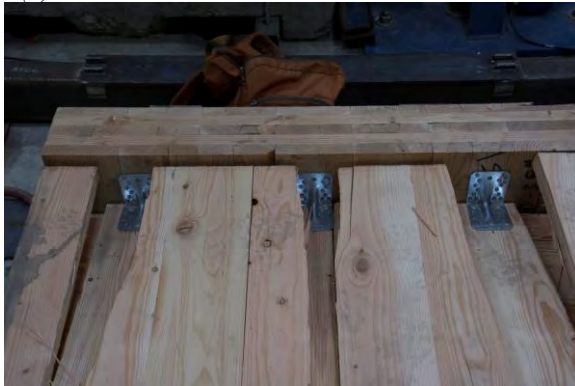
(c) Top Board Disengagement.

- Panels that are not continuously supported are susceptible to top board disengagement at high deformations (Figure 2-5c).

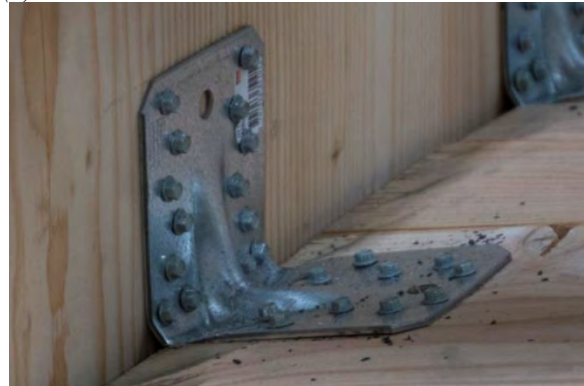
(d) SST Bracket Deformation (L4x4 Similar).

Figure 2-5. Quasi-Static Testing Connection Test Failure Patterns.

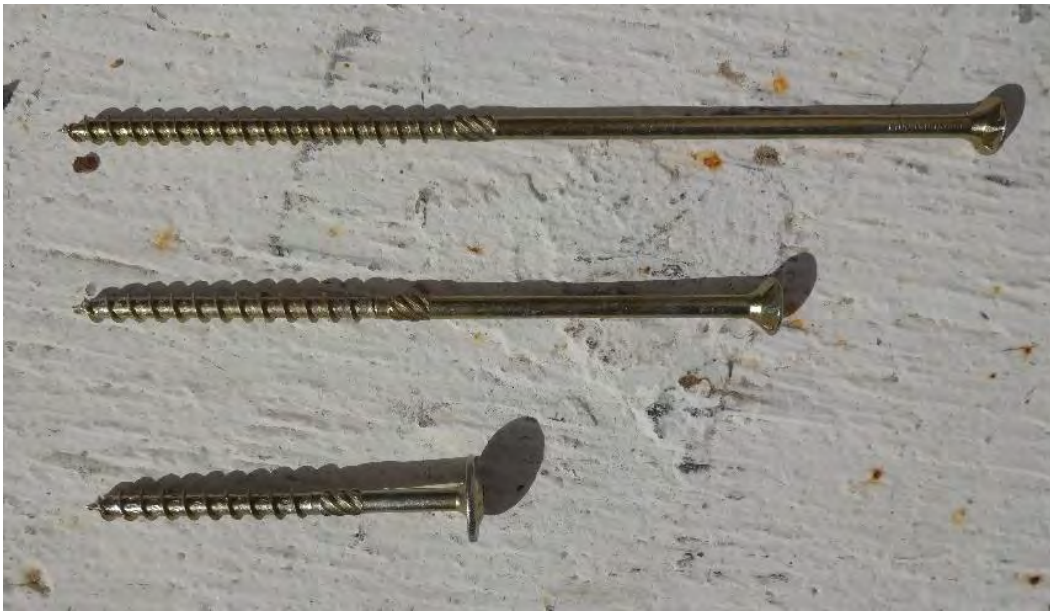
Figure 3-3. Self-Tapping Screws Used in Test Structure Connections.

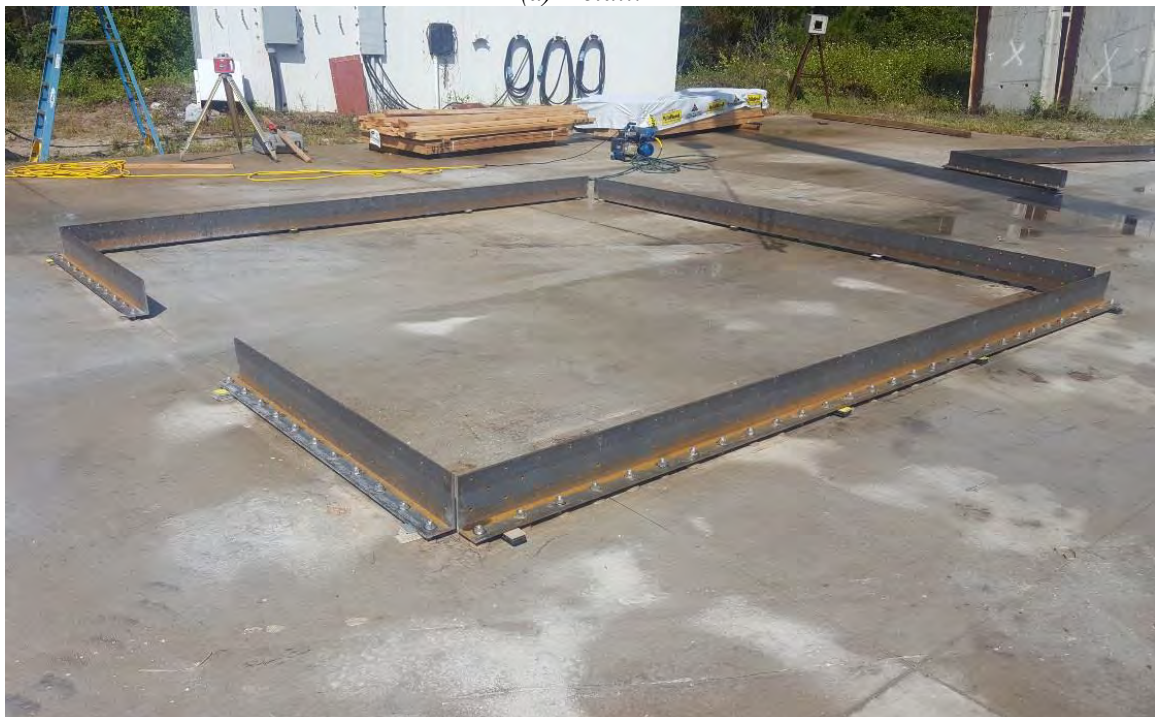
(b) Angle Placement Prior to Panel Install.

Figure 3-4. Panel-to-Foundation Connection.

The panel-to-foundation connection is shown in Figure 3-4. This connection aims to limit the visibility of the connection elements while still allowing for a robust connection capable of resisting panel inbound and rebound forces (i.e., deriving from airblast loads applied in the out-of-plane direction) and global structure overturning forces simultaneously.

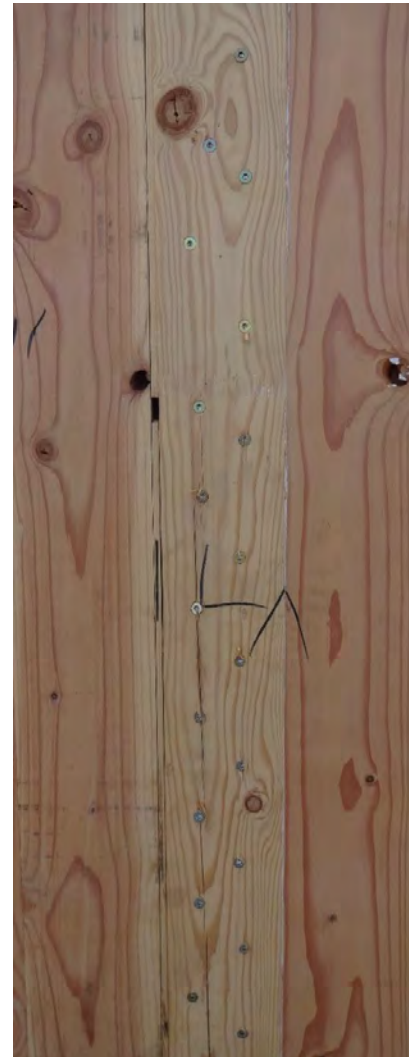
(d) Wall Panel Splice – As Installed.

Figure 3-5. Panel Splice Connection.

The panel splice connections are shown in Figure 3-5. Half-lapped joints were used to cause adjacent diaphragm and shear wall panels to act together. Self-tapping screw spacing was computed to resist the in-plane shear forces associated with Test 2. In all cases, screw length was sized to engage all plies of the respective CLT panel.

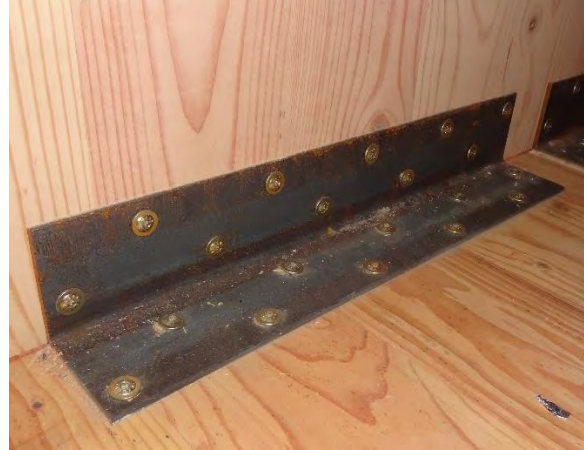
(b) As Installed.

Figure 3-6. Wall-to-Floor Panel (Platform Framing) Connection.

The wall-to-floor panel connection for the platform framing condition is shown in Figure 3-6. This connection is designed to resist the out-of-plane shear forces delivered by the first and second floor wall panels. Inward panel response is resisted by angle bearing and screw shear limit states while rebound panel response is resisted by screw withdrawal, screw head pull-through, and screw shear limit states. Self-tapping screw spacing was computed to resist the out-of-plane shear forces associated with Test 2.

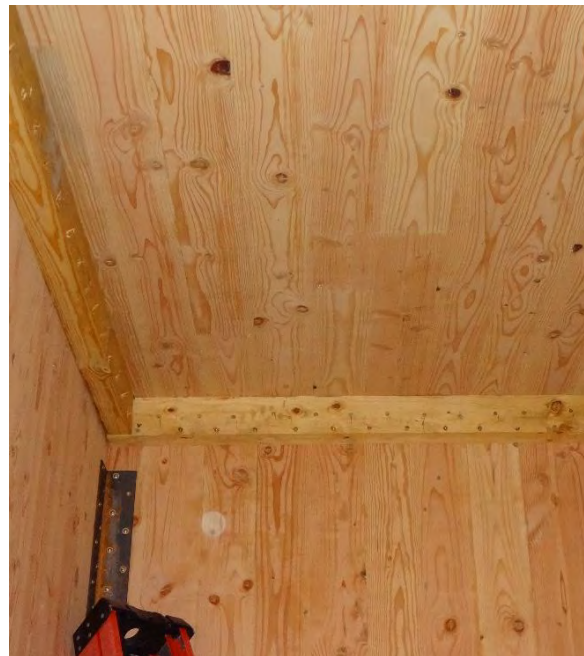
(b) As Installed.

Figure 3-7. Wall-to-Floor Panel (Balloon Framing) Connection.

The wall-to-floor panel connection for the balloon framing condition is shown in Figure 3-7. This connection is designed to resist the out-of-plane shear forces delivered by the second-floor wall panels and roof. Inward panel response is resisted by angle bearing and screw shear limit states while rebound panel response is resisted by screw withdrawal, screw head pull-through, and screw shear limit states. Self-tapping screw spacing was computed to resist the out-of-plane shear forces associated with Test 2.

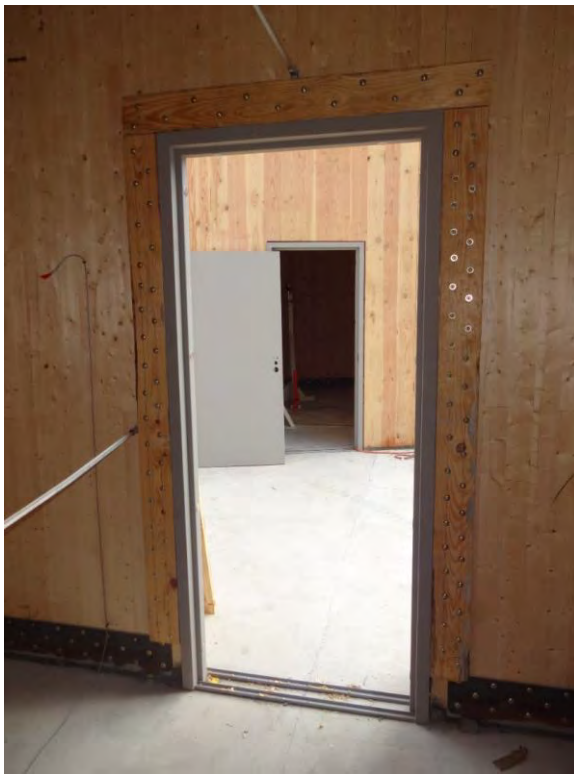
(a) As Installed (Interior).

Figure 3-10. Door Opening Figures.

Actual $1\frac{3}{4}$ -inch thick by 36-inch wide by 86-inch high pedestrian doors manufactured using 14 gage galvanized steel were provided by American Direct and manufactured by Ambico. The door shop drawings provided by American Direct are included as Appendix C. As-installed photographs of the door are included as Figure 3-10a and b. Doors were designed to exhibit a low level of protection (i.e., as defined in UFC 4-010-01) for Explosive Weight II (i.e., as defined in UFC 4-010-02 [8]) with 105-feet of standoff distance.

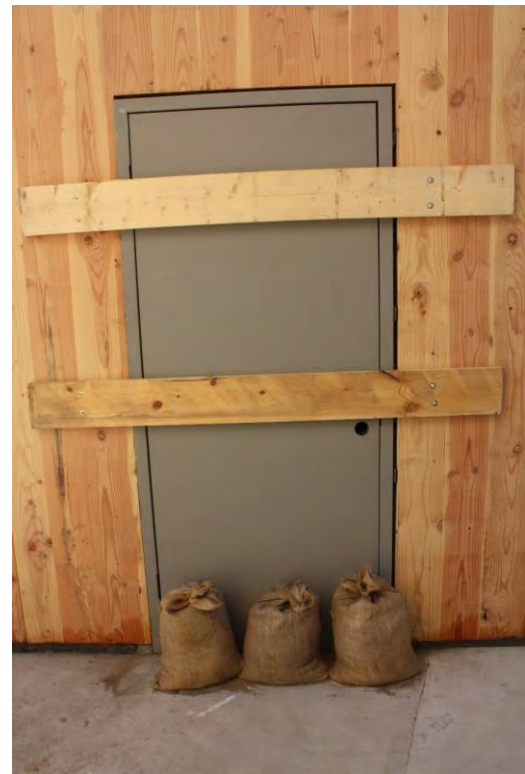
(b) As Installed (Exterior).

No locking hardware was employed to lock the door during the blast tests to limit the possibility that the door would jam shut due to the applied airblast load. Additionally, no hinges were provided for the Grade V1 or Grade E1 test structures. (Three stainless steel heavy weight bearing hinges (i.e., T4A3386 NRP $4\frac{1}{2}$ "x $4\frac{1}{2}$ "") manufactured by McKinney were used to secure the door panel to the door frame in the Grade V4 test structure.) Instead, sand bags and dimensional lumber were used to keep the door closed at the beginning of the test for all test structures as shown in Figure 3-10b.

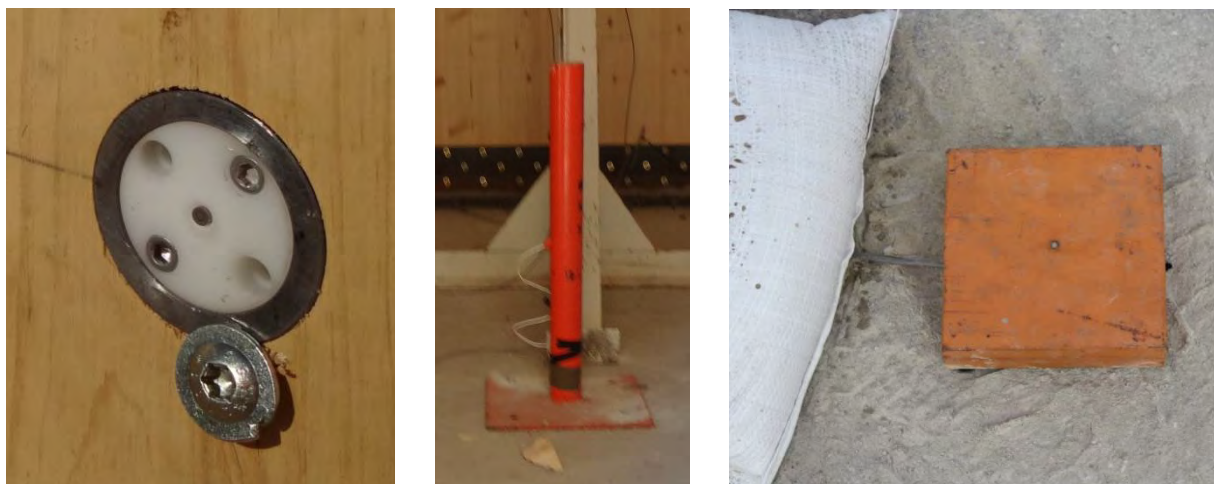
(a) *Reflected Pressure.*(b) *Internal Pressure.*(c) *External Incident Overpressure.***Figure 3-16. Pressure Gages Used in Testing.**

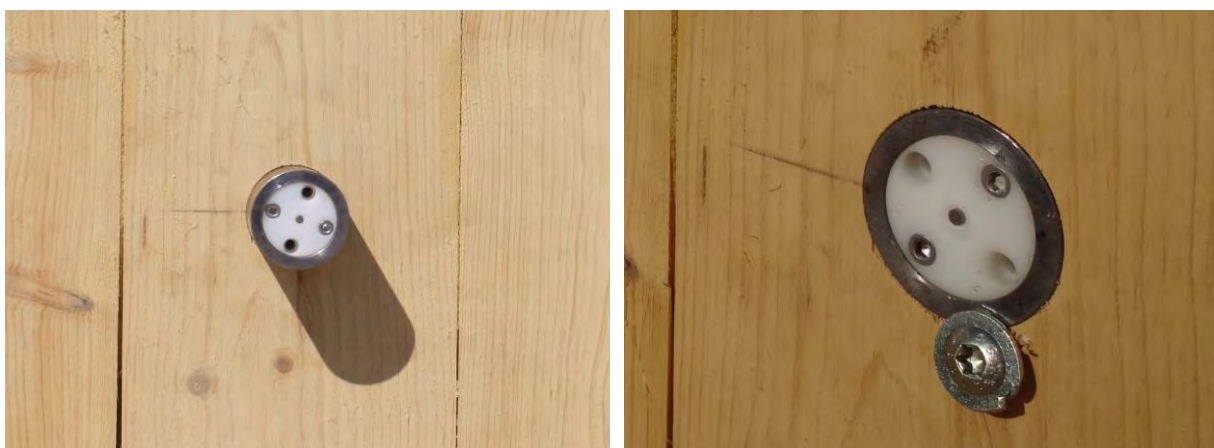
(a) *Gage Pop Out.*(b) *With Self Drilling Screw.***Figure 3-17. Attachment Problem Observed for Reflected Pressure Gages.**

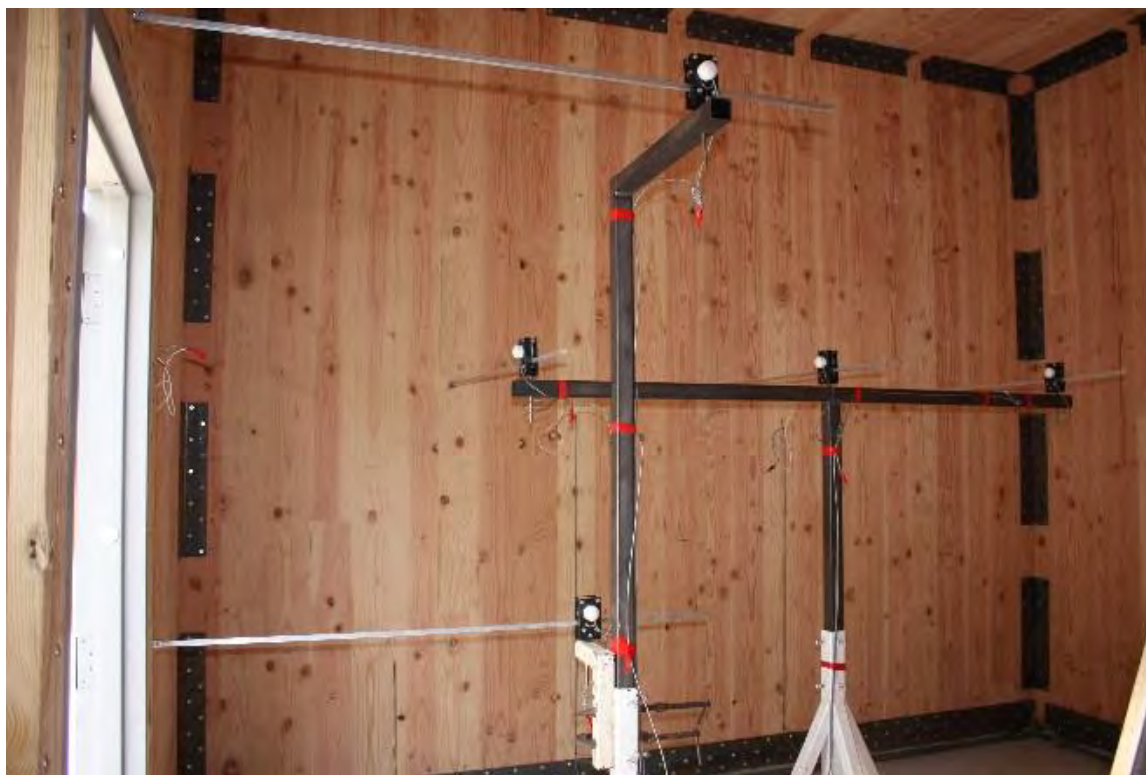
Figure 3-18. Rack and Wheel Displacement Gages with Support Stands.

ID	Structure Grade	Measurement	Location	Range
DG1 – DG11	V1	Out-of-Plane Displacement	Flush w/ wall (Figure 3-13)	36" (in) 12" (out)
DG12 – DG22	E1	Out-of-Plane Displacement	Flush w/ wall (Figure 3-14)	36" (in) 12" (out)
DG23 – DG33	V4	Out-of-Plane Displacement	Flush w/ wall (Figure 3-15)	36" (in) 12" (out)

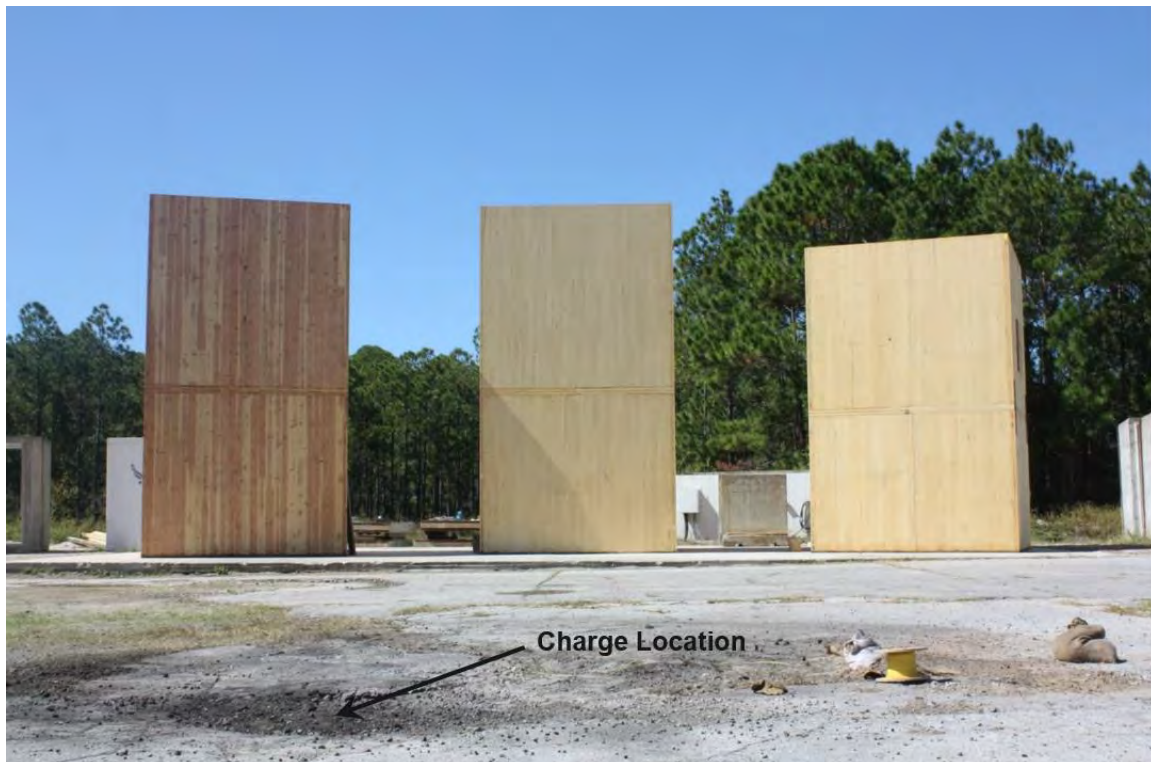
Figure 4-1. Test 1 Post-Test Photograph of All Test Structures.

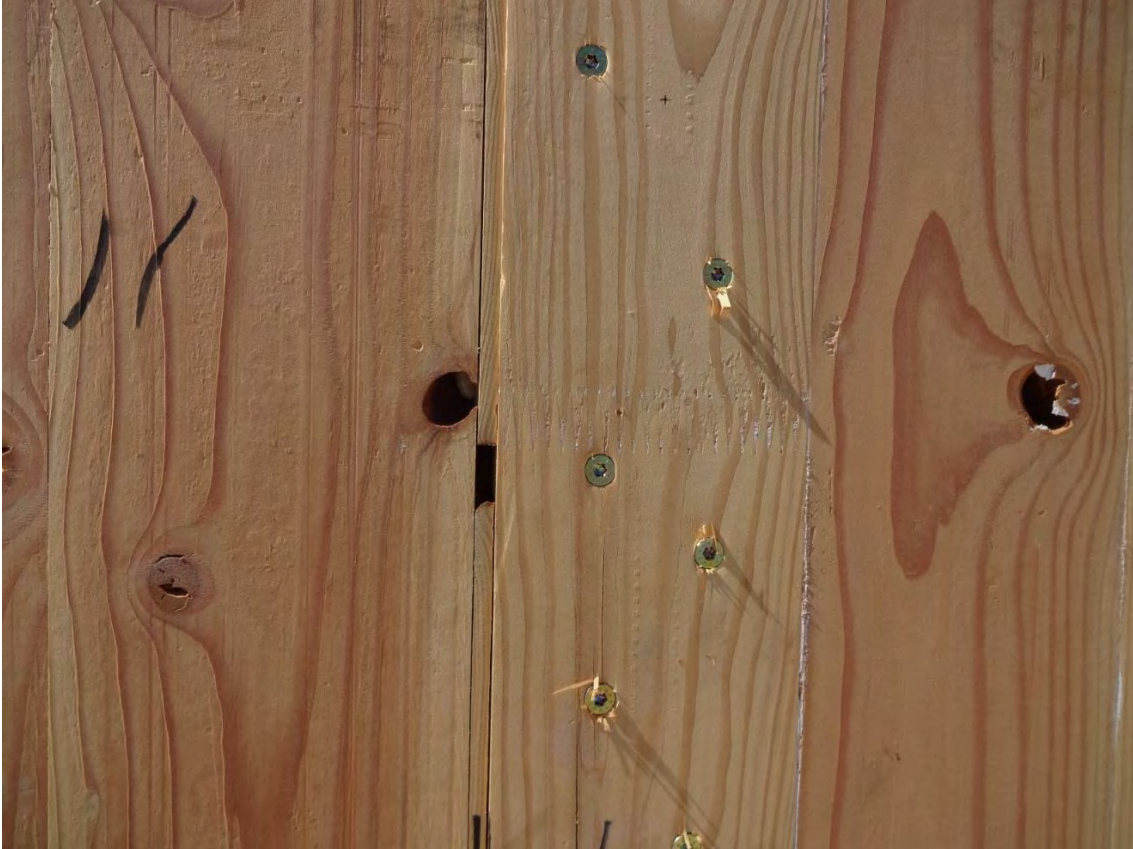
Figure 4-2. Knot Pop Out on Exposed Face of Grade V1 Test Structure Following Test 1.

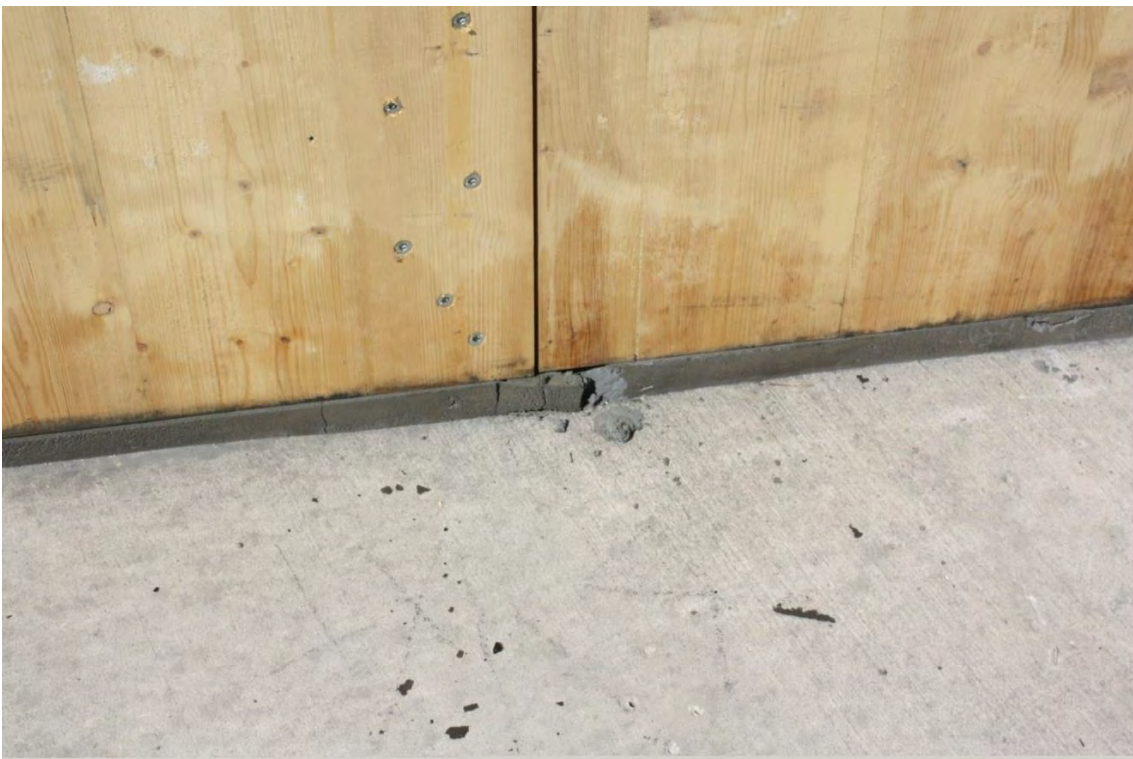
Figure 4-3. Test 1 Post-Test Photograph of Grout Breakup.

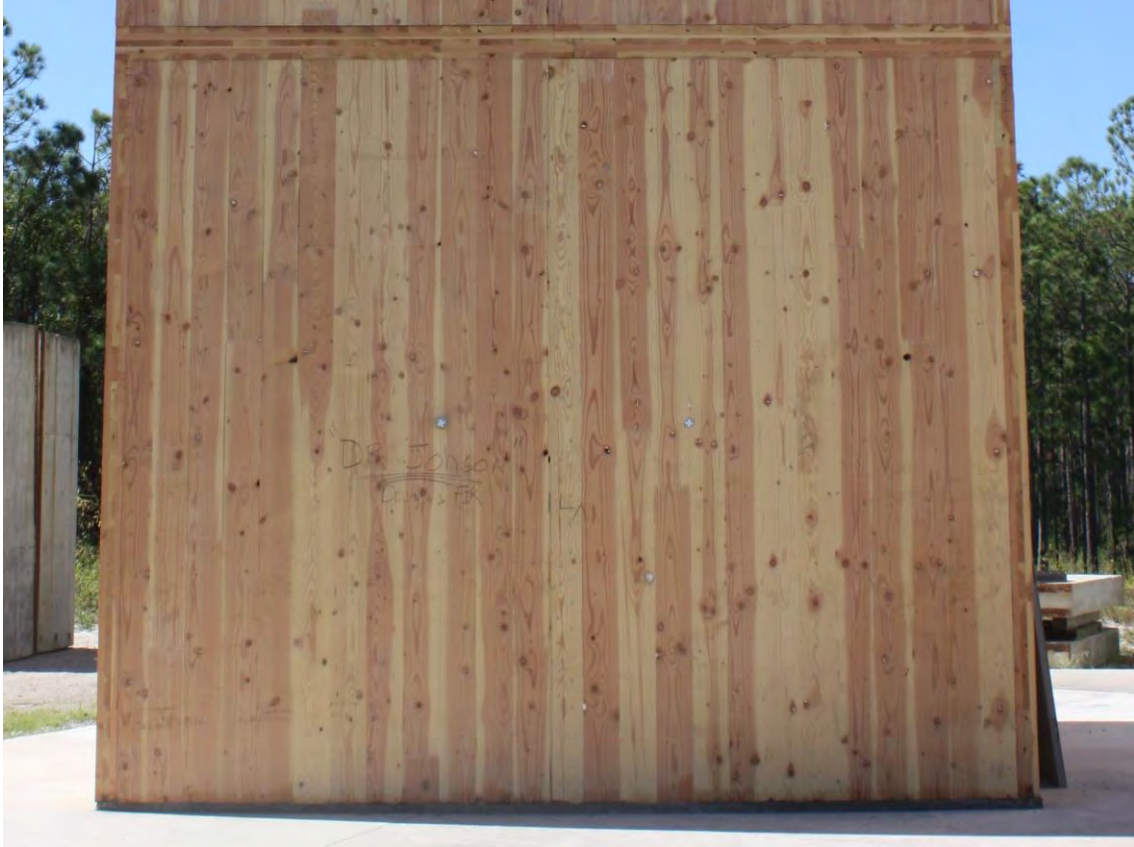
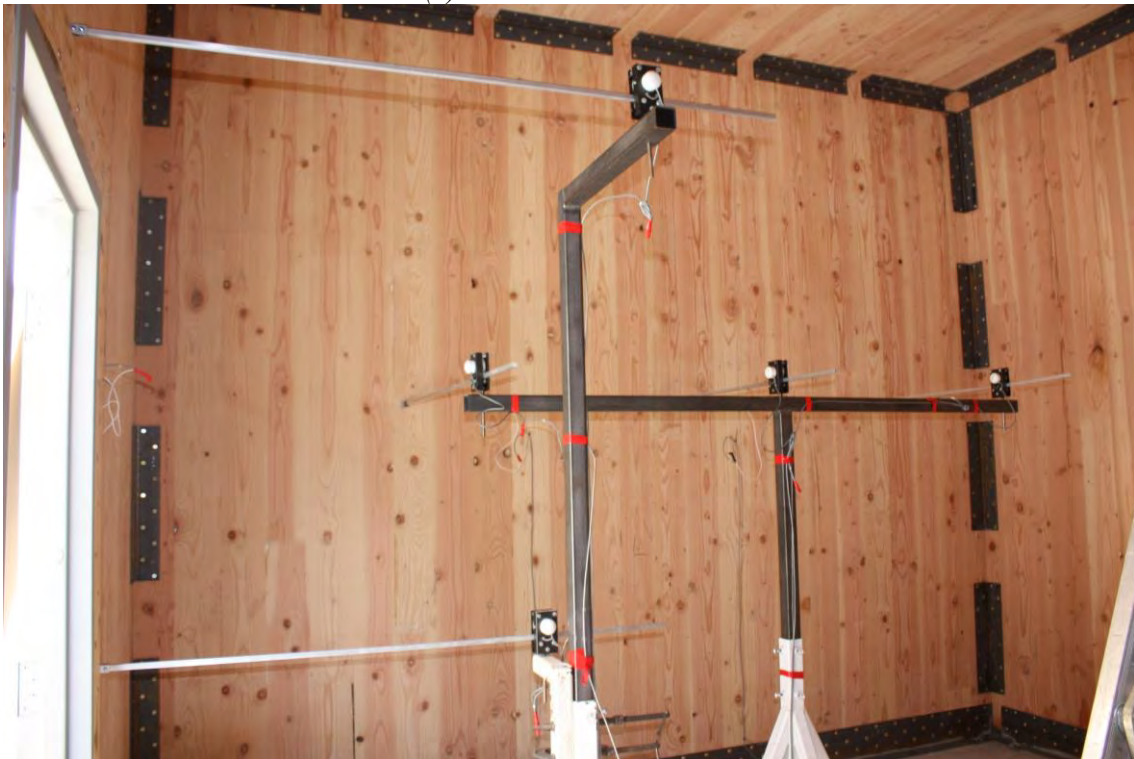
(a) Grade VI – Exterior.

(b) Grade VI – Interior.

Figure 4-4. Test 1 Post-Test Photographs of First-Floor Front Panel.

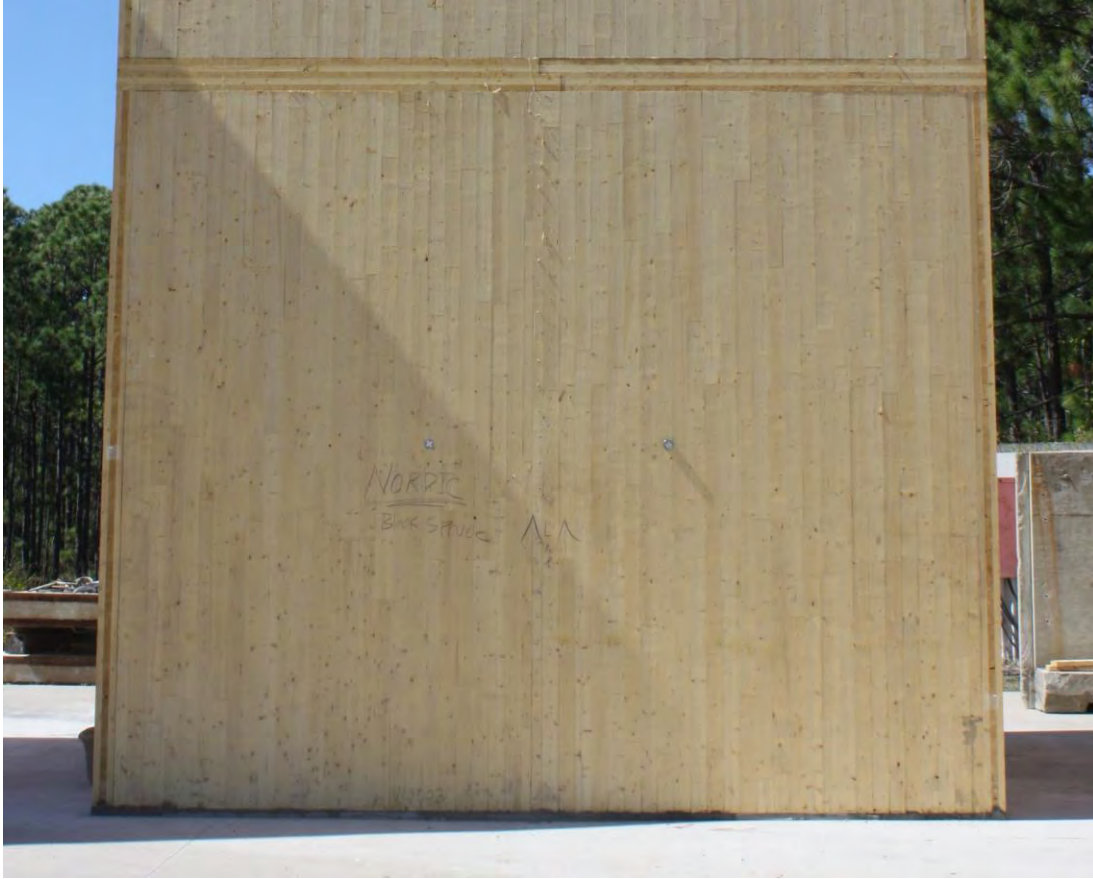
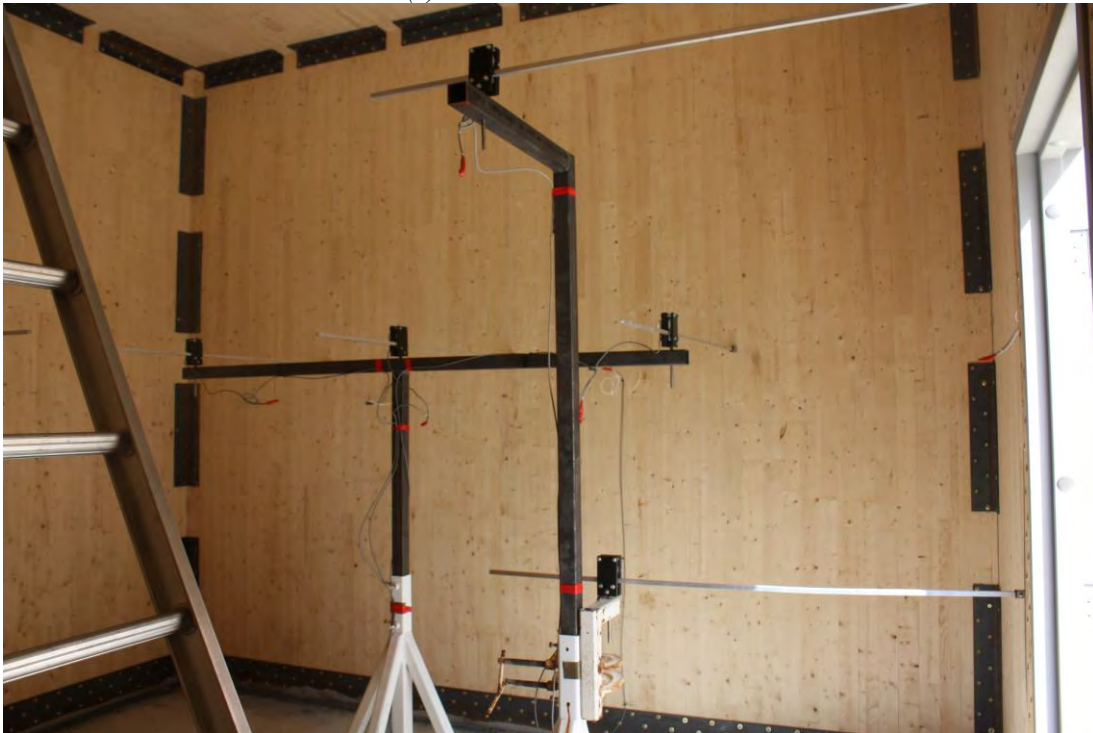
(c) Grade E1 – Exterior.

(d) Grade E1 – Interior.

Figure 4-4. Test 1 Post-Test Photographs of First-Floor Front Panel. (Cont'd)
