BLAST-RESISTANT TESTING FOR MASS TIMBER EXTERIOR WALLS: FINAL ACCOMPLISHMENT REPORT

Lisa Podesto, P.E.¹

Mark K. Weaver, S.E.²

October 9, 2017

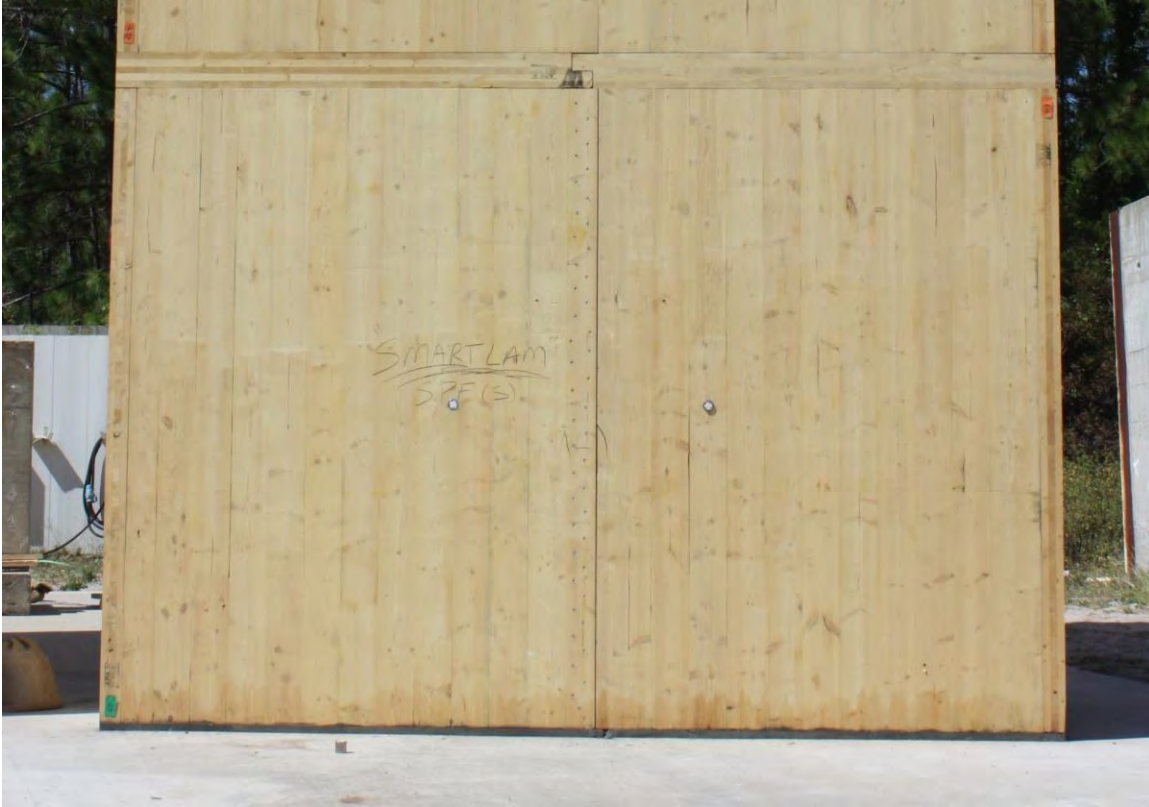
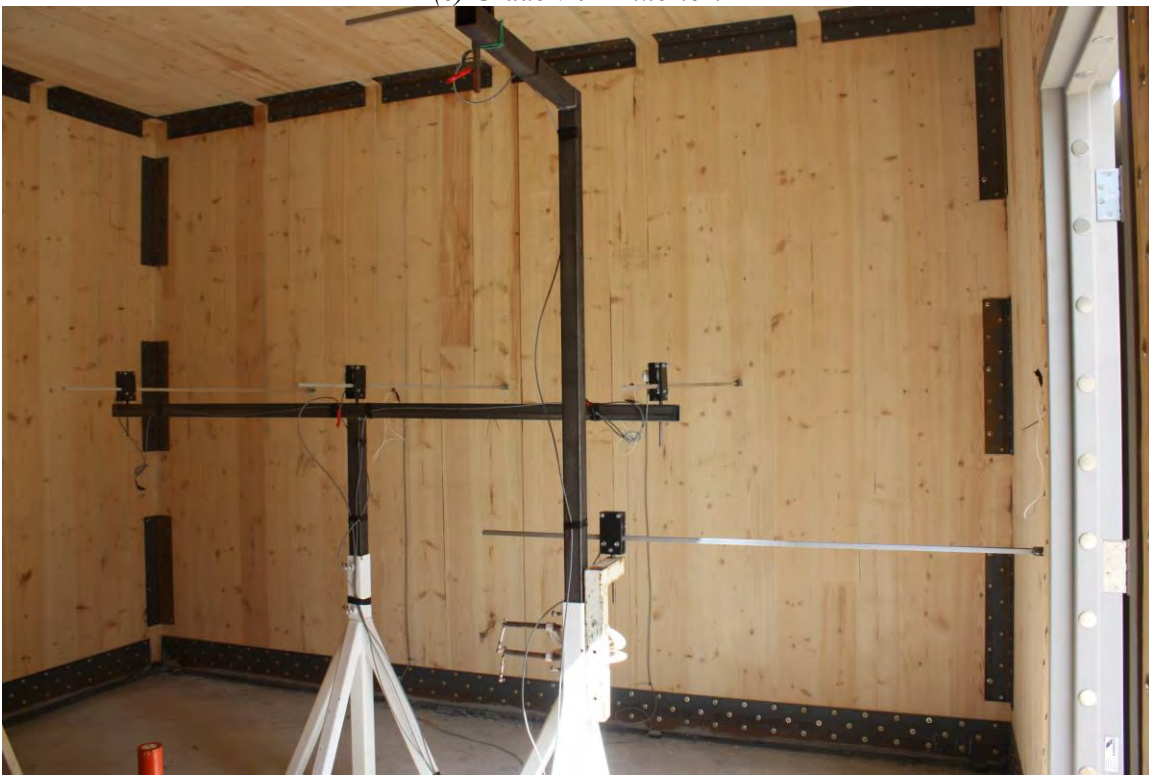
(e) Grade V4 – Exterior.

(f) Grade V4 – Interior.

Figure 4-4. Test 1 Post-Test Photographs of First-Floor Front Panel. (Cont'd)

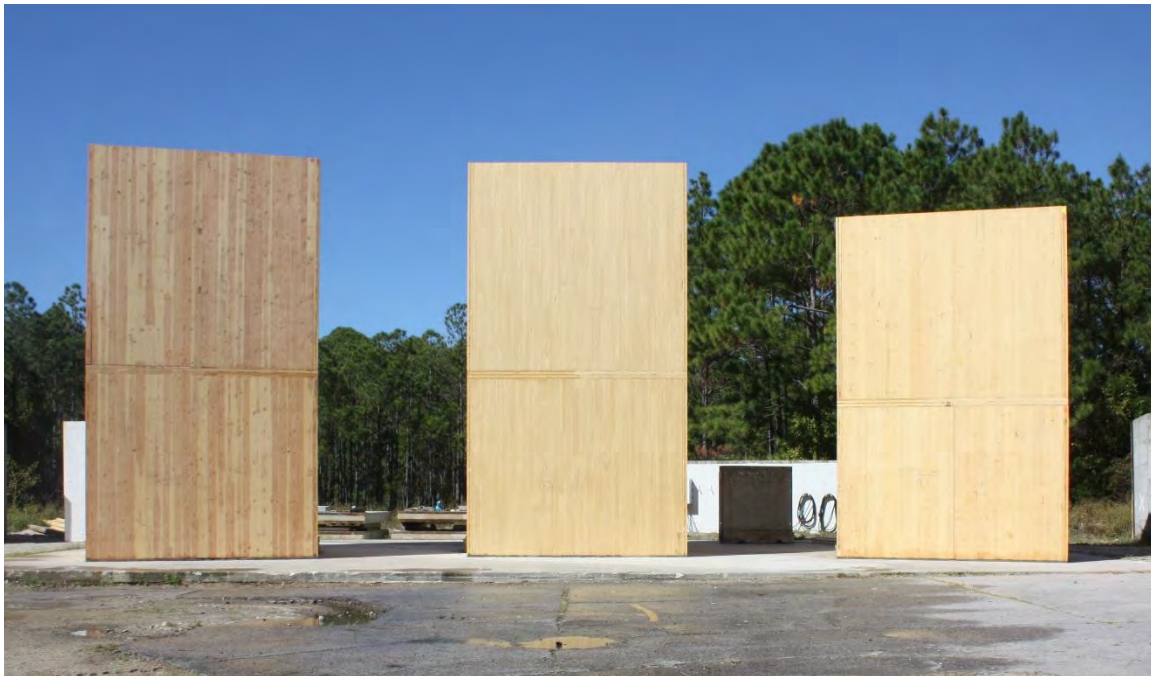
Figure 4-5. Test 2 Post-Test Photograph of All Test Structures.

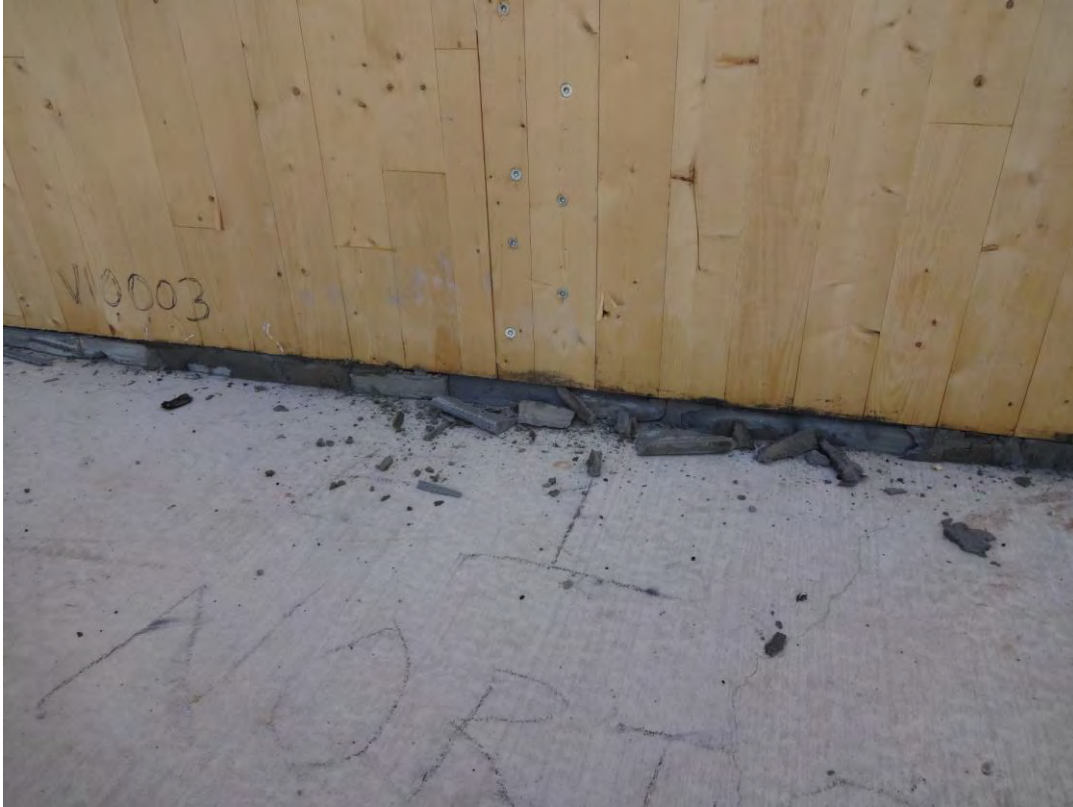
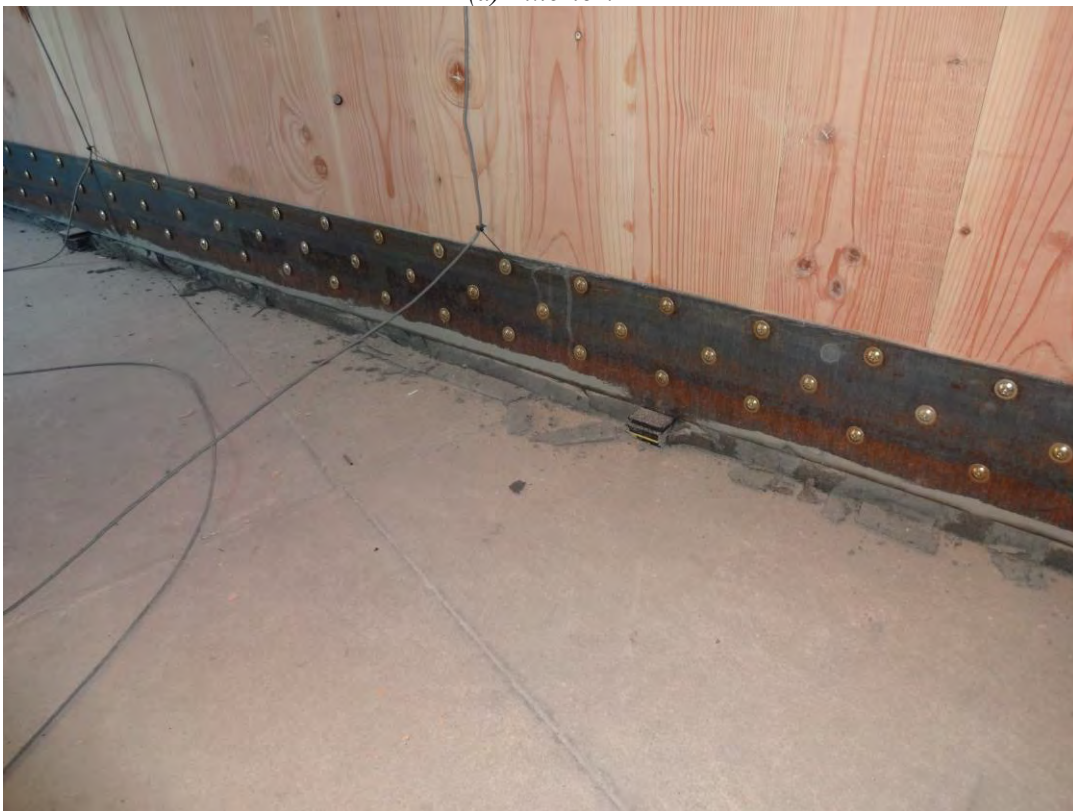
(a) Exterior.

(b) Interior.

Figure 4-6. Test 2 Post-Test Photograph of Grout Breakup.

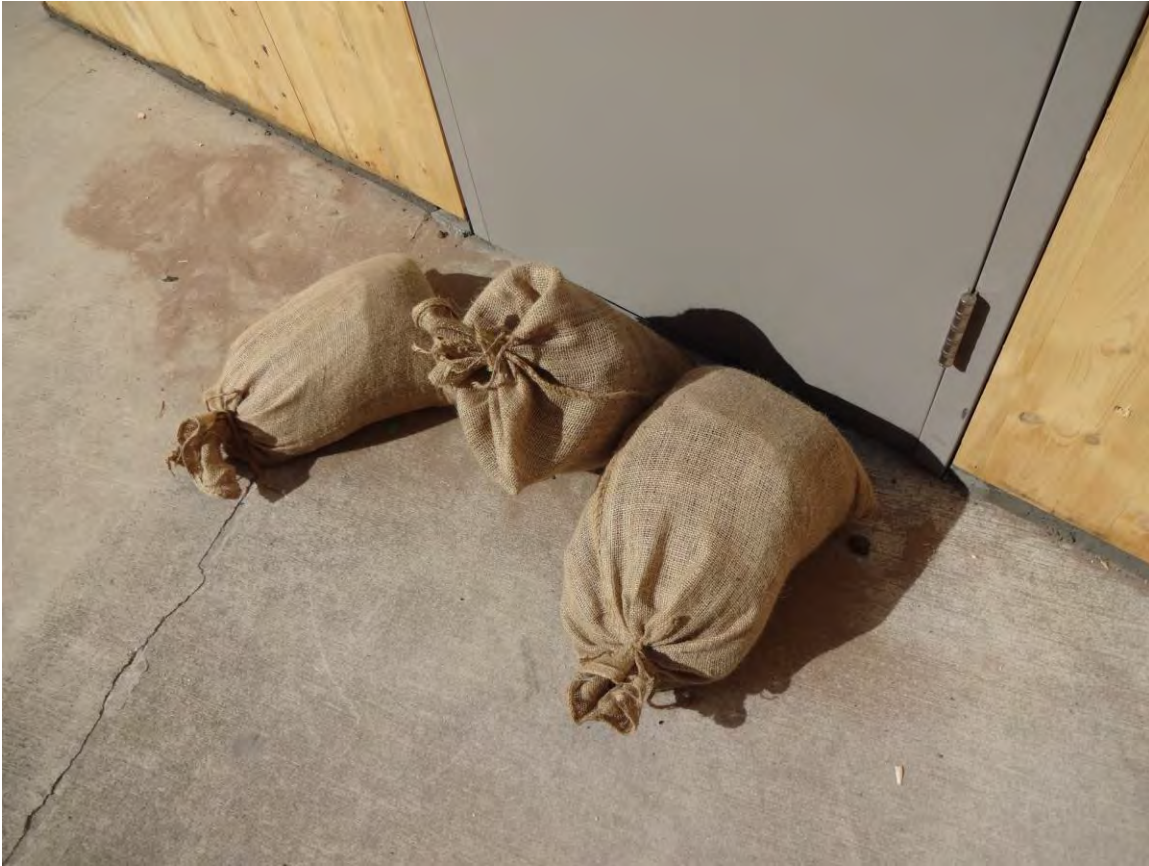
Figure 4-7. Test 2 Post-Test Photograph of Sand Bag Overturning.

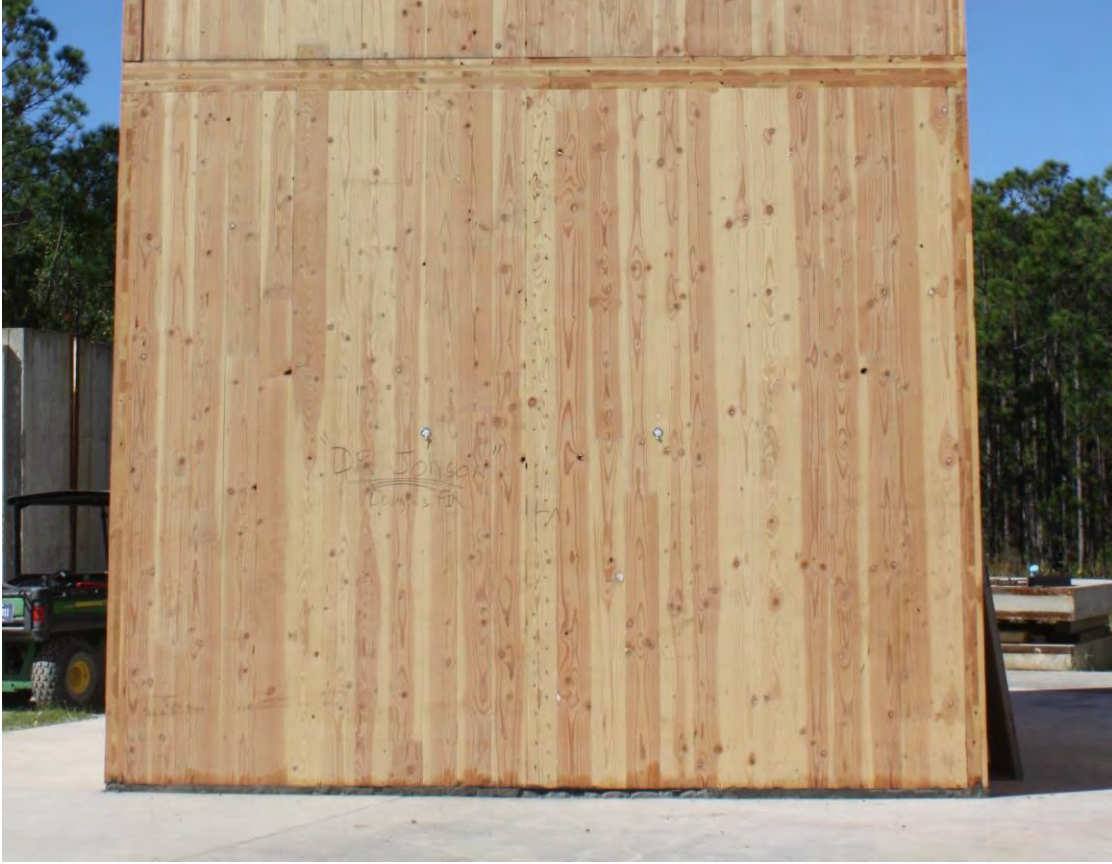
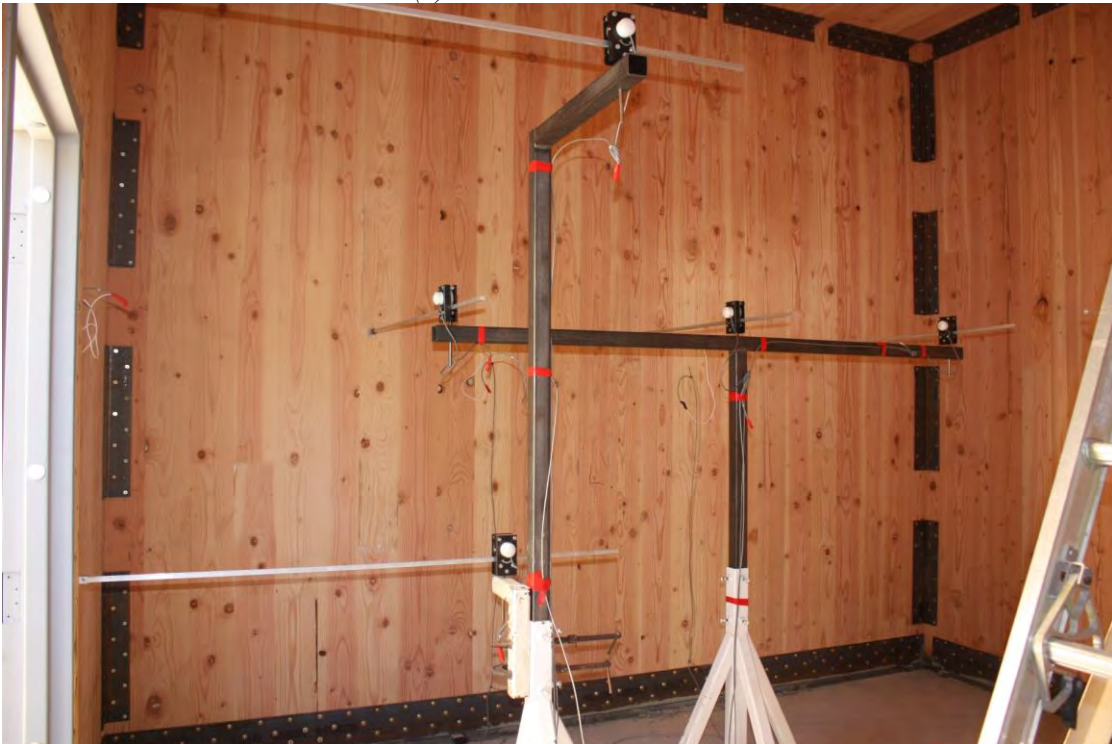
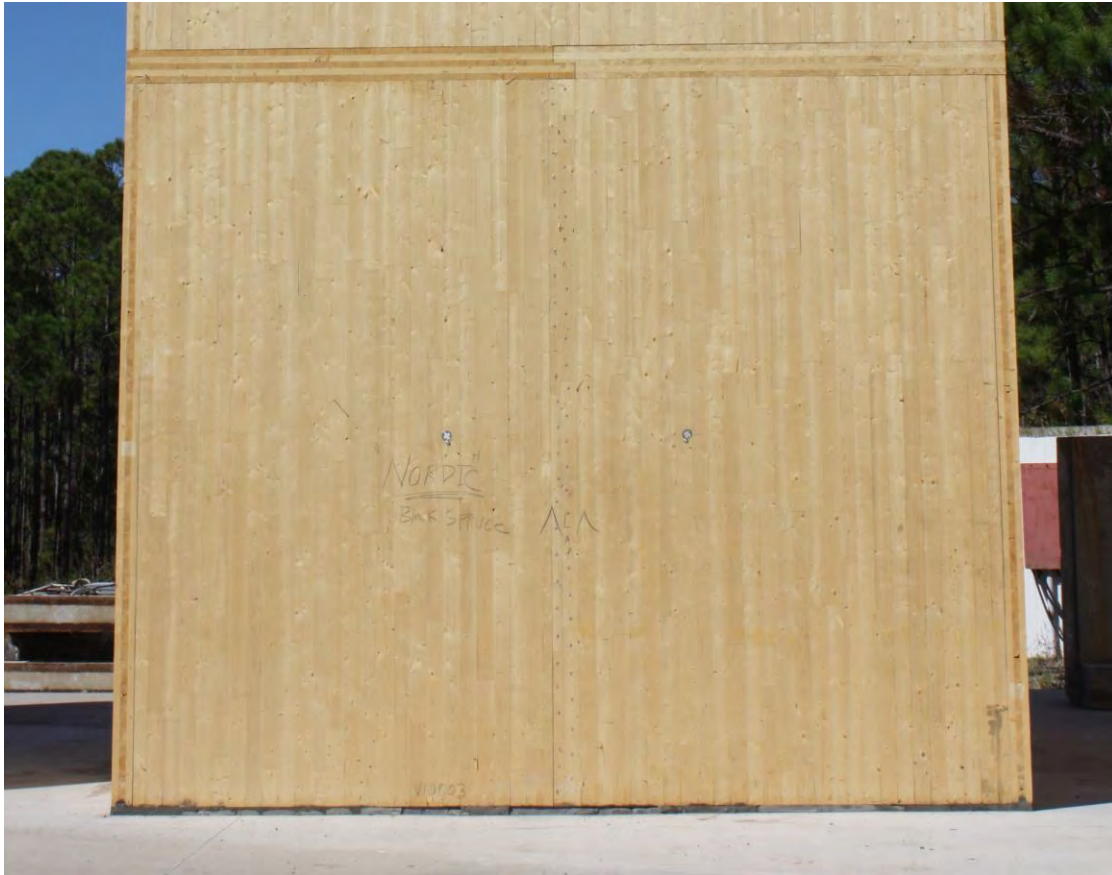
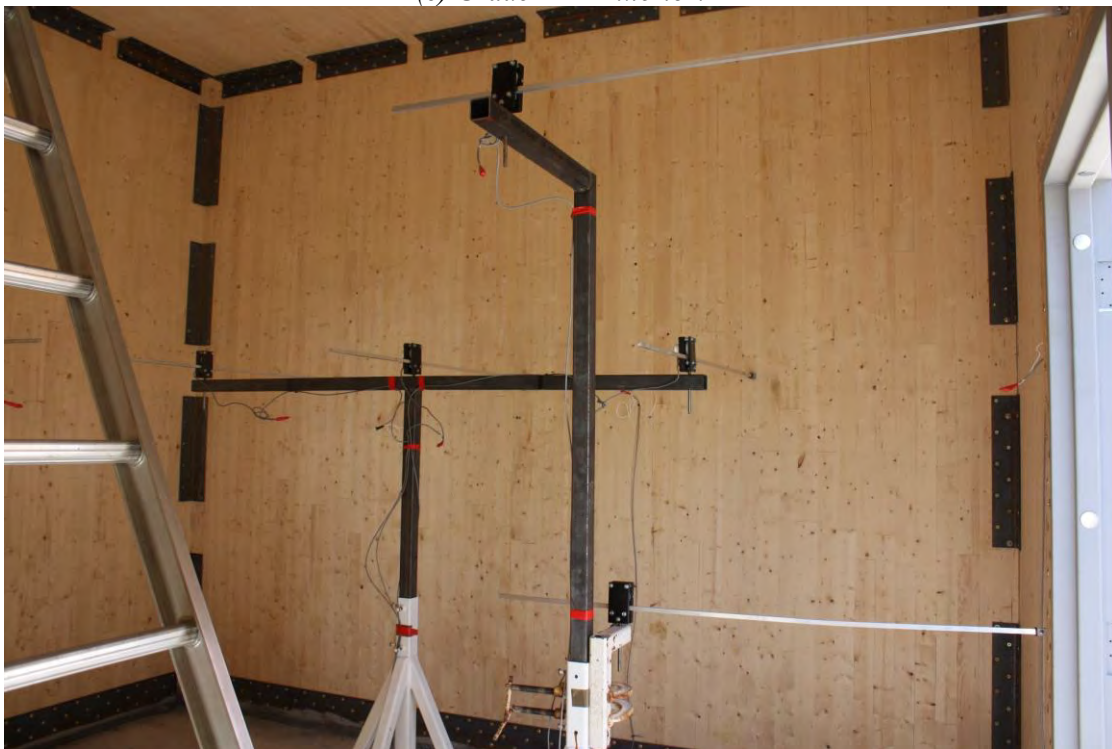
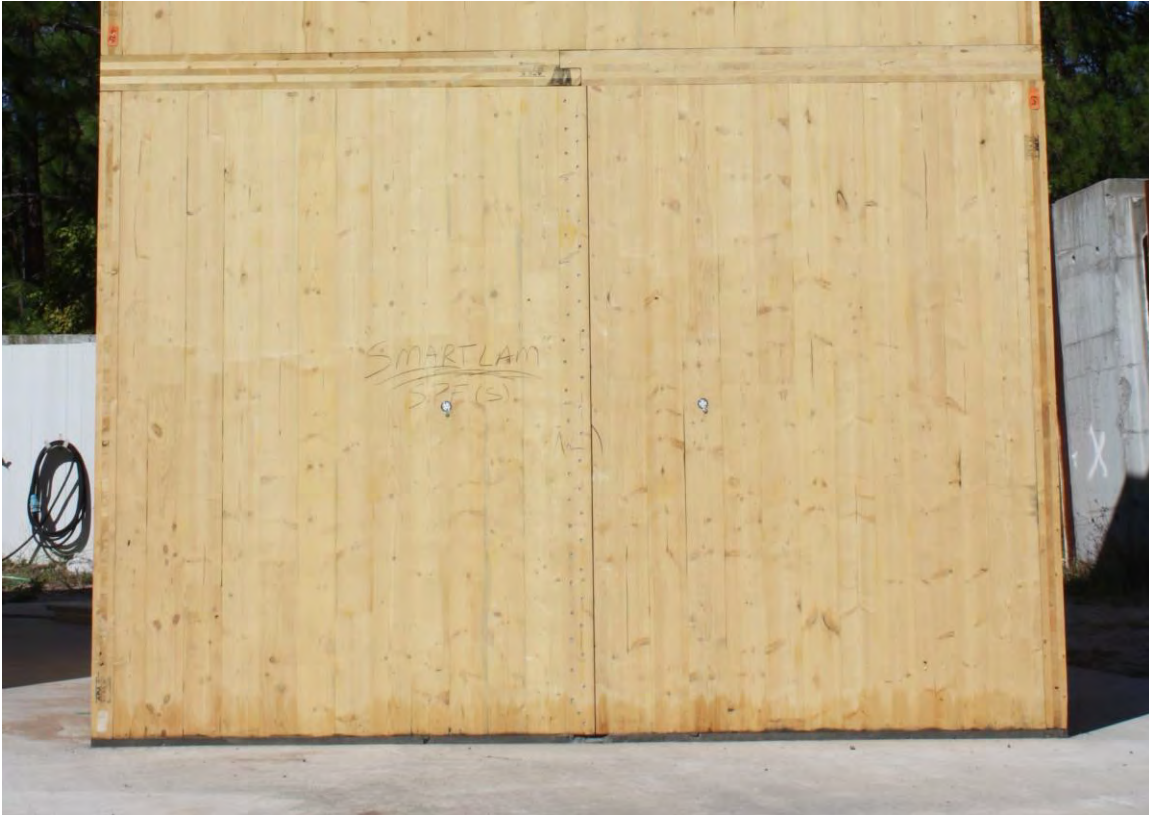
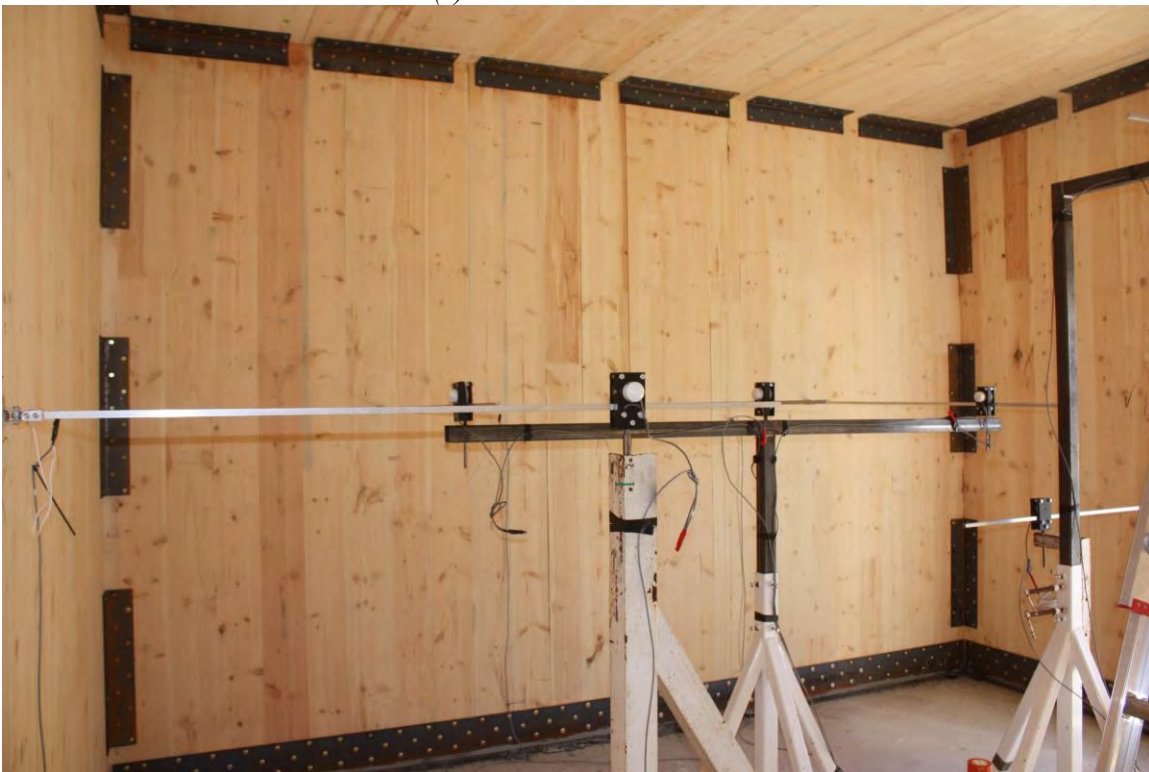
Figure 4-8. Test 2 Post-Test Photographs of First-Floor Front Panel.

(a) Grade VI – Exterior.

(b) Grade VI – Interior.

(c) Grade E1 – Exterior.

(d) Grade E1 – Interior.

(e) Grade V4 – Exterior.

(f) Grade V4 – Interior.

Besides a few more knots popping out of exposed CLT panel plies, no signs of damage to or permanent deformation in the constituent panels of the CLT test structures were observed following Test 2. Further cracking and breaking up of the grout placed under the foundation angle was visible both from inside and outside of the test structures following Test 2 (Figure 4-6). Additionally, the sand bags retaining the door in its frame overturned as a result of door rebound during Test 2 (Figure 4-7).

Photographs of the post-test condition of the first-floor panel directly facing the charge are included as Figure 4-8.

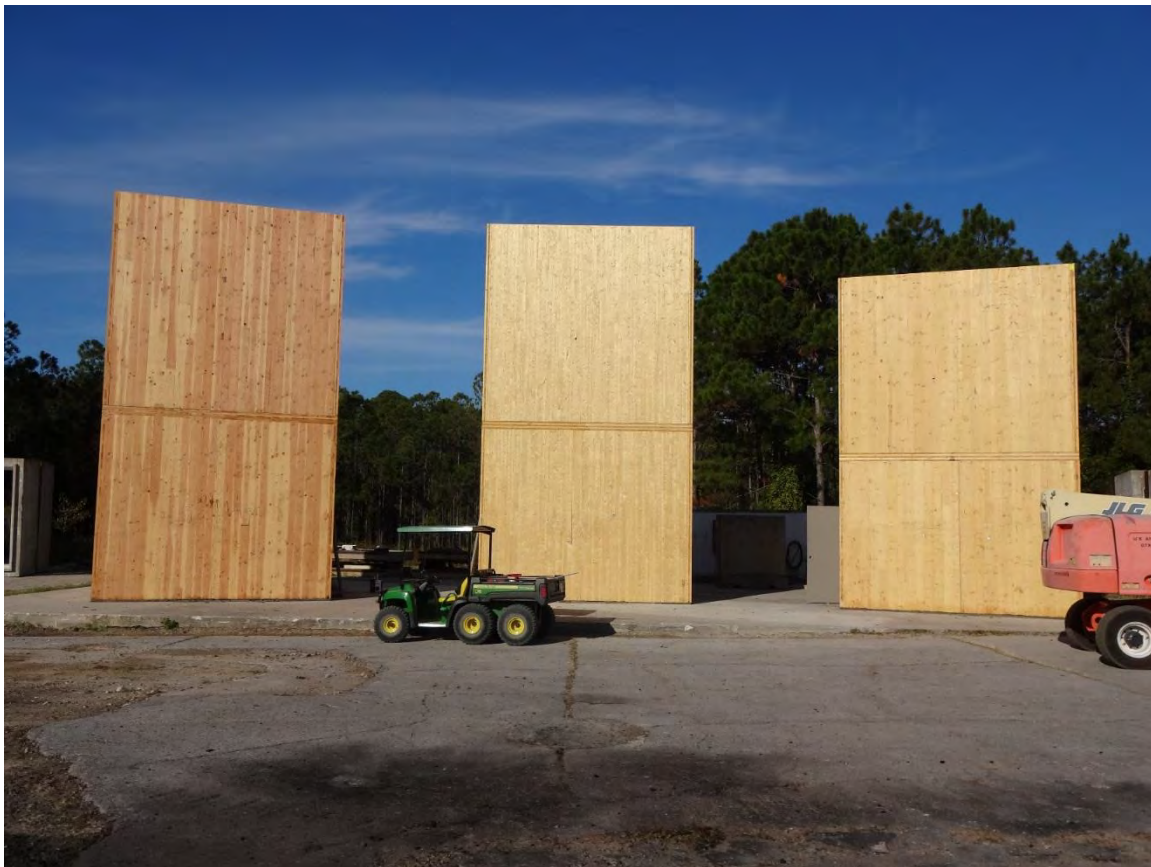
Figure 4-9. Test 3 Post-Test Photograph of All Test Structures.

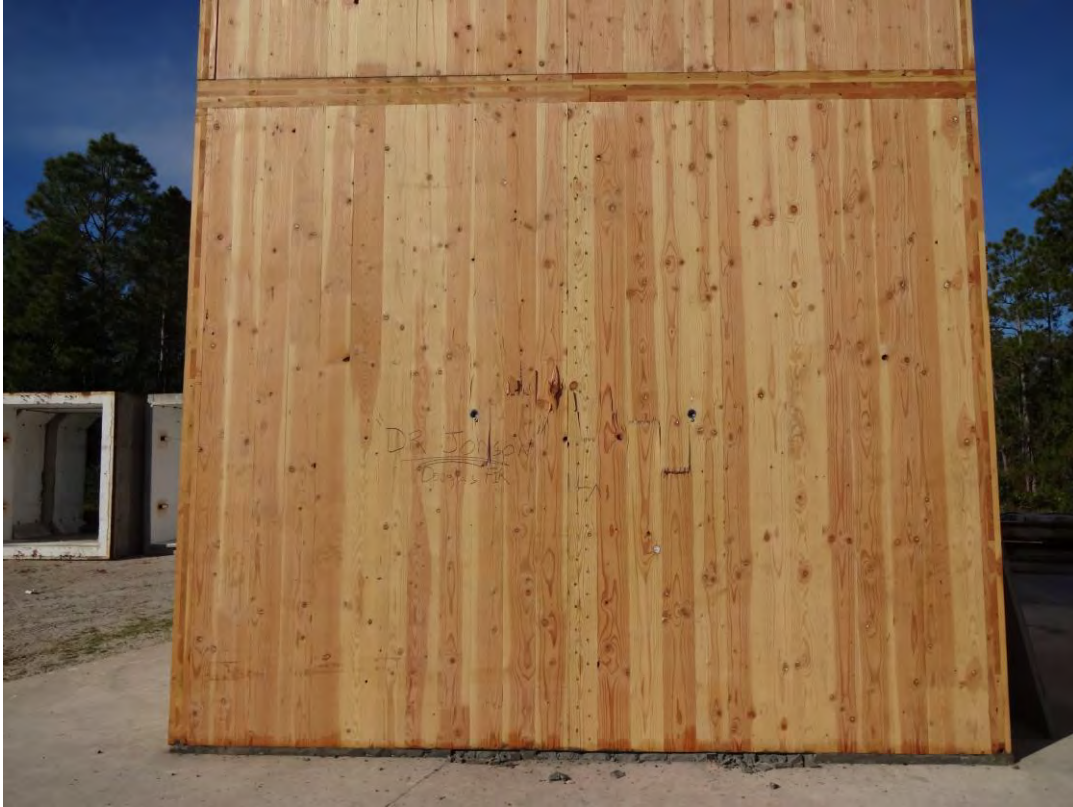
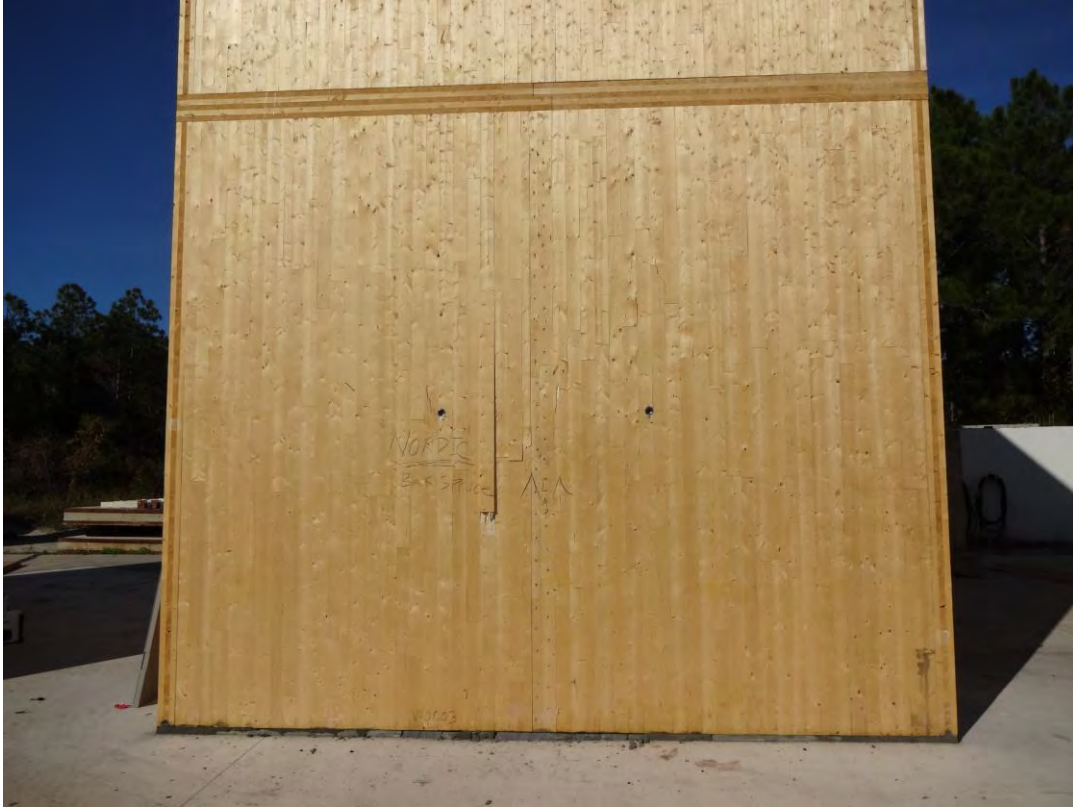
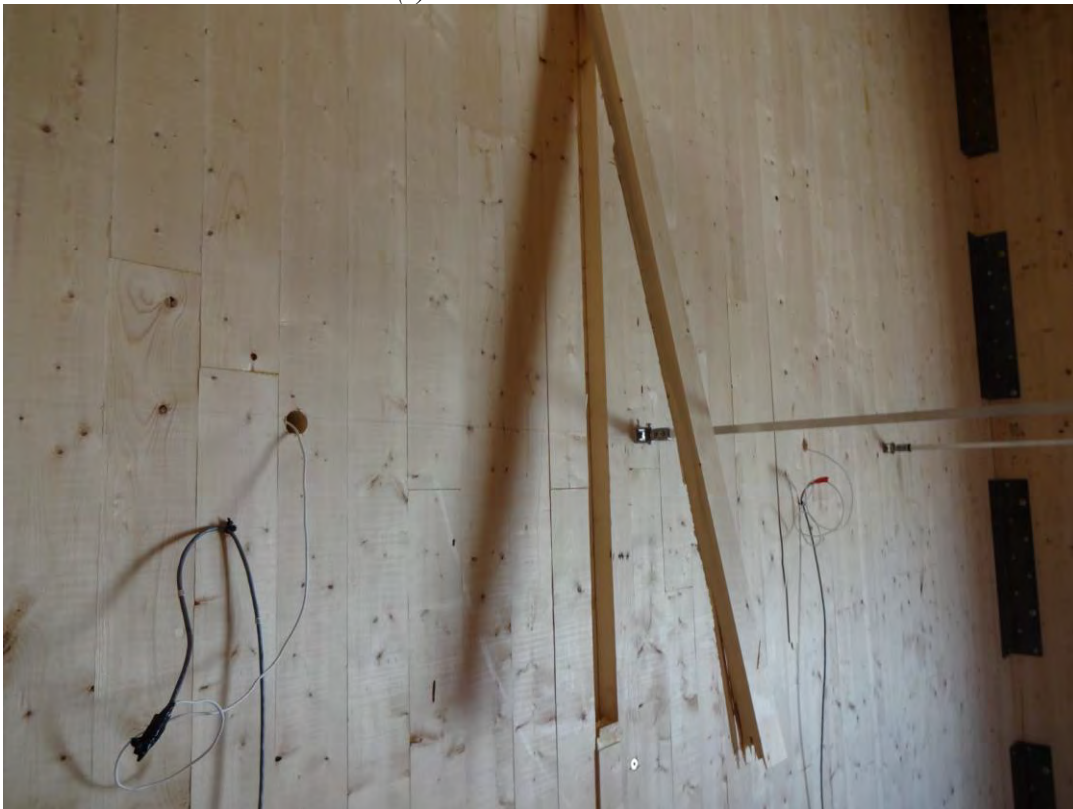
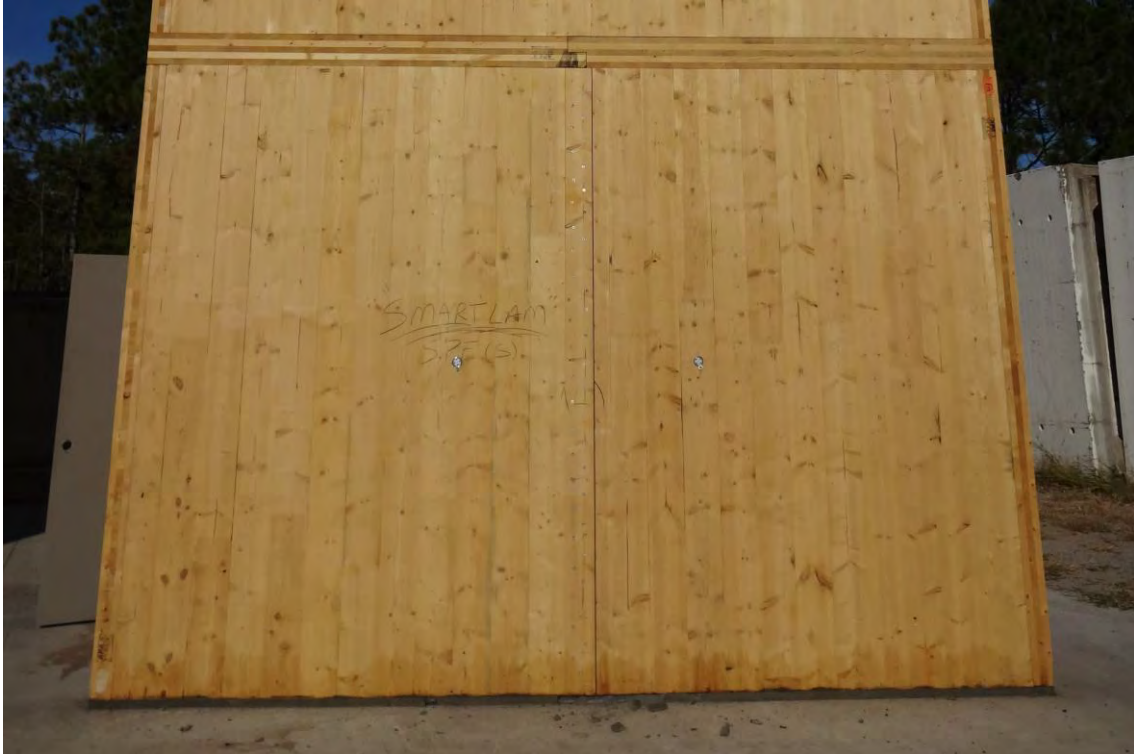
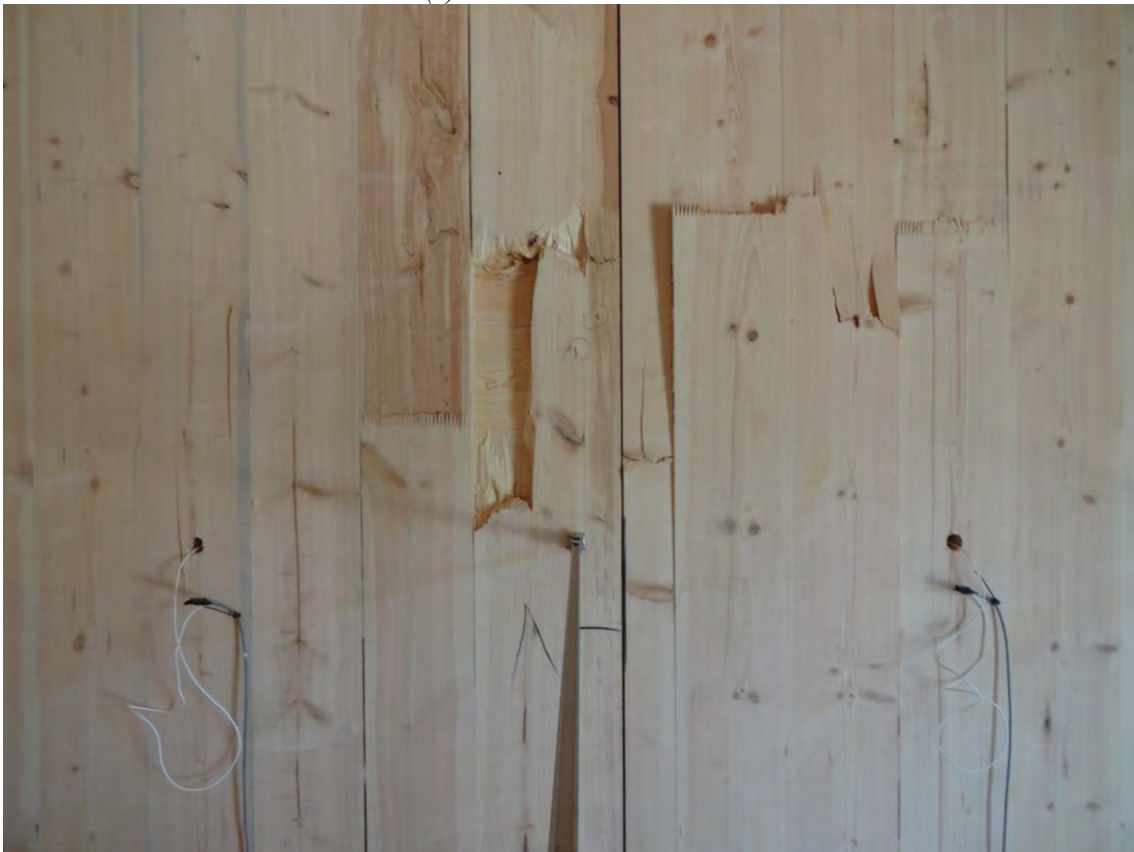
Figure 4-10. Test 3 Post-Test Photographs of First-Floor Front Panel.

(a) Grade V1 – Exterior.

(c) Grade E1 – Exterior.

(d) Grade E1 – Interior.

(e) Grade V4 – Exterior.

(f) Grade V4 – Interior.

Damage to both interior and exterior faces was observed in all three test structures following Test 3. Observable damage was primarily concentrated in the front panel facing the explosive charge.

Photographs of the post-test condition of the first-floor panel directly facing the charge from the exterior and interior are included as Figure 4-10. For the Grade V1 and Grade E1 test structures, noticeable damage was observed near mid-height and mid-width of the first-floor front panel on both the interior and exterior faces. On the other hand, most of the observable damage for the Grade V4 test structure was located on the interior face of the first-floor front panel, although there was minor damage observed on exterior face of this structure (Figure 4-11).

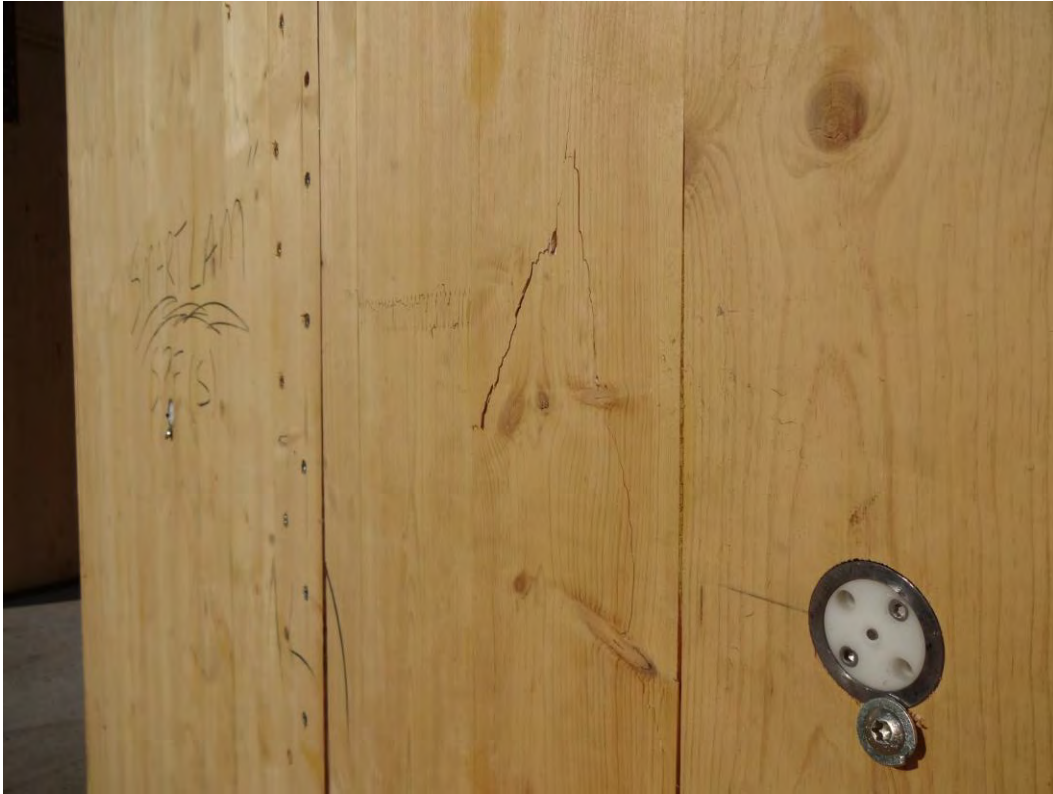
(a) Crack in Board.

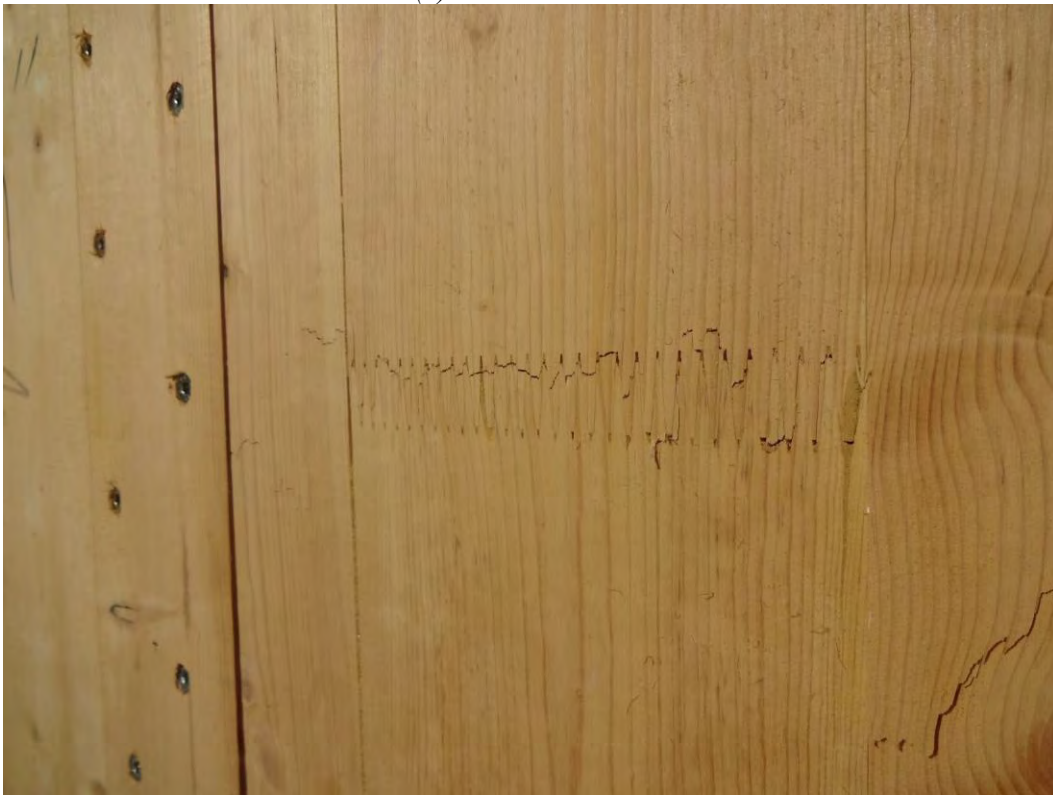
(b) Finger Joint Crack.

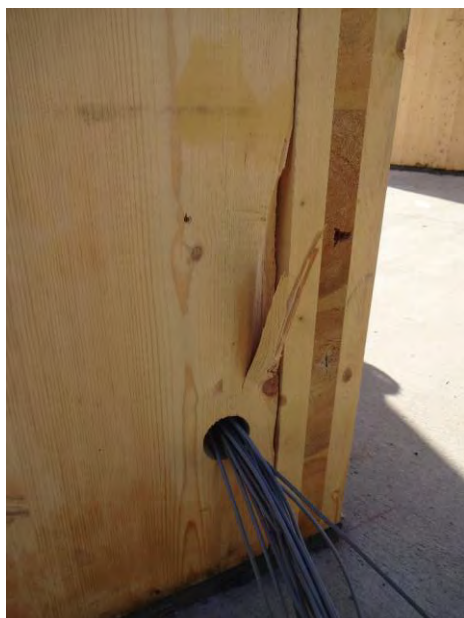
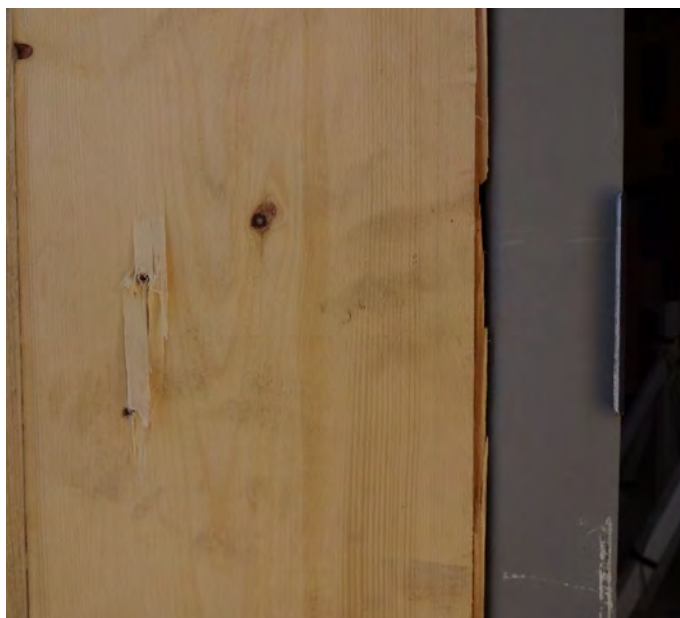
Figure 4-12. Test 3 Post-Test Photograph of Localized Damage Away from Front Panel.

(a) Grade V4 Test Structure Near Instrumentation Hole (back wall panel).

(b) Grade V4 Test Structure Near Door Frame.

Although most of the damage to the CLT panels was concentrated in the first-floor front panel, localized damage was observed at various points throughout the rest of the structure. These areas are identified in photographs included as Figure 4-12.

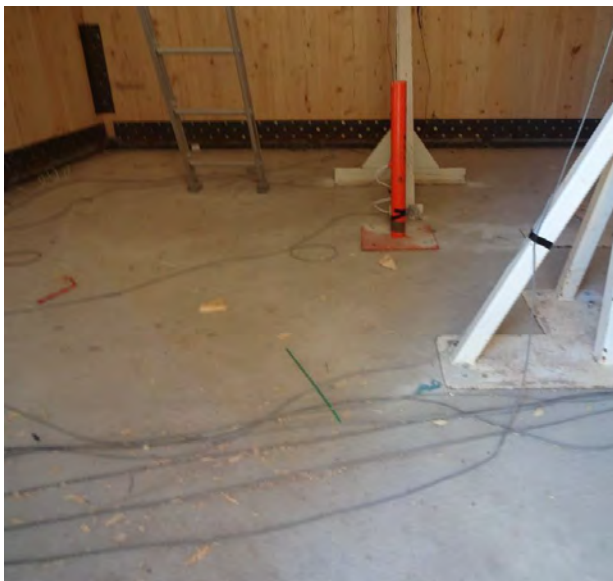
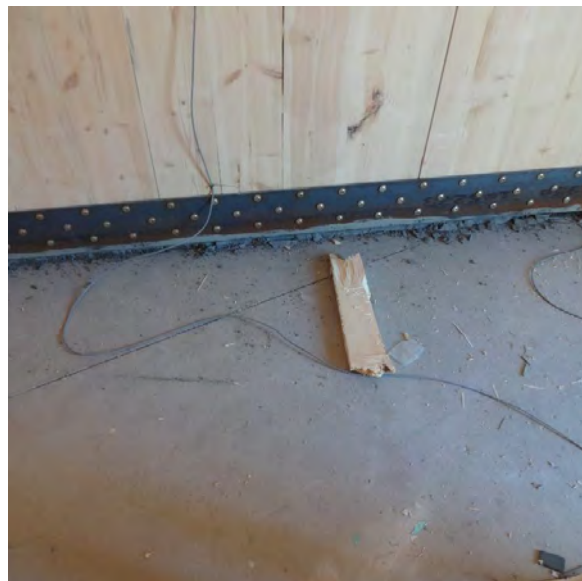
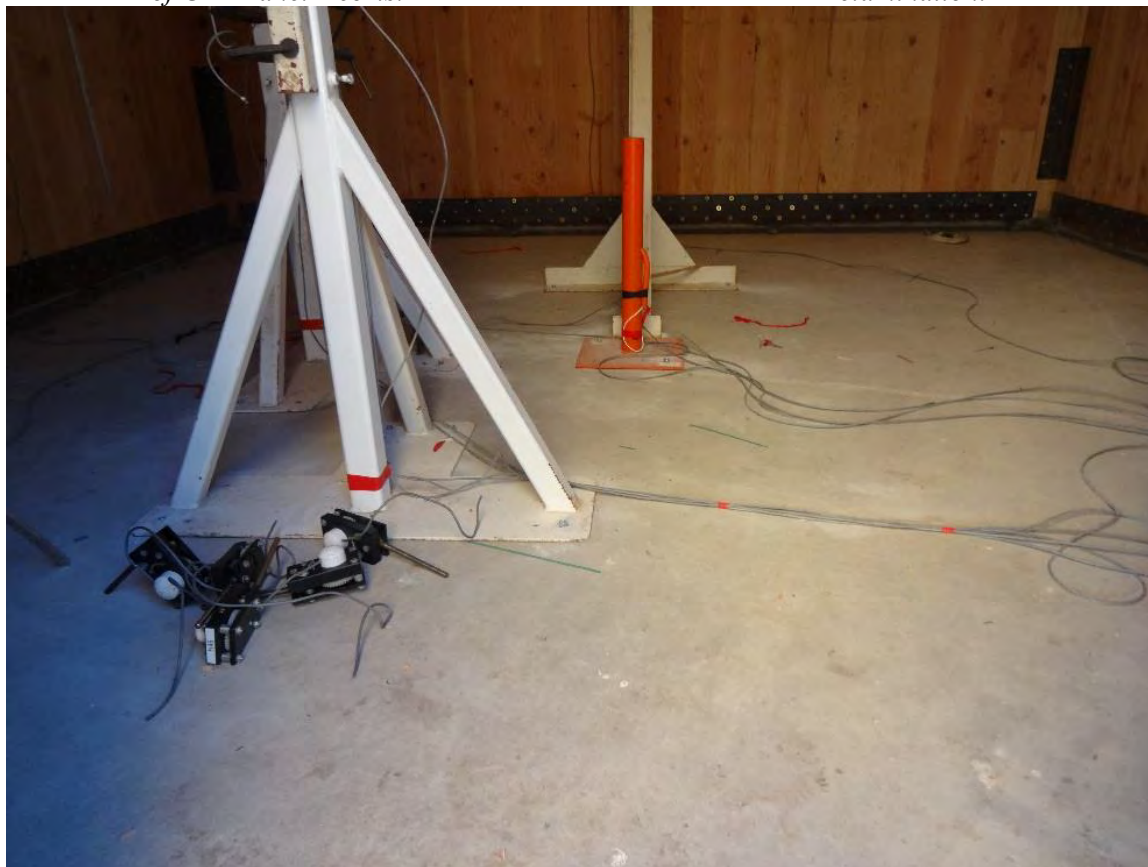
Figure 4-13. Test 3 Post-Test Photograph of Internal Debris.

(a) Grade V4 Test Structure – Many Small Pieces of CLT Panel Debris.

(b) Grade V4 Test Structure – Board Delamination.

(c) Grade V1 Test Structure (Grade E1 similar).

Also, small pieces of debris were found on the inside of the Grade V4 test structure at the first floor following Test 3. Similar debris was not observed for the Grade V1 or Grade E1 test structures. Examples of this debris are shown in Figure 4-13.

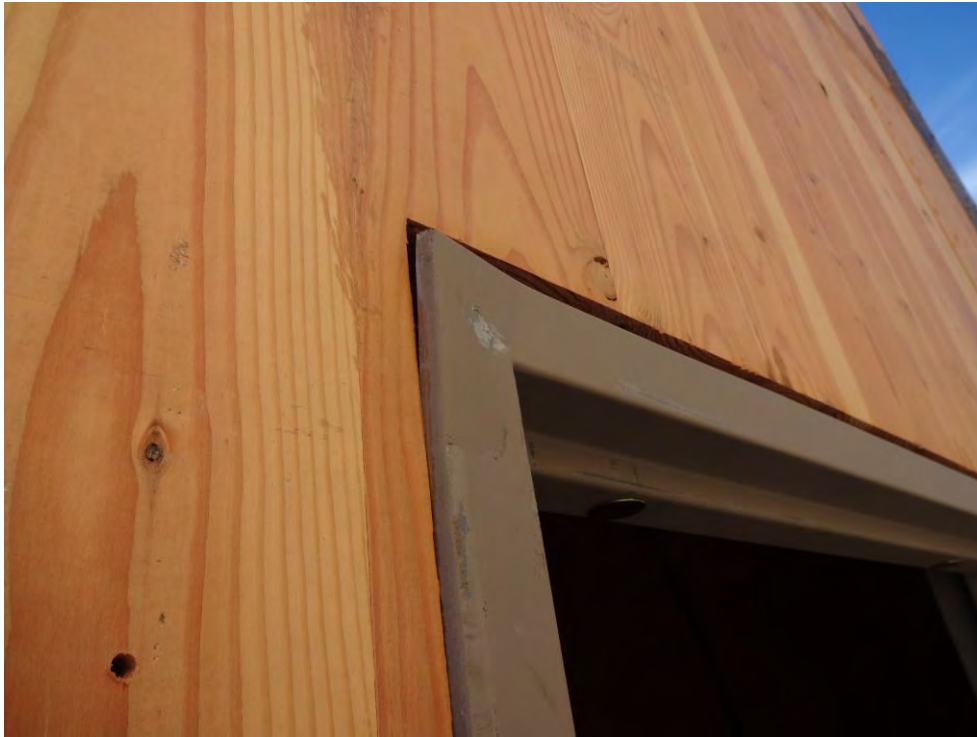
(a) Door Frame Inelastic Deformation.

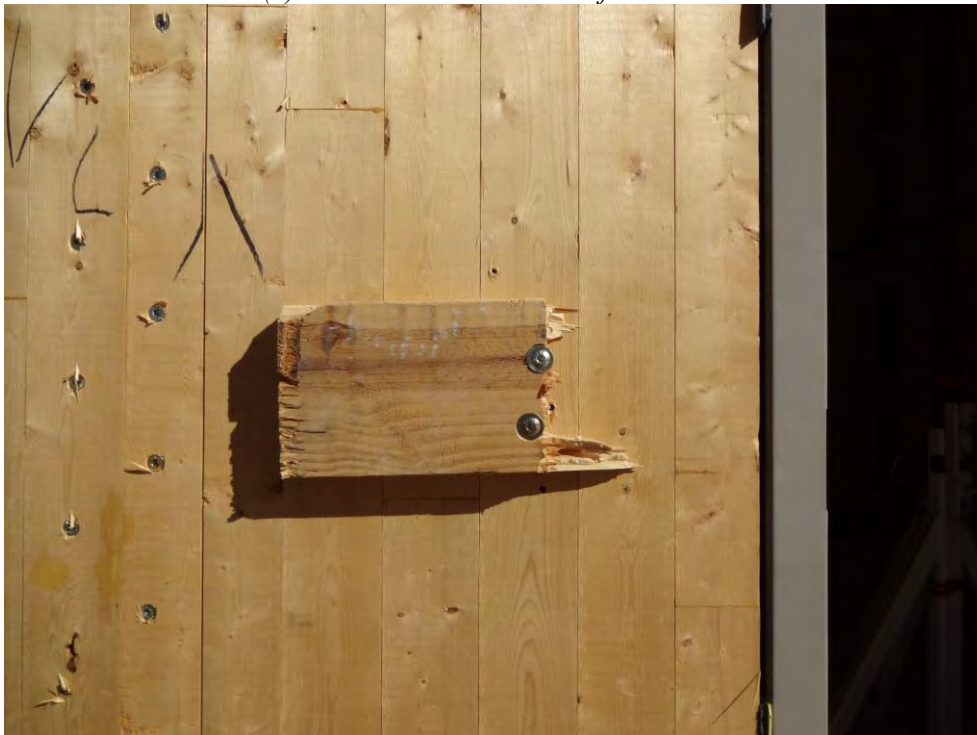
(b) 2x Restraint Rupture.

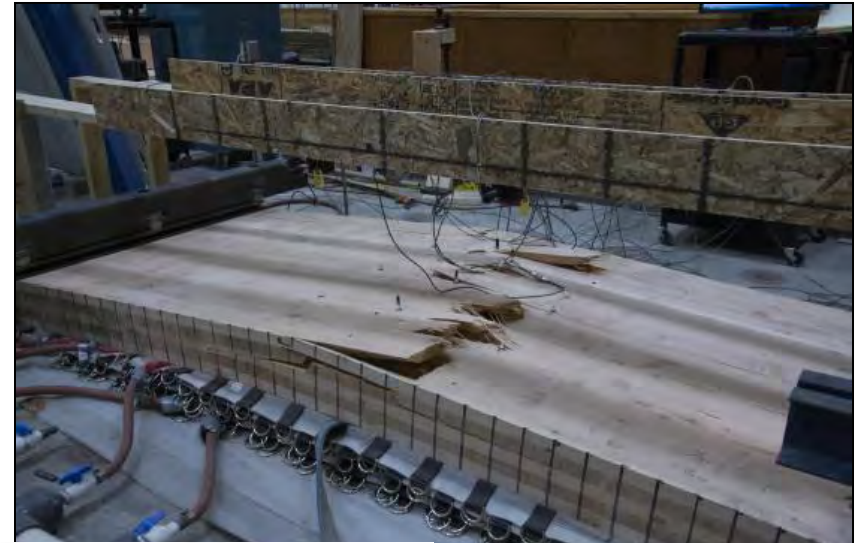
- Water bladder at the University of Maine used to perform static evaluation of CLT resistance
- Parameters included panel grade, ply number, dimensions, and boundary conditions
- Shock tube testing by PDC and University of Ottawa indicated a dynamic increase factor of between 1.2 and 1.35 for CLT (K&C)
