BLAST-RESISTANT TESTING FOR MASS TIMBER EXTERIOR WALLS: FINAL ACCOMPLISHMENT REPORT

Lisa Podesto, P.E.¹

Mark K. Weaver, S.E.²

October 9, 2017

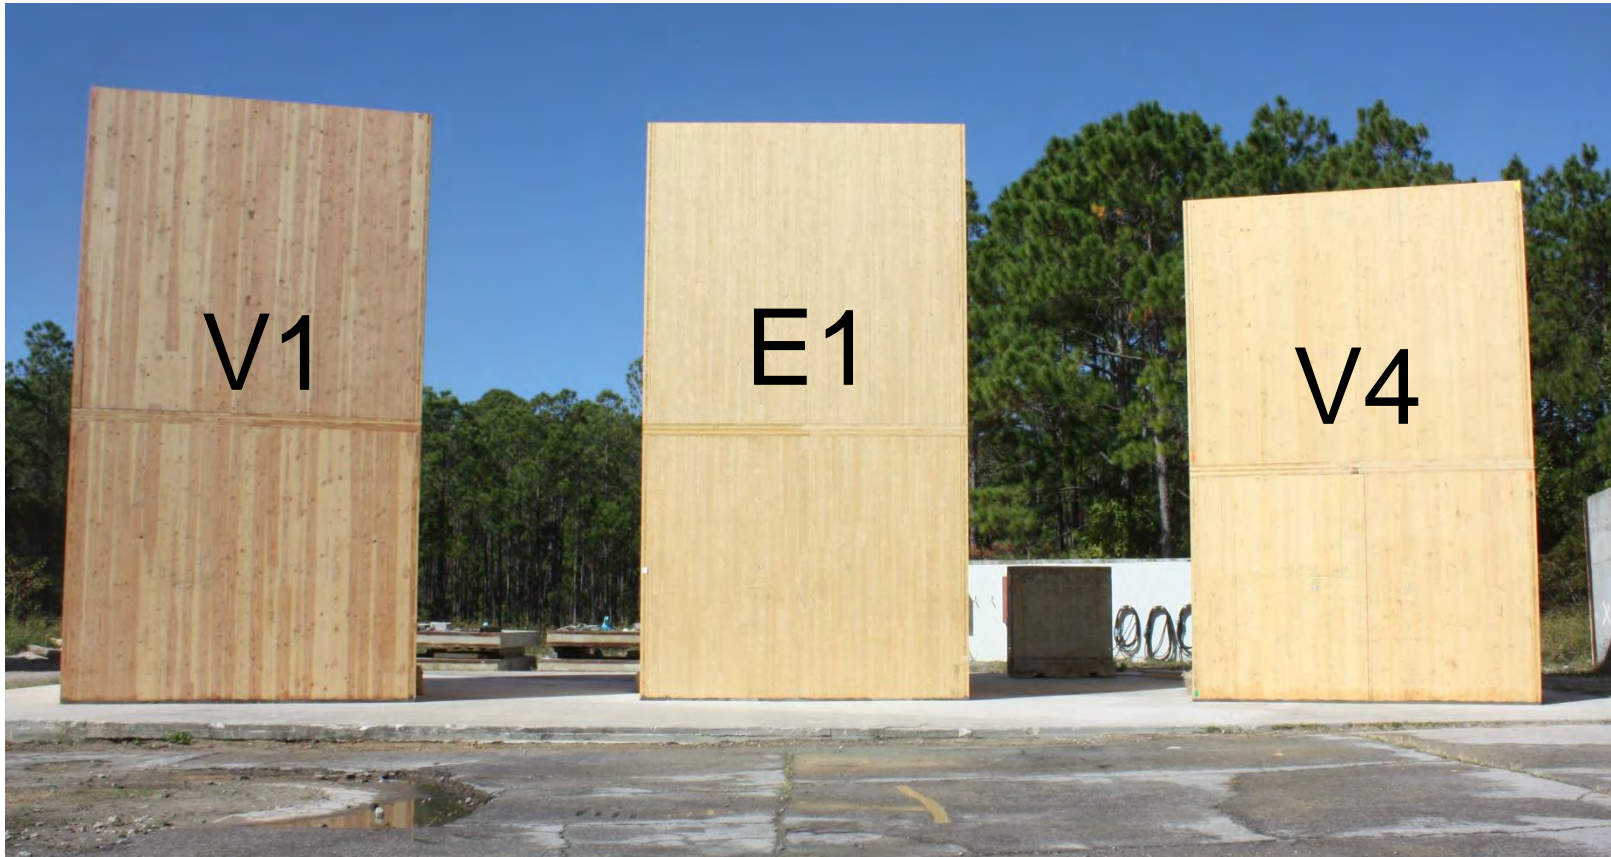
Buildings labeled according to grade of CLT panels

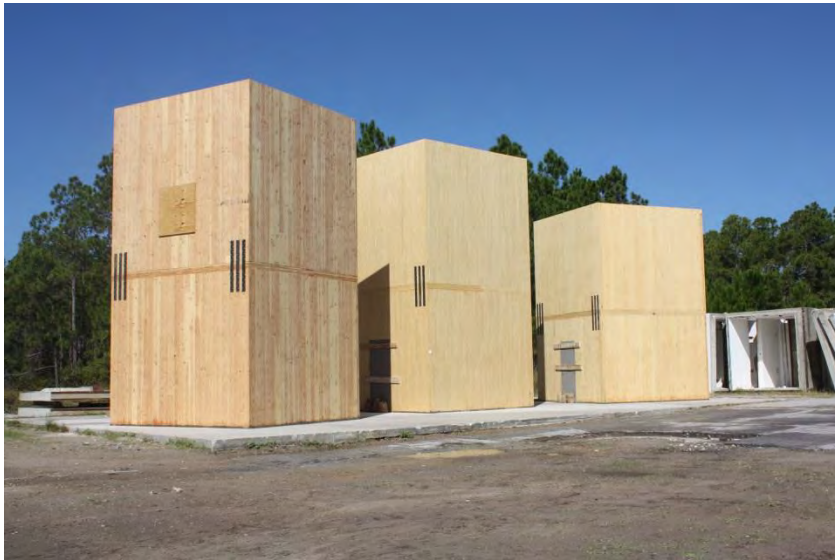
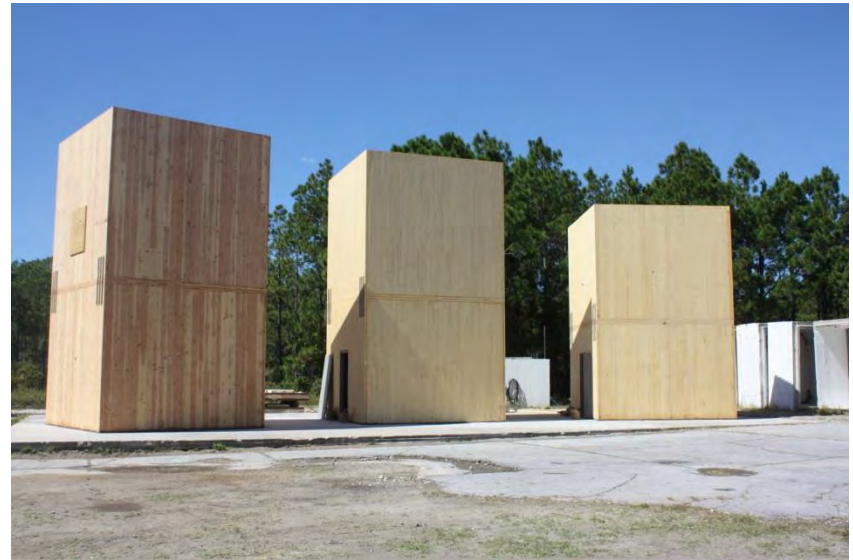
Full-Scale Validation #1

Pre-test

Post-test

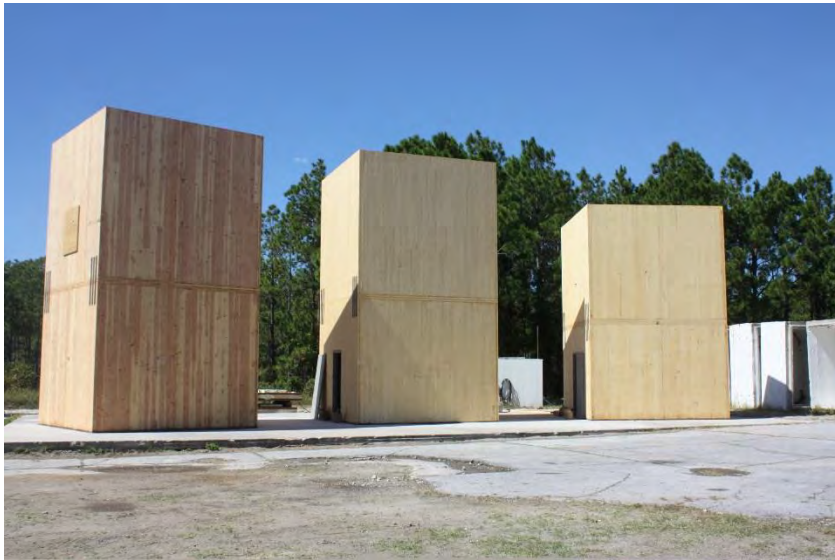
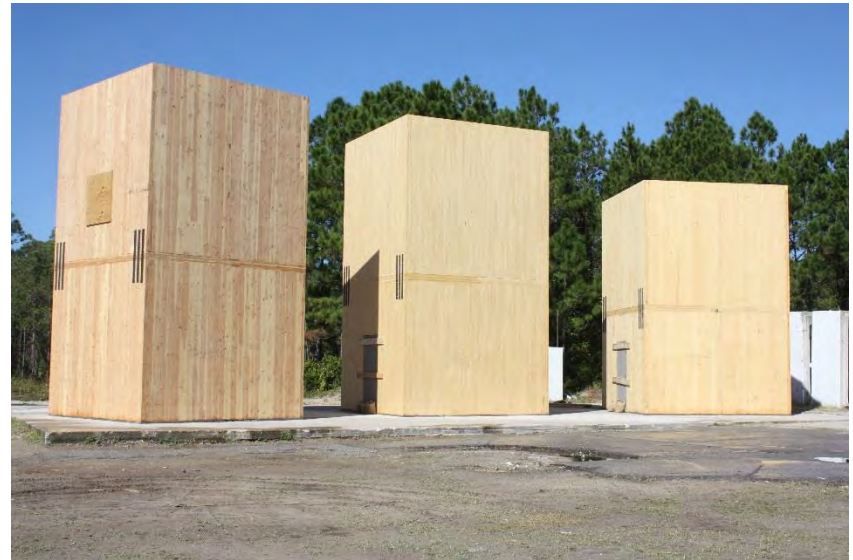
Full-Scale Validation #2

Pre-test

Post-test

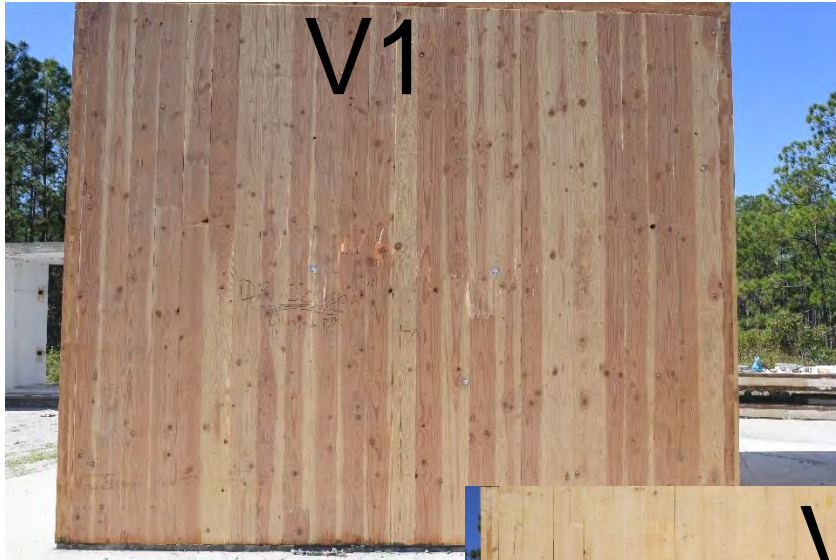
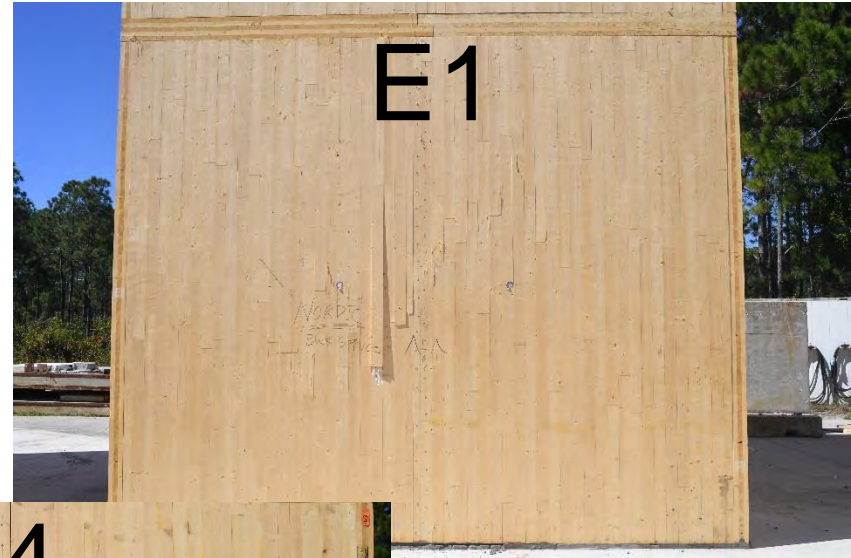
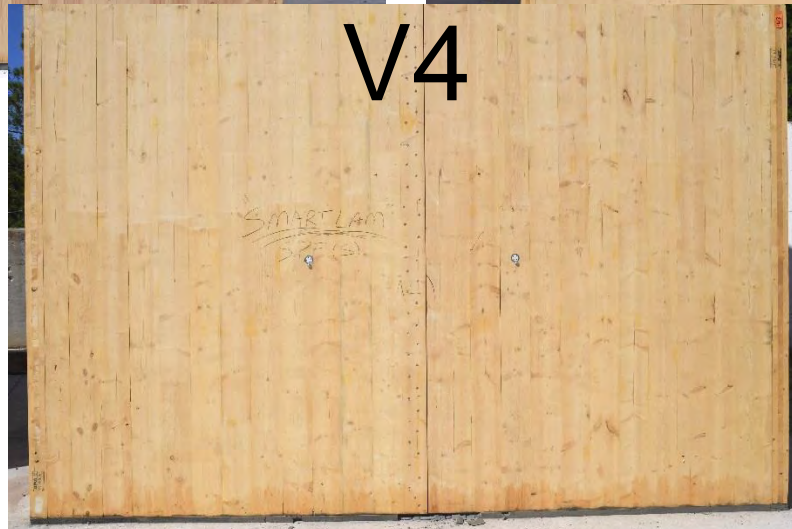
Full-Scale Validation #3

Post-test
