AMERICAN WOOD COUNCIL

Cross Laminated Timber (CLT)

Fire Testing Overview

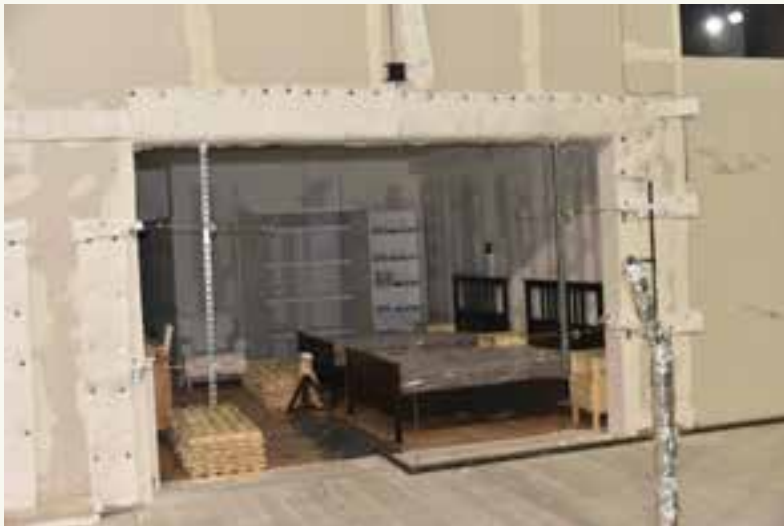
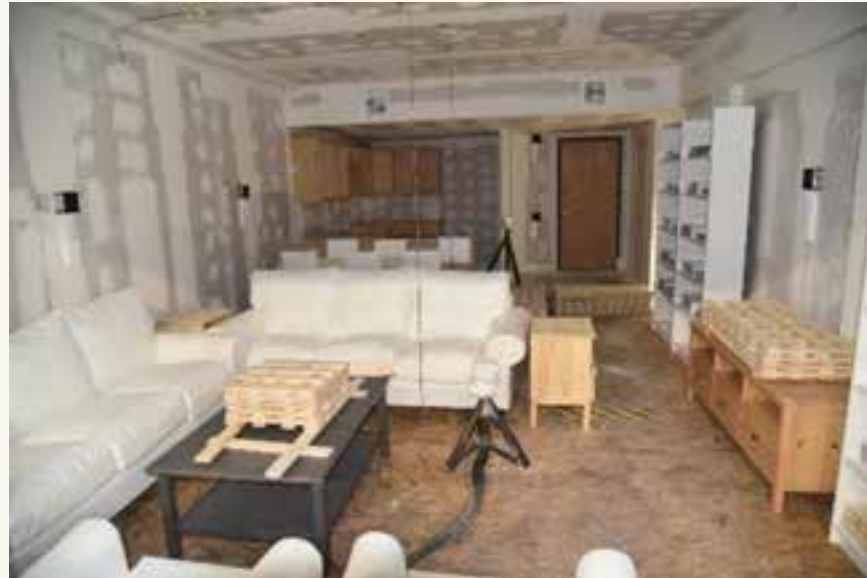
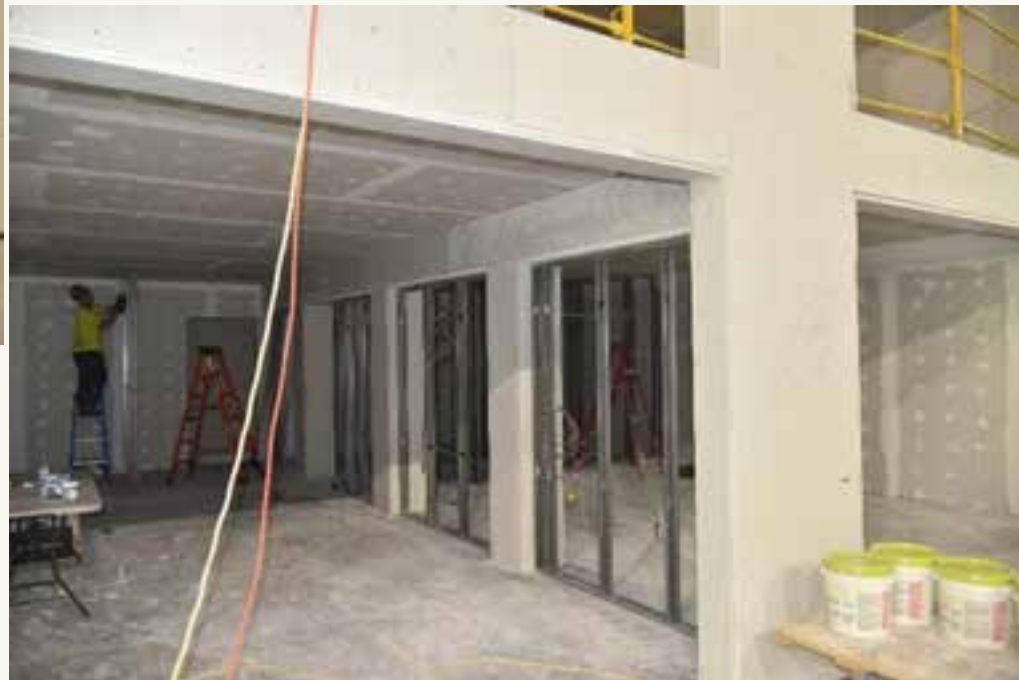
Test #1 – All Mass Timber Protected

**All mass timber surfaces
protected with 2 layers
of 5/8" Type X GWB**

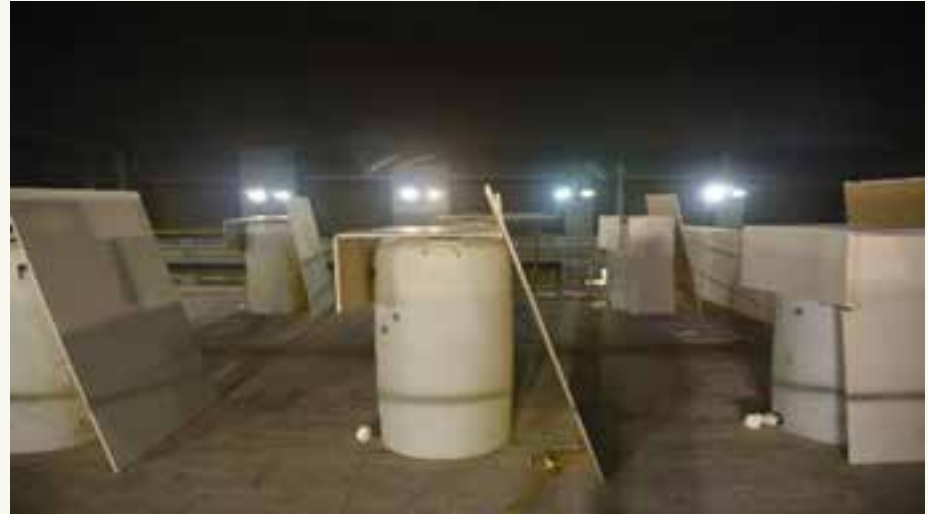
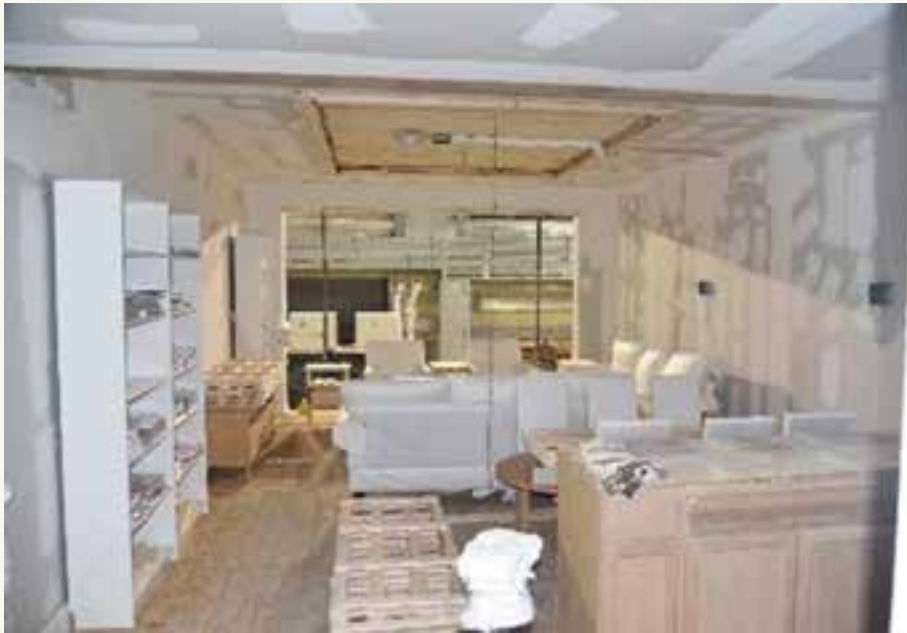
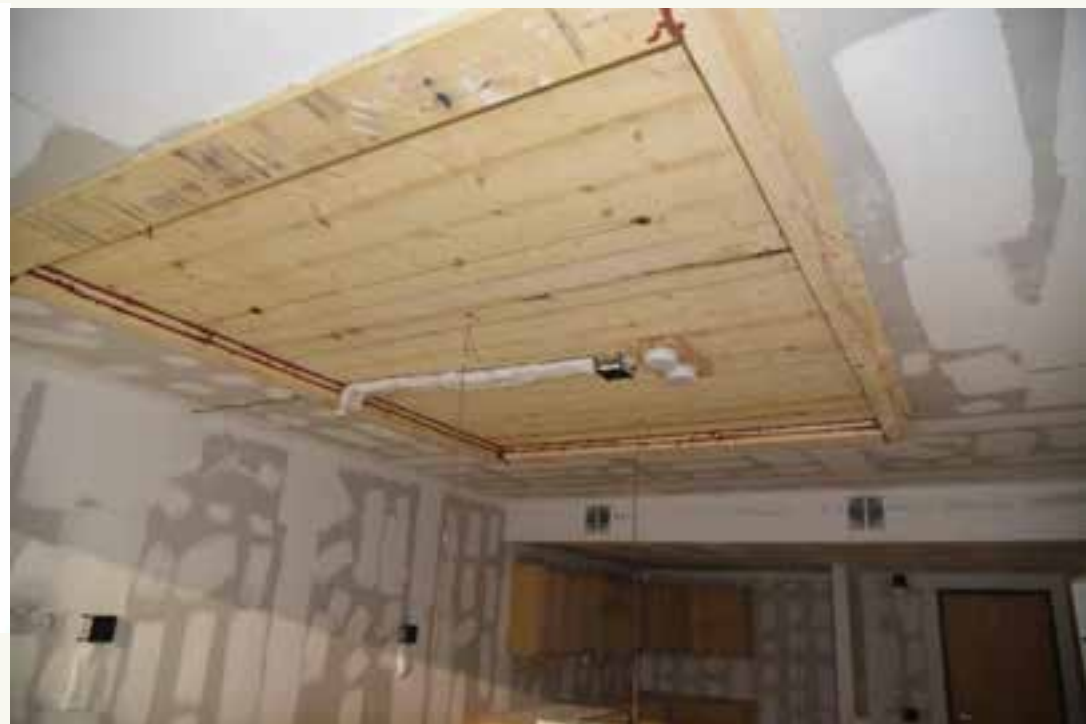
Test #2 – 30% CLT Ceilings Exposed

30% of CLT ceiling area in living room and bedroom exposed

Live load applied using water barrels

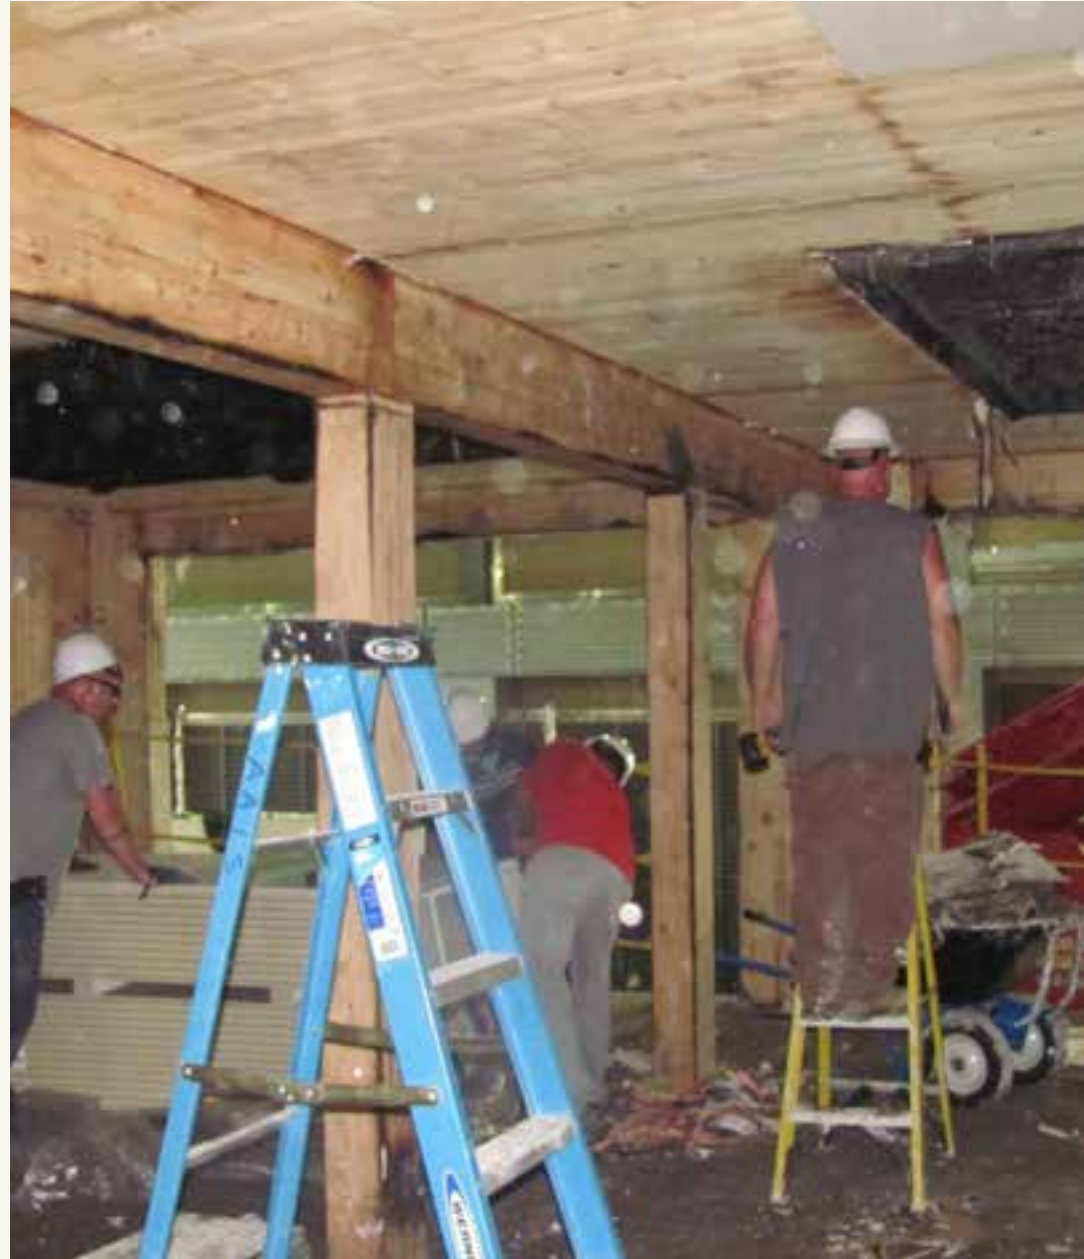
Post-Fire Condition of Glulam After Gypsum Removal

- Fire intensity decreased subsequent to consumption of furnishings and contents (known as decay phase)
- Exposed mass timber surfaces self-extinguished in the decay phase
- Mass timber surfaces protected with 2 layers of 5/8" Type X GWB remained mostly uncharred

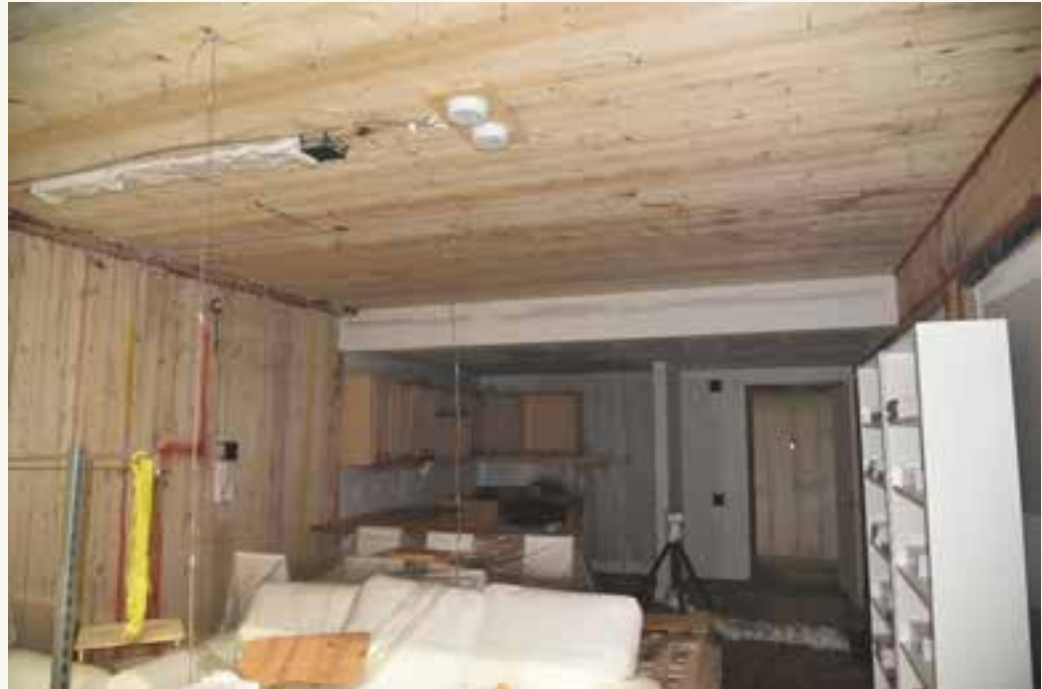
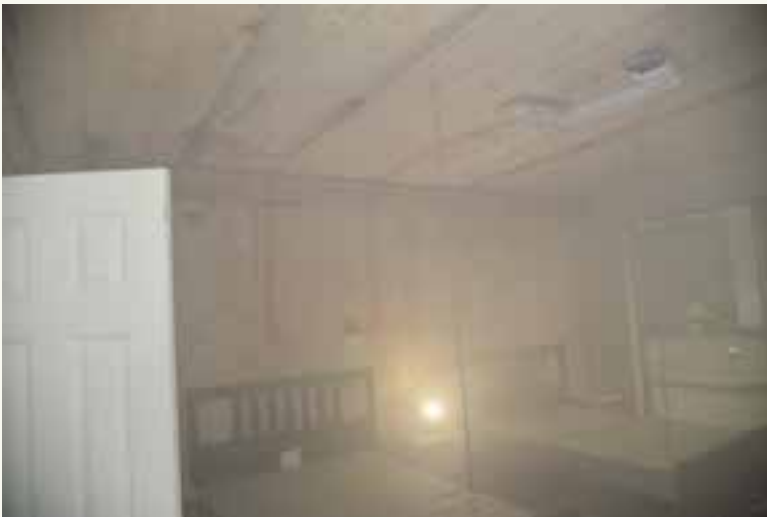
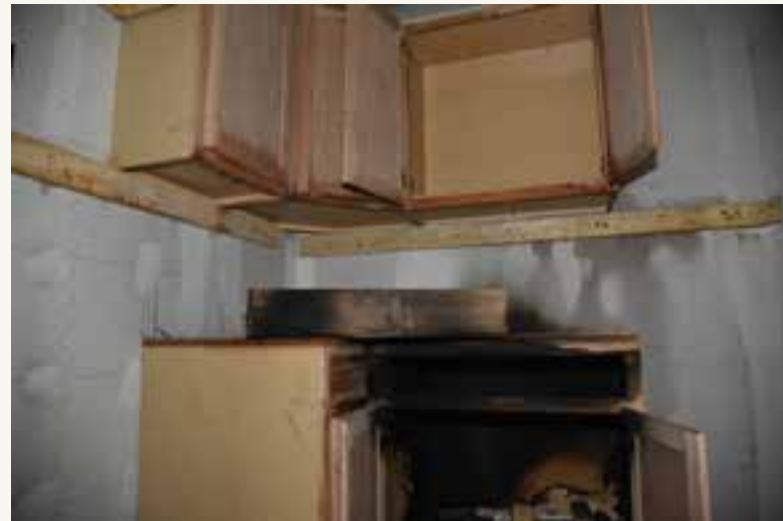
Test #4 – Sprinklers Protected, Exposed

All mass timber surfaces fully exposed in bedroom and living room.

Sprinkler – normal activation

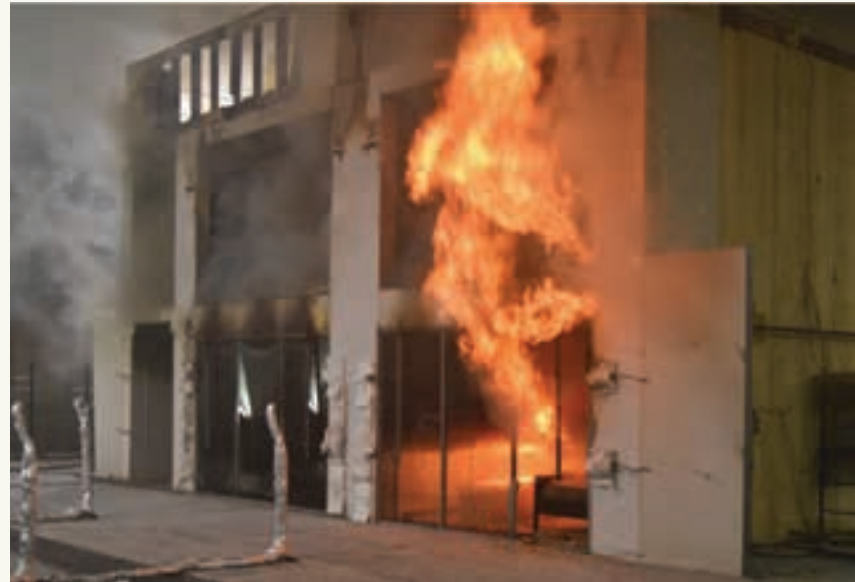
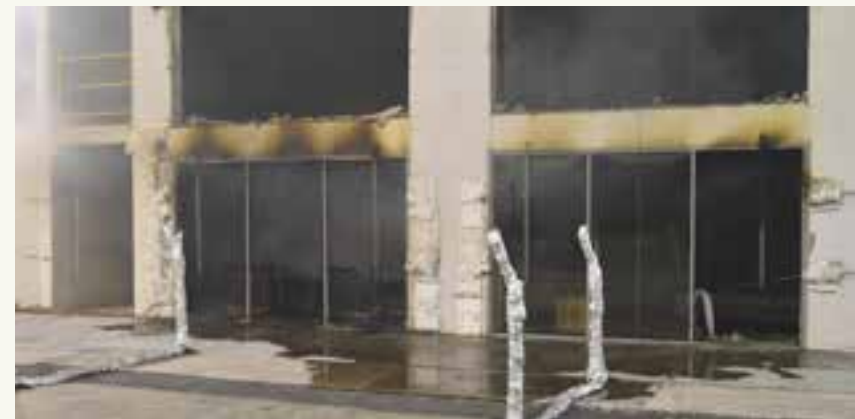
Test #5 – Delayed Sprinklers

All mass timber surfaces fully exposed in bedroom and living room.

Sprinkler – water delayed for 20 minutes after sprinkler activation within the test compartment...approximately 23 minutes from ignition

Flashover conditions were reached in the kitchen, and the bedroom was very near reaching flashover

The sprinkler system effectively suppressed the fire

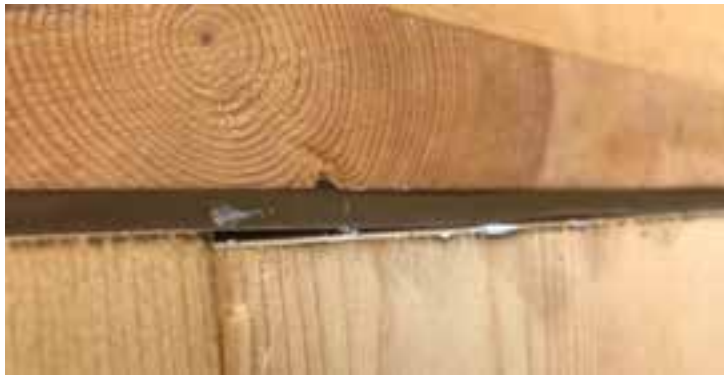
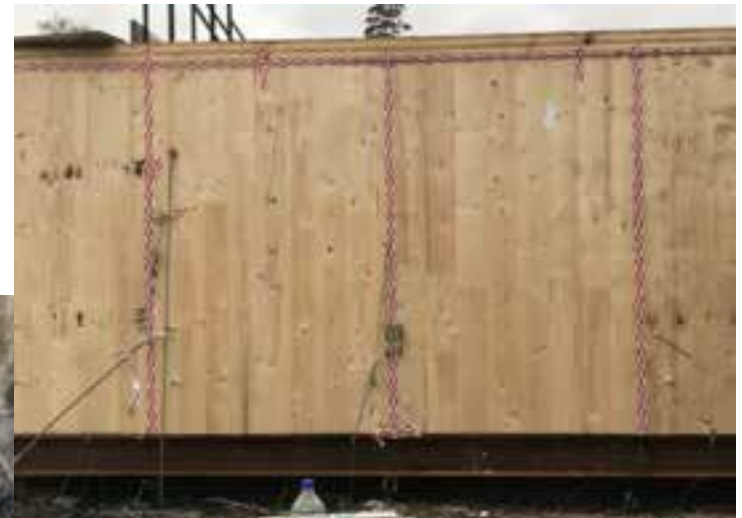
Intersections

- All airtight sealed mass timber intersections were effective to prevent fire spread.
- One of the designed intersections had locally no airtight seal and led to smoke and some flaming through the intersection
- Geometrical tolerances need to be accounted for.
- The sealing material does not have to be resistant against elevated temperatures if positioned in a well insulated location.

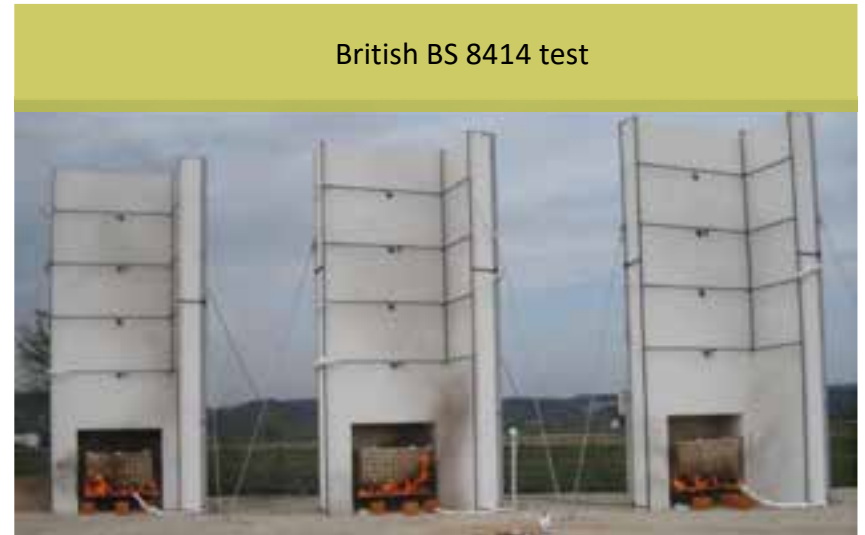
British BS 8414 test

Facade Exposure

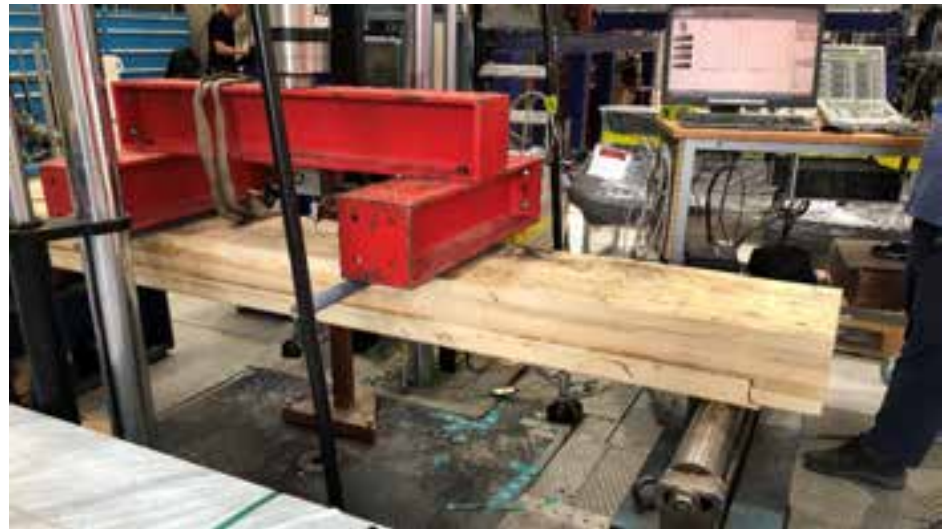
Characteristics

- Flexural stiffness and bending capacity maintained
- Shear capacity reduced, but sufficient for most applications
