QUASI-STATIC OUT-OF-PLANE TESTING OF CLT AND NLT PANELS

Edwin Nagy, Ph.D., P.E.¹ Mark K. Weaver, S.E.²

December 21, 2016

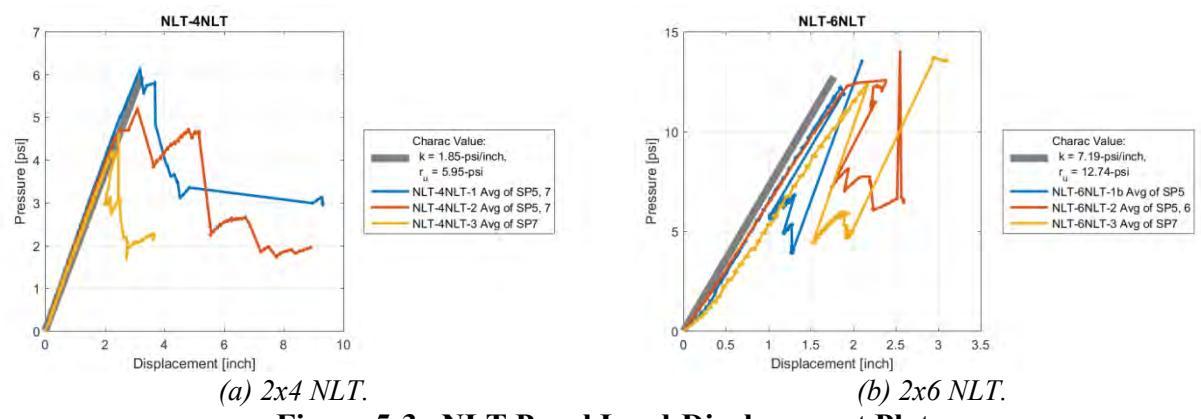
Figure 5-3. NLT Panel Load-Displacement Plots.

Initially, the expected average and tested bending stiffness values are consistent for the NLT panels. However, while the 2x4 NLT exhibits essentially linear response in the pre-peak region, the 2x6 NLT appears to exhibit a measure of nonlinearity. Whether this nonlinearity is related to the test setup or the panel itself is not known. Concerning strength, the expected average value is remarkably consistent for the 2x6 NLT. However, for the 2x4 NLT, the expected average value exceeds one of the tested values by approximately 25 percent.

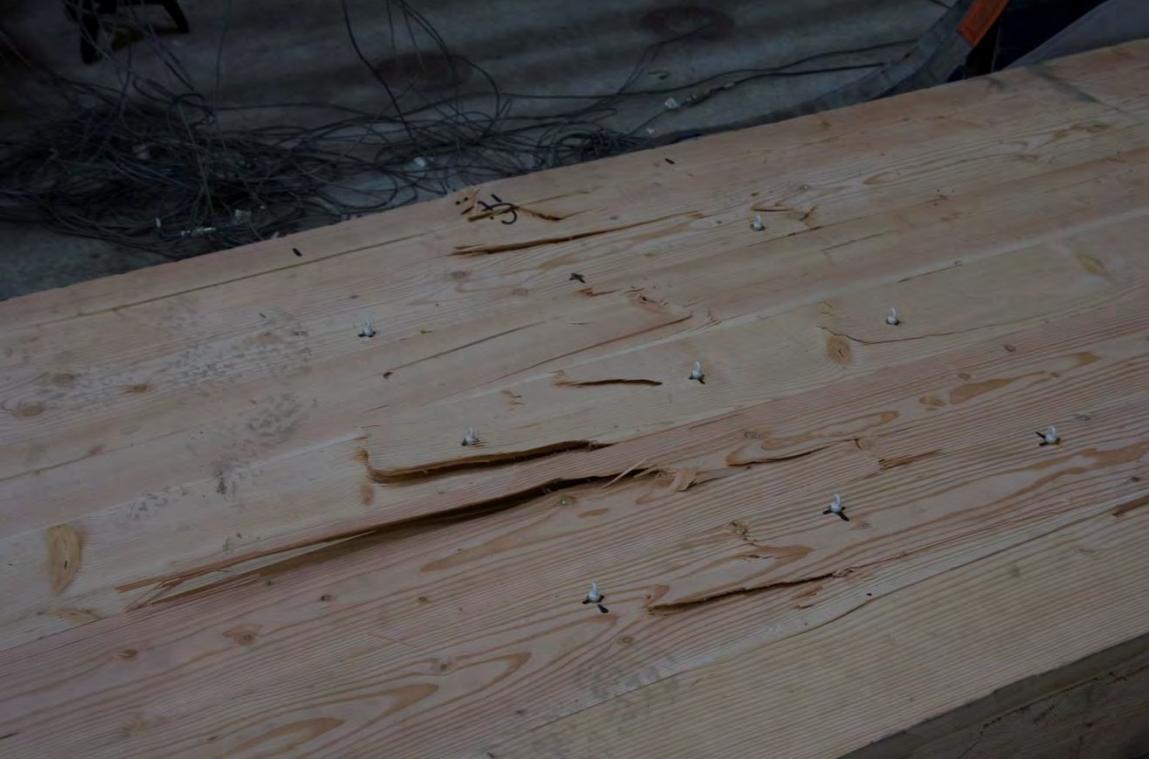
(b) Top view (looking east). Figure A-6. 5-Ply Grade V1 CLT – Test 1 (5V1-1).

(a) Elevation view (looking west). (Note bladder leakage at lower right.)

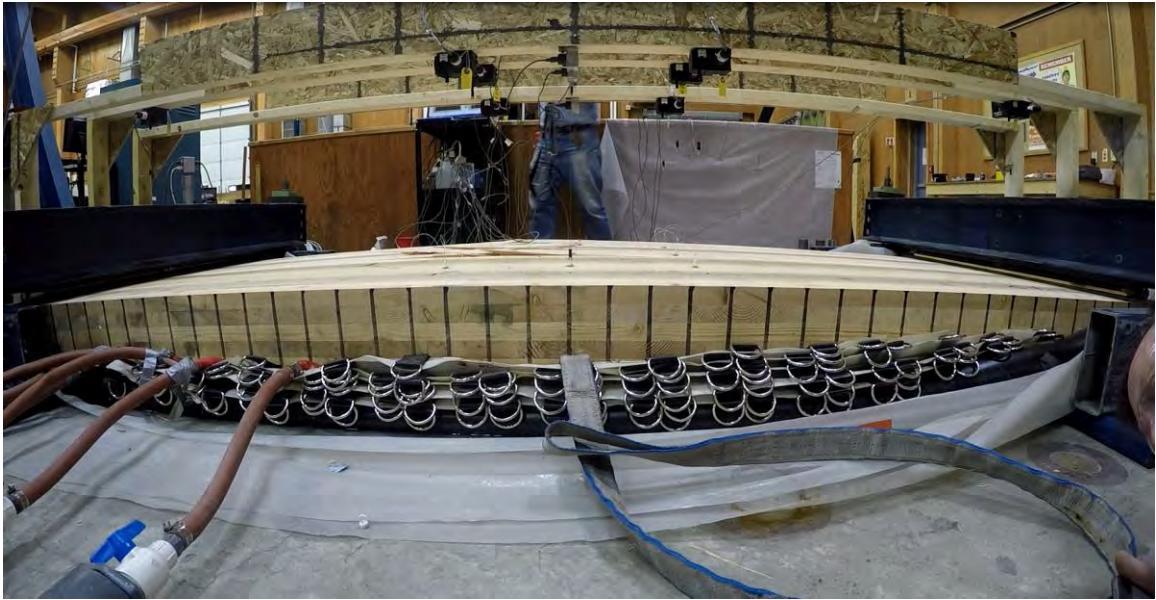
(a) Elevation view (looking west). (Note this photo is taken just prior to bladder rupture.)
