# **RESULTS FROM PHASE 2 BLAST TESTS OF FULL-SCALE CROSS-LAMINATED TIMBER STRUCTURES**

Mark K. Weaver, S.E.<sup>1</sup> Charles Newberry, P.E.<sup>2</sup> Casey O'Laughlin, P.E.<sup>3</sup> Lisa Podesto, P.E.<sup>4</sup>

October 9, 2020

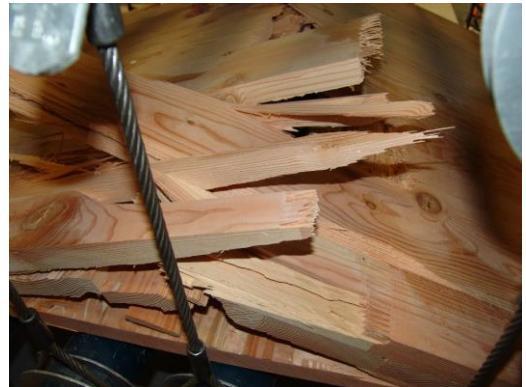
Panel rupture typically occurred near mid-span at knots, finger joints, or sloped grain (Figure 2-3a). This result was consistent with findings in the Phase 1 tests and expected because these material imperfections engender stress concentrations. (It should be noted that the grading of the constituent lumber in CLT panels accounts for the frequency of these imperfections.) No visual signs of wood crushing were observed, although the out-of-plane pressure versus displacement plots appeared to indicate that some occurred for the higher axial loads.

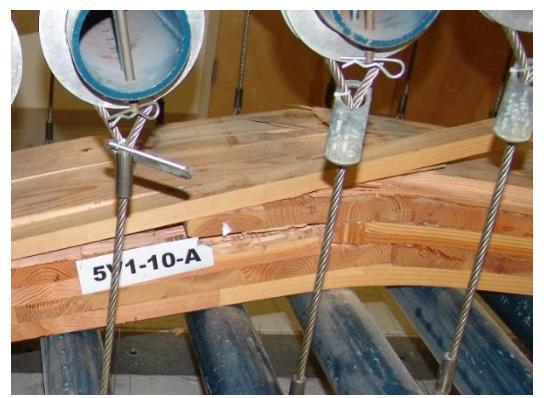
For a few tests with lower axial loads, planar (or rolling) shear damage appeared to occur (Figure 2-3b). Additionally, in most of the 5-ply panel tests, portions of the top-most ply detached from the crosswise ply near panel mid-span prior to rupturing in tension (Figure 2-3c). Whether or not the "rolling shear" noted in Table 2-2 is instead more aptly characterized as "top ply detachment followed by rupture" could be argued.

*(c) Top ply detachment followed by rupture (5V1-20-A).*

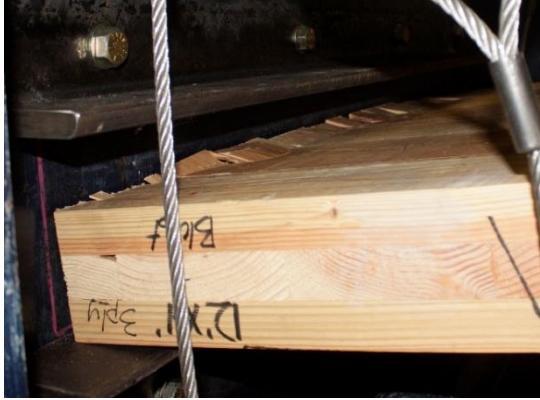
For all tests with an axial load greater than or equal to 10%  $F_c^*$ , (i.e., except for the Grade V4 panels) damage to either the top or side of the panel was observed near the support. (It is suspected that the Grade V4 panels did not exhibit this damage because it had the smallest ASD reference axial compressive stress value (i.e., 1,000 psi) and thus the smallest applied axial load of any grade at 10%  $F_c^*$ . This damage consisted of crushing due to the concentrated compressive stress imparted by the bearing support angle (Figure 2-3d) or splitting due to the tension perpendicular to grain stress associated with the friction force applied by the load platen (Figure 2-3e and f).

(d) Crushing at top of panel (V1-10-A).

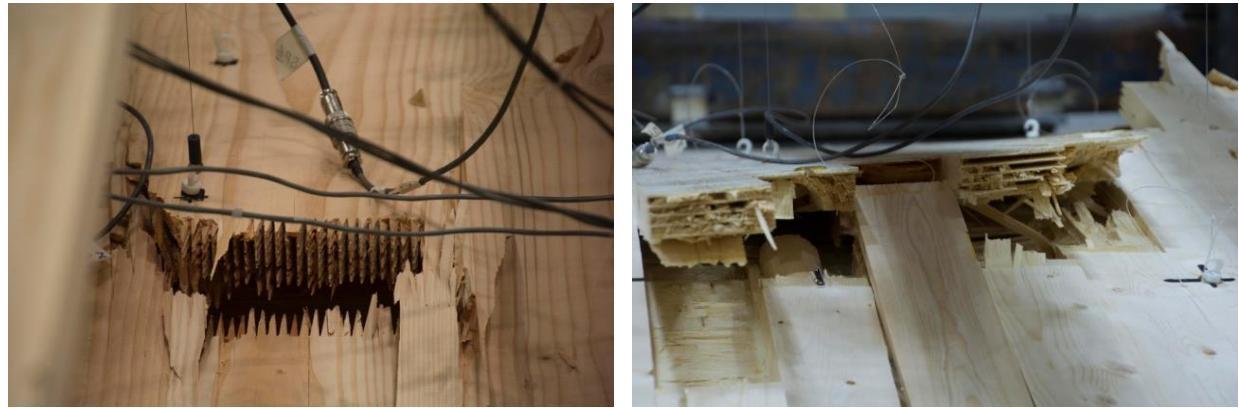
(a) Grade V1 (Grade V4 similar). (b) Grade E1. Figure 2-10. Finger Joint Orientation in Panels.

These photographs illustrate the phenomenon noted in comment (2) above, namely that the Grade E1 panels exhibited greater post-peak residual capacity and fewer sudden drops in capacity. Instead of the points of rupture localizing at finger joints or knots, as was typically observed in the Phase 1 testing and for the CLT composed of solely visually graded lumber, it appears a "hinge" is formed at panel mid-span and that the wood ruptures near this hinge. Finger joint orientation combined with modulus of rupture (MOR) variability could at least partially account for this difference in post-peak response. Whereas the Grade V1 and V4 panels have finger joints consisting of vertical grooves (Figure 2-10a), the Grade E1 panels have finger joints consisting of horizontal grooves (Figure 2-10b). The presence of axial load could serve to better "lock" the finger joints and minimize the potential for this discontinuity to serve as a point of failure. This combined with the lower MOR variation for MSR lumber could serve to localize failure and force rupture in sections of wood absent imperfection, which may enable more incremental, rather than large sudden, drops in flatwise bending capacity.

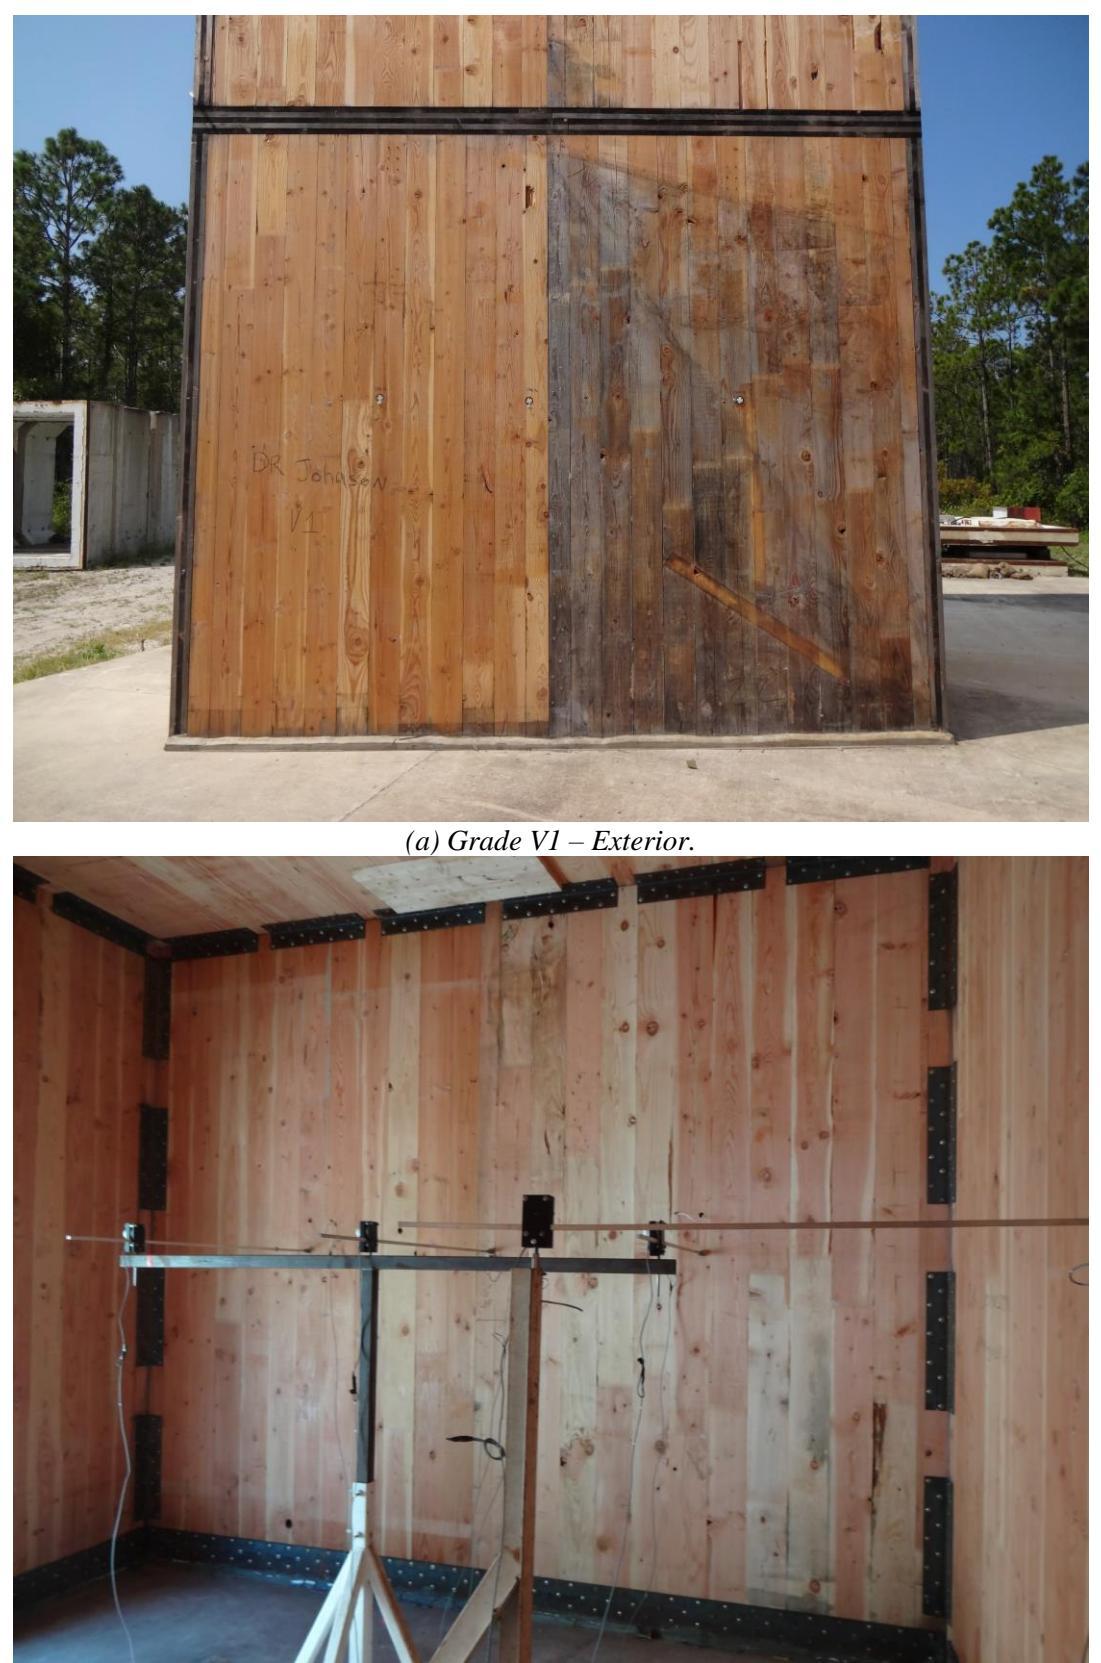
Test 4 was performed on the morning of September 19, 2017. No signs of damage to or permanent deformation in the constituent panels of the test structures were observed following Test 4. While no damage was observed on the CLT panels themselves, the grout placed under the foundation angle cracked and broke up in isolated cases (Figure 4-1).

Photographs of the post-test condition of the first-floor panel directly facing the charge are included as Figure 4-2.

(b) Grade V1 – Interior. Figure 4-2. Test 4 Post-Test Photographs of First-Floor Front Panel.

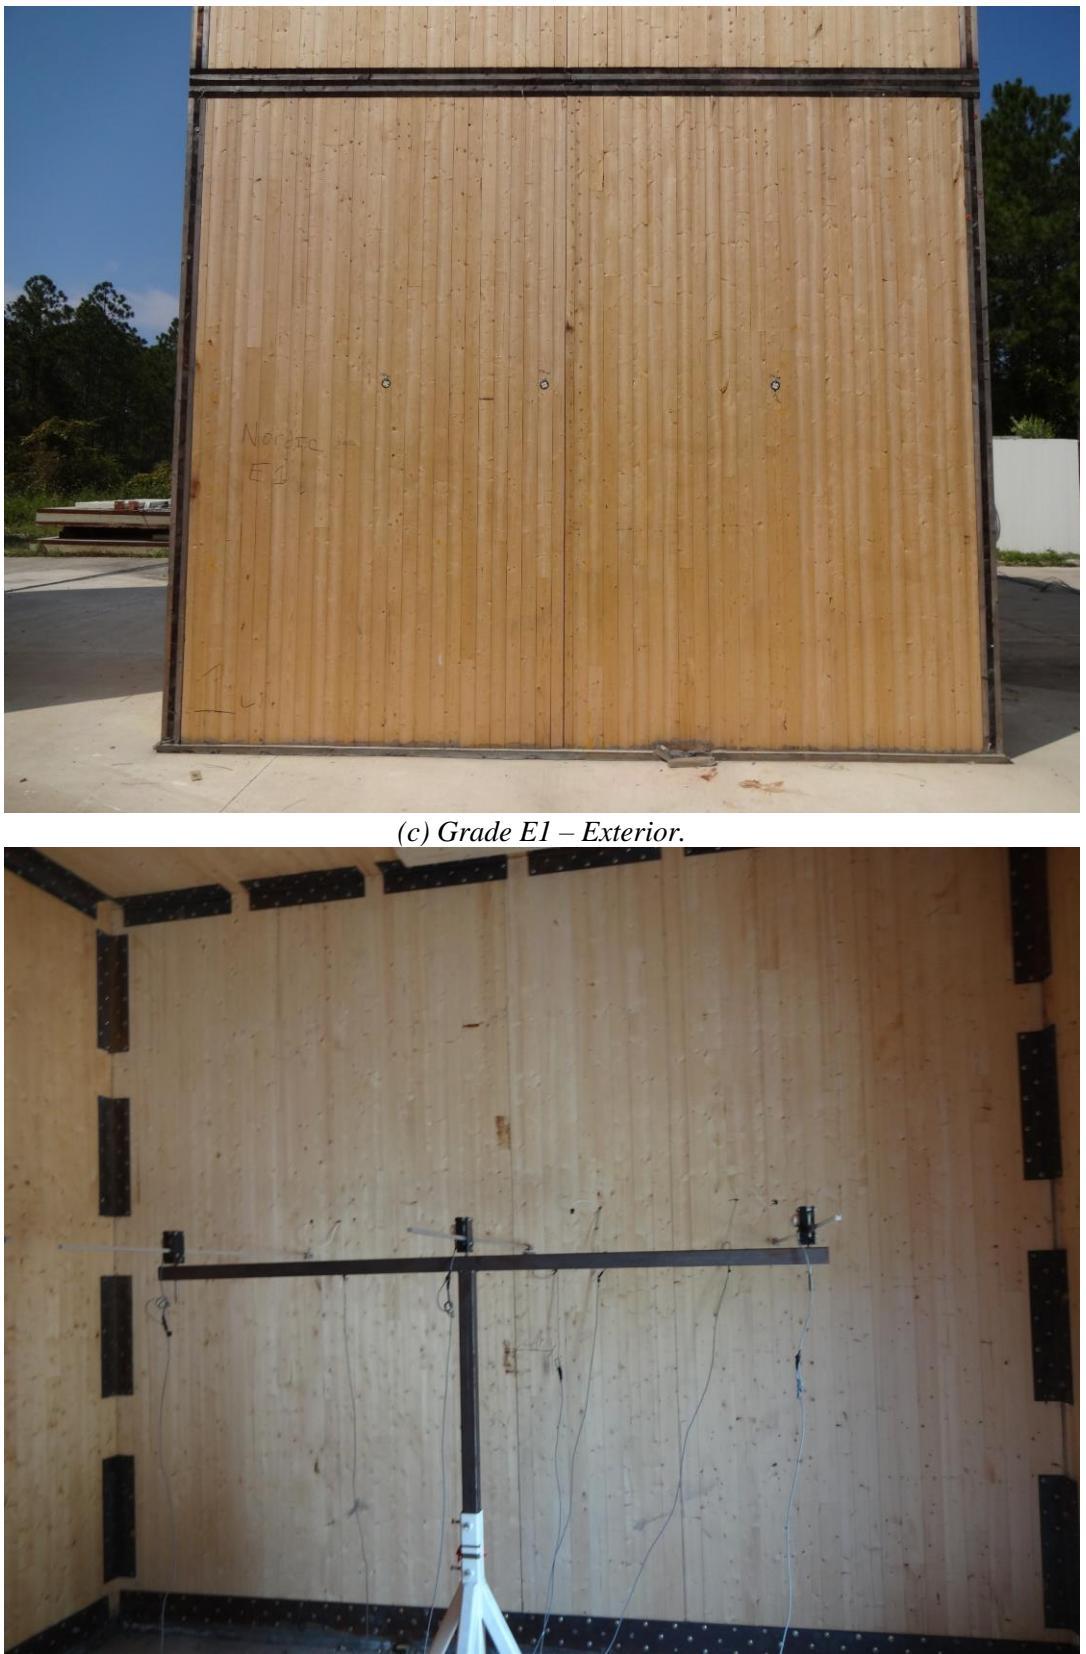
(d) Grade E1 – Interior. Figure 4-2. Test 4 Post-Test Photographs of First-Floor Front Panel. (Cont'd)

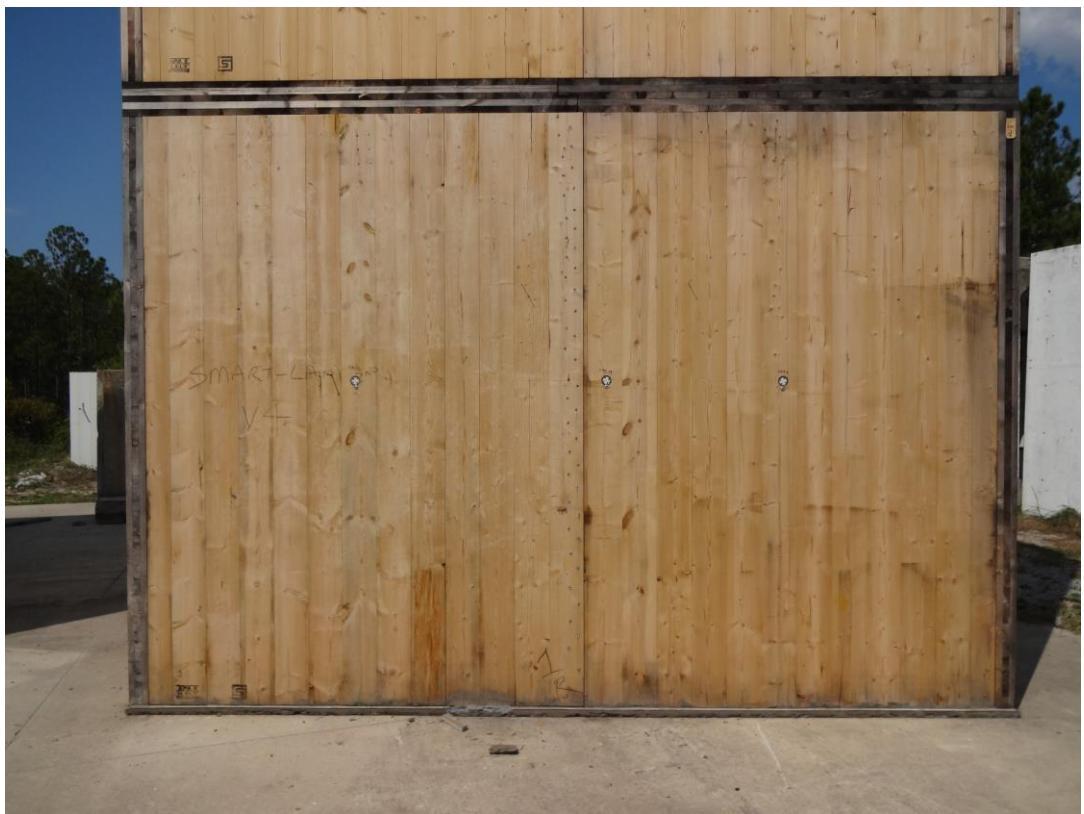
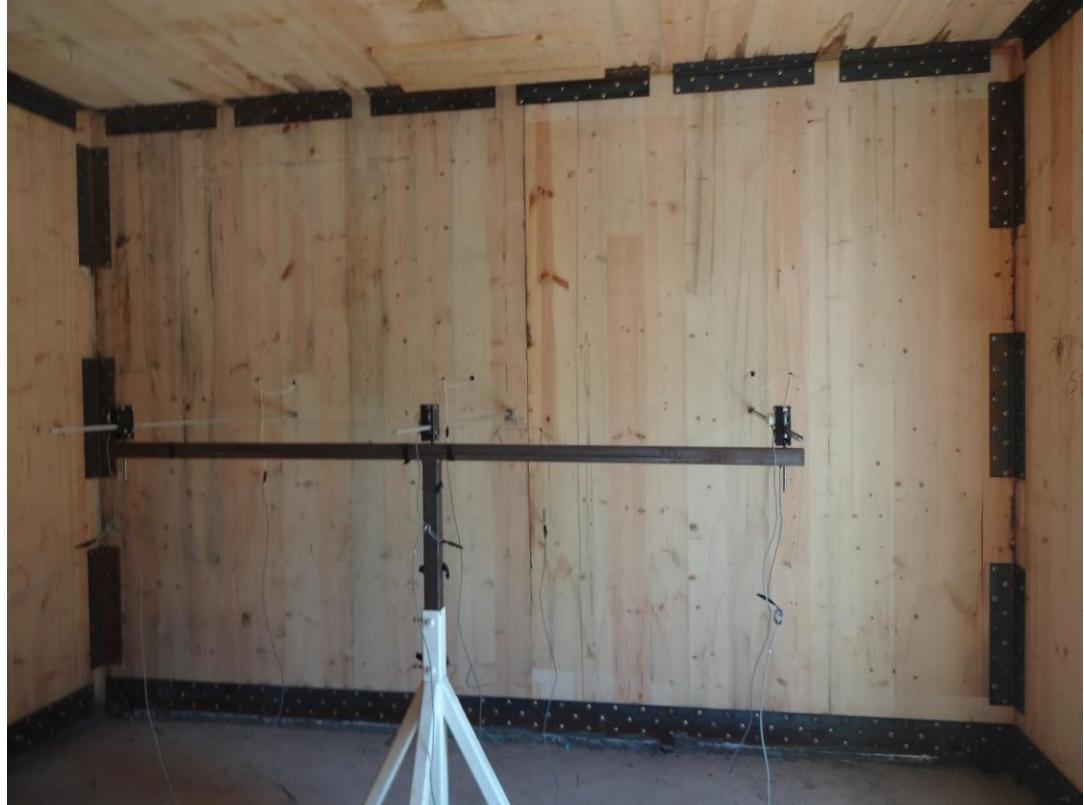
(e) Grade V4 – Exterior.

(f) Grade V4 – Interior. Figure 4-2. Test 4 Post-Test Photographs of First-Floor Front Panel. (Cont'd)

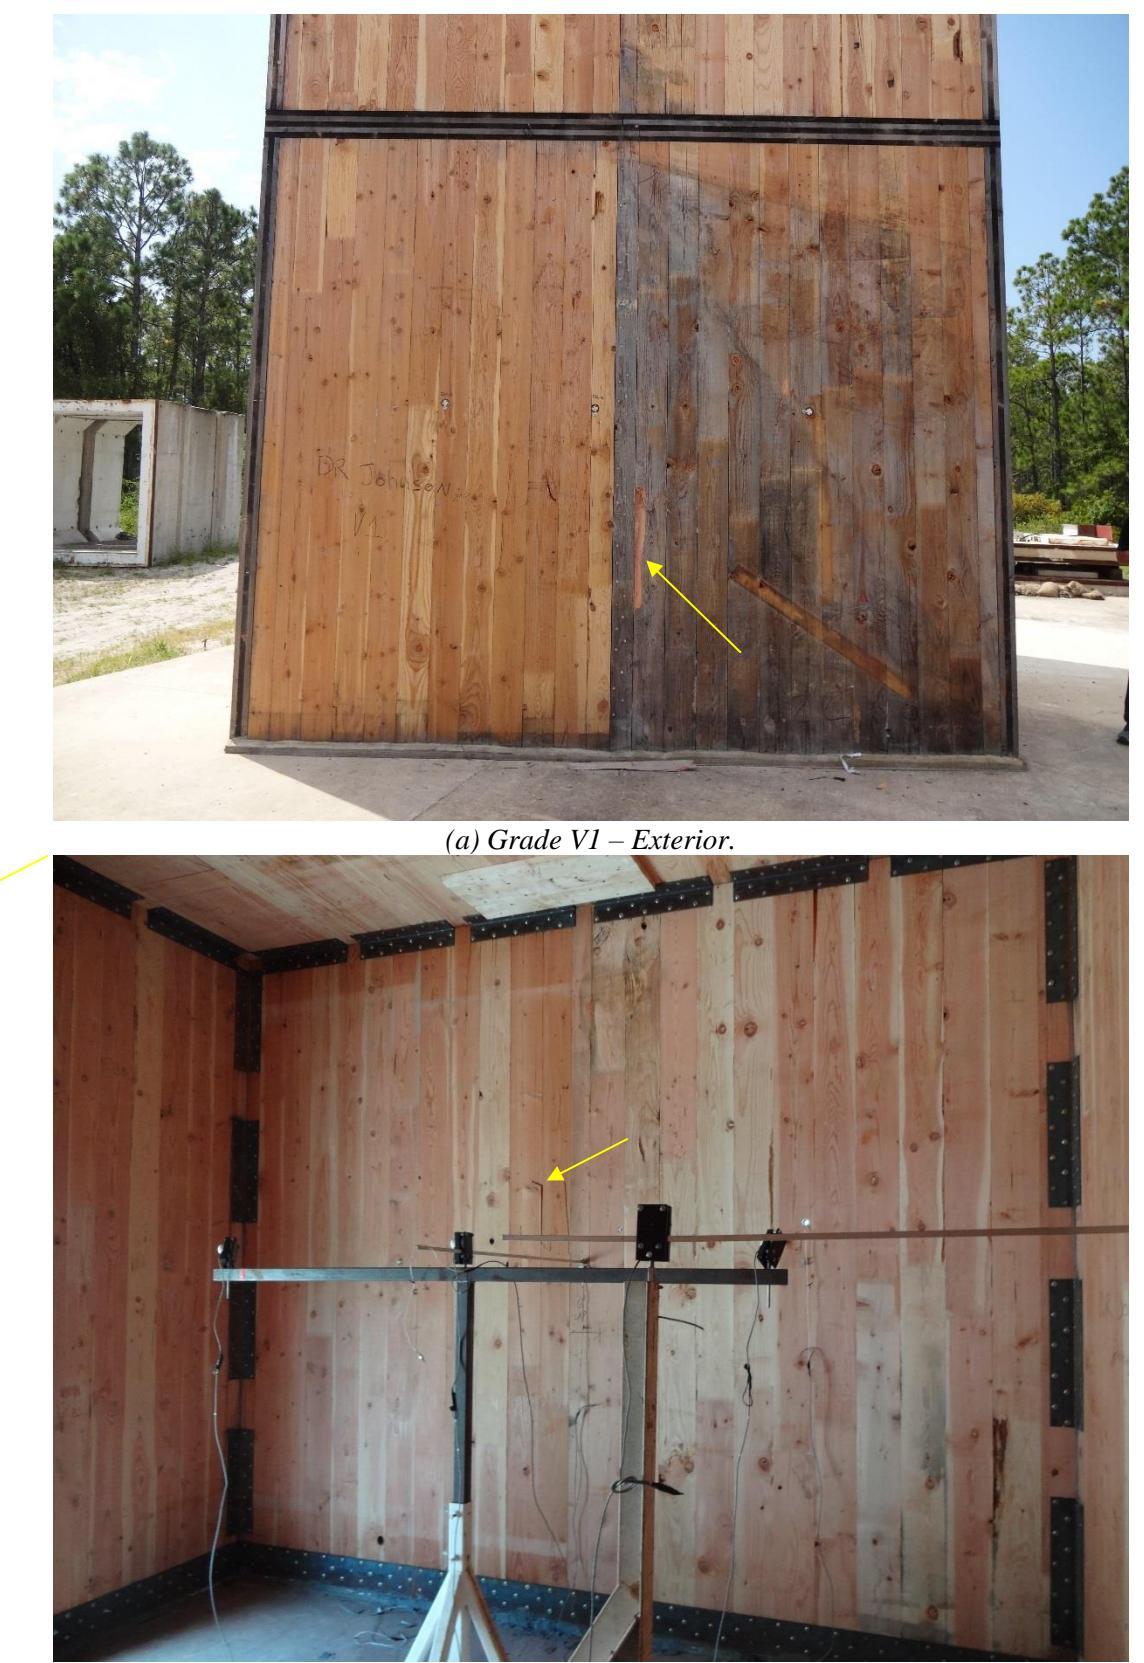
Damage to both interior and exterior faces was observed in all three test structures following Test 5. Observable damage was primarily concentrated in the front panel facing the explosive charge.

Photographs of the post-test condition of the first-floor panel directly facing the charge from the exterior and interior are included as Figure 4-4. For the Grade V1 and Grade E1 test structures, noticeable damage was observed near mid-height and mid-width of the first-floor front panel on both the interior and exterior faces. On the other hand, only minor cracking was observed in the Grade V4 test structure (with shorter plate height) at mid-height / mid-width of the first-floor front panel on the exterior face. No damage on the interior faces of the Grade E1 and Grade V4 test structures were observed. Photographs documenting the localized damage observed in the first-floor front panels of the test structures is included in Figure 4-5 and Figure 4-6.

(b) Grade V1 – Interior. Figure 4-4. Test 5 Post-Test Photographs of First-Floor Front Panel.

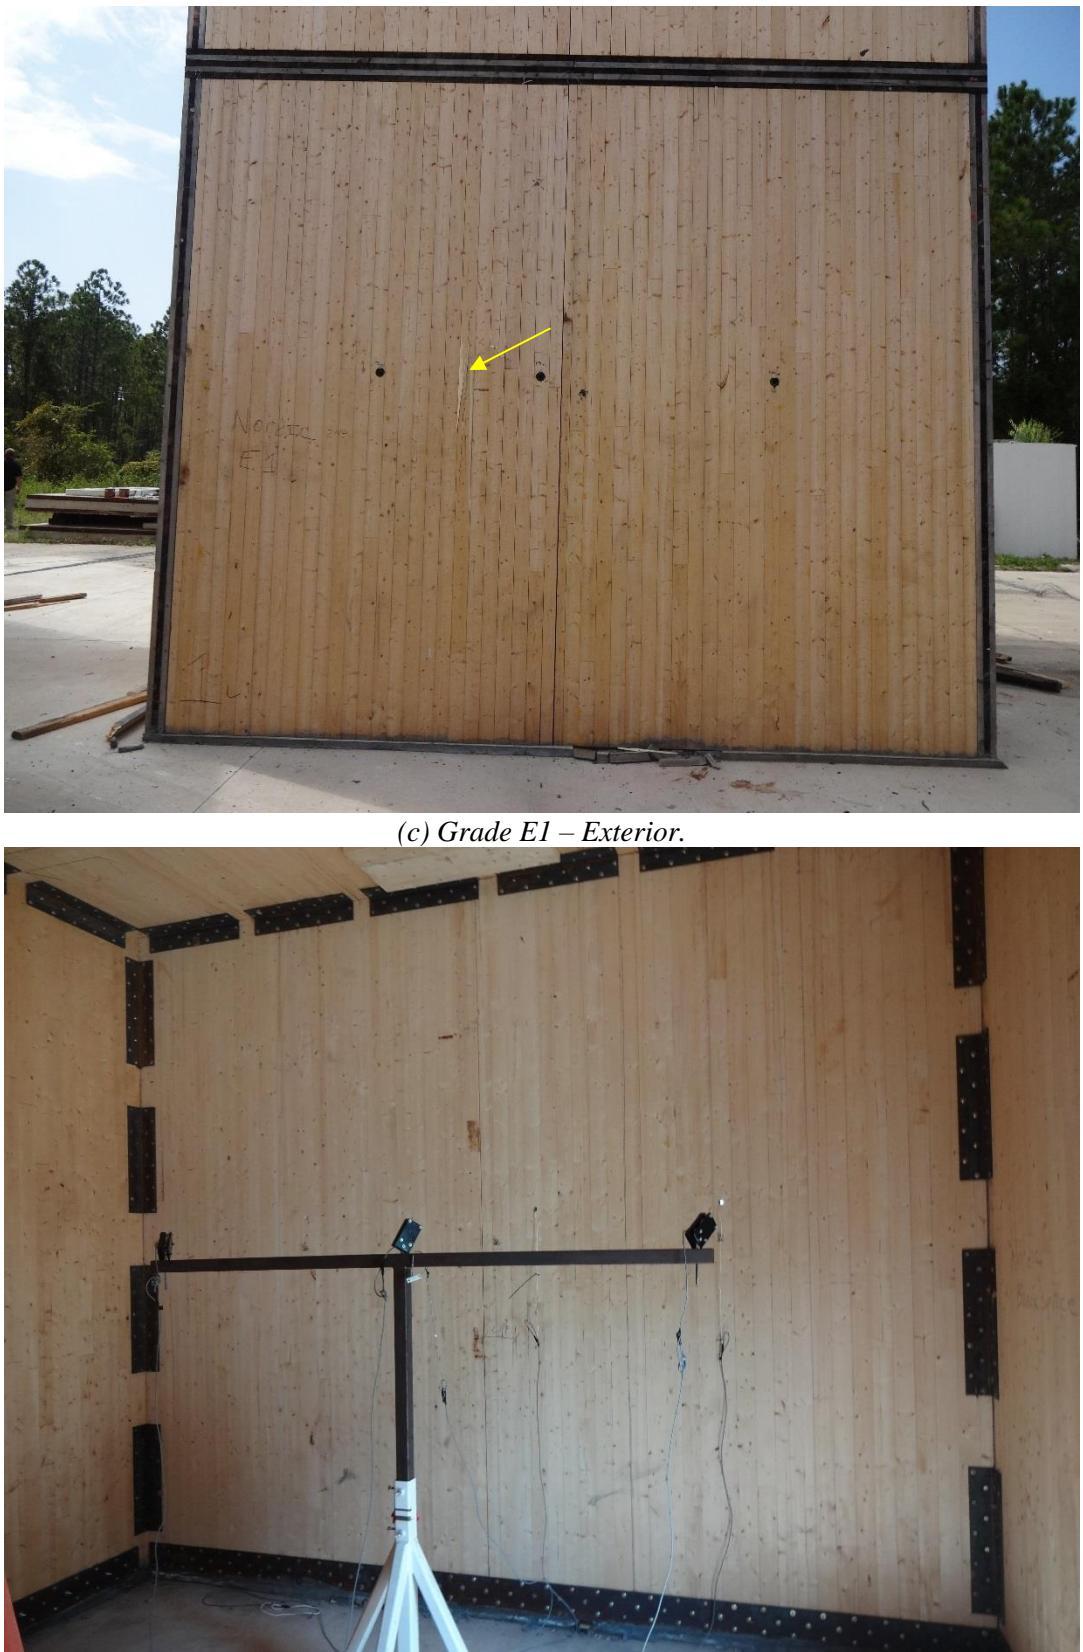
(d) Grade E1 – Interior. Figure 4-4. Test 5 Post-Test Photographs of First-Floor Front Panel. (Cont'd)

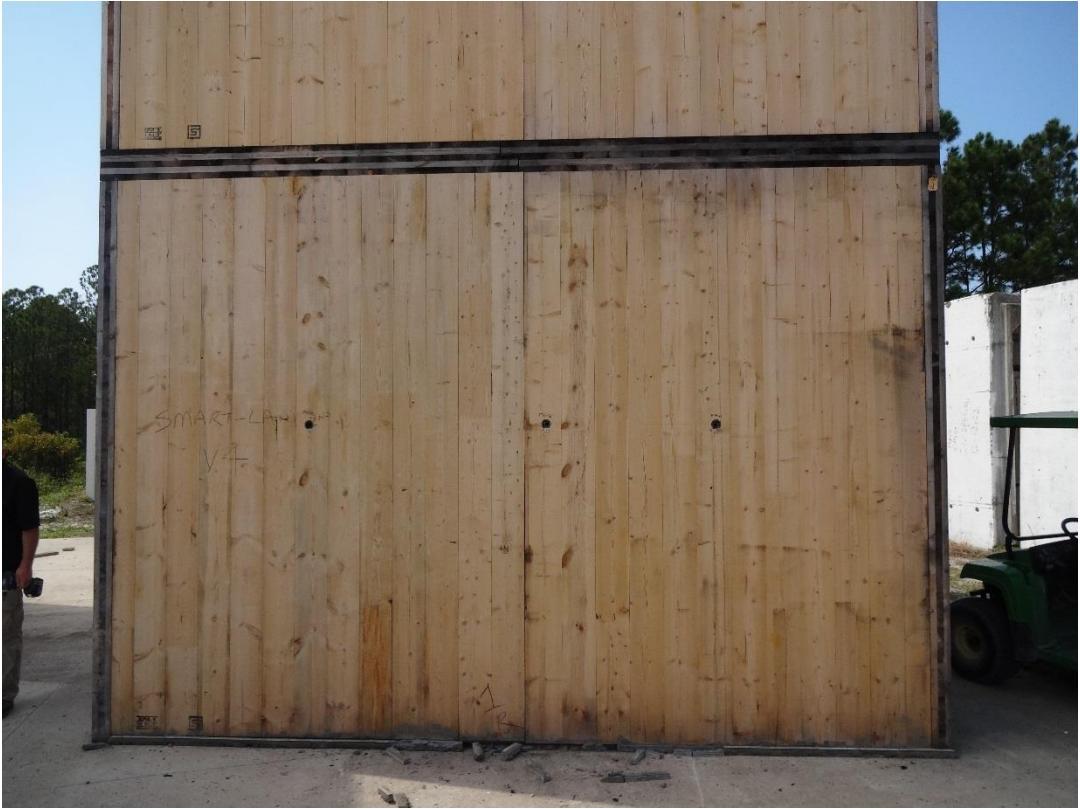
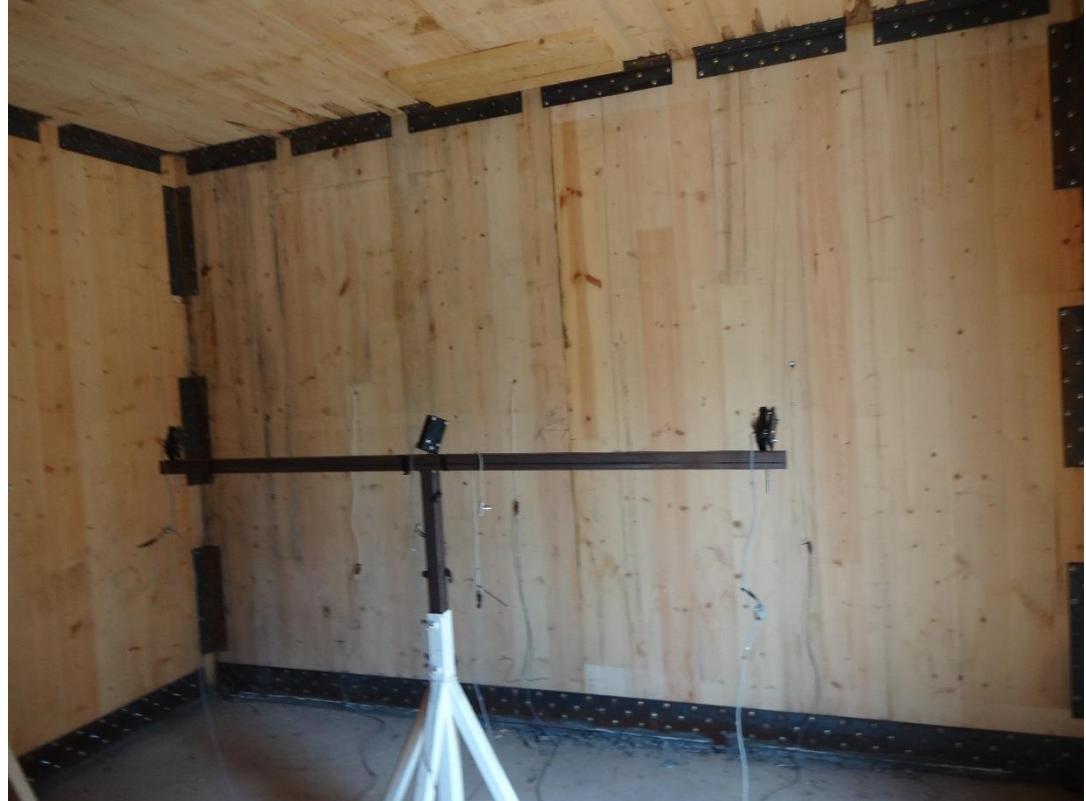
(e) Grade V4 – Exterior.

(f) Grade V4 – Interior. Figure 4-4. Test 5 Post-Test Photographs of First-Floor Front Panel. (Cont'd)

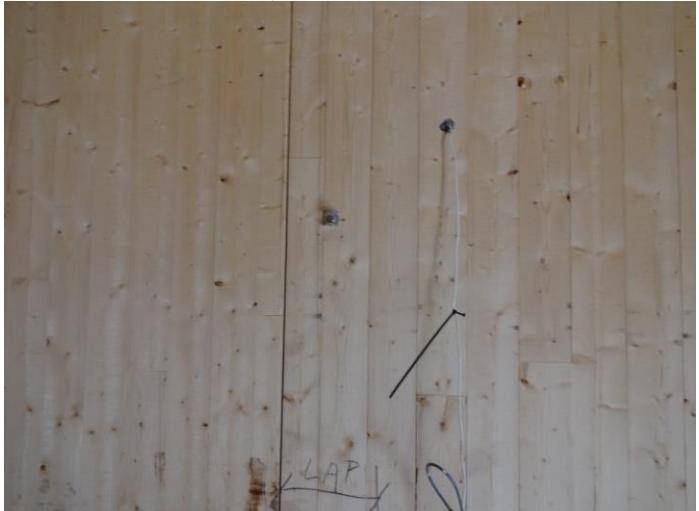
(b) Grade E1.

(c) Grade V4. Figure 4-6. Test 5 Post-Test Photograph of Interior Face Damage at 1<sup>st</sup> Floor Front Panel.

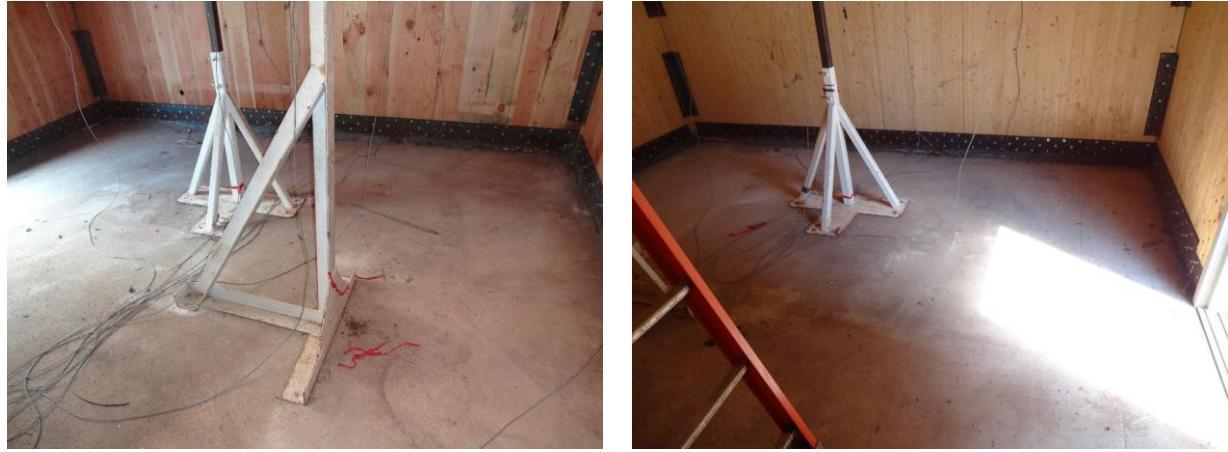
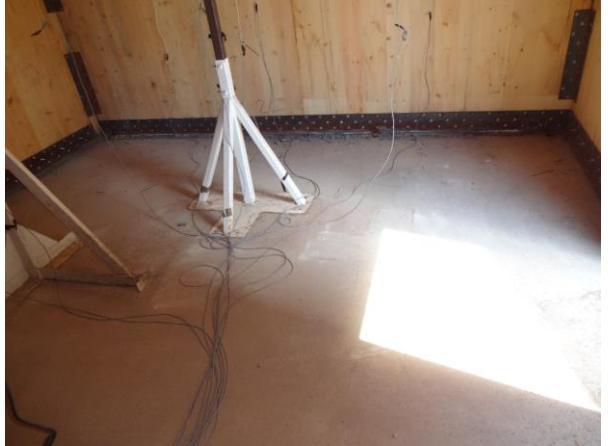
Unlike following Test 3 in the Phase 1 testing, no CLT panel debris was observed on the floor inside the Grade V4 test structure following Test 5 (Figure 4-7c). Although this result could simply be due to panel variability, it is possible that the presence of axial load in the wall panels served to limit the propensity for CLT panel debris generation. Also, as observed in the Phase 1 testing, no debris was observed on the floor inside the Grade V1 or Grade E1 test structures (Figure 4-7a and b).

*(c) Grade V4.* **Figure 4-7. Test 3 Post-Test Photographs of Floors.**
All doors opened (in rebound) during Test 5. Either rupture of the dimensional lumber restraints securing the door or withdrawal of the fasteners securing this dimensional lumber was observed in the test structures (Figure 4-8). It should be noted these lumber restraints were installed to merely keep the door closed at the outset of the test. They were not designed to resist the imposed blast loading, nor would they be installed in an actual building.

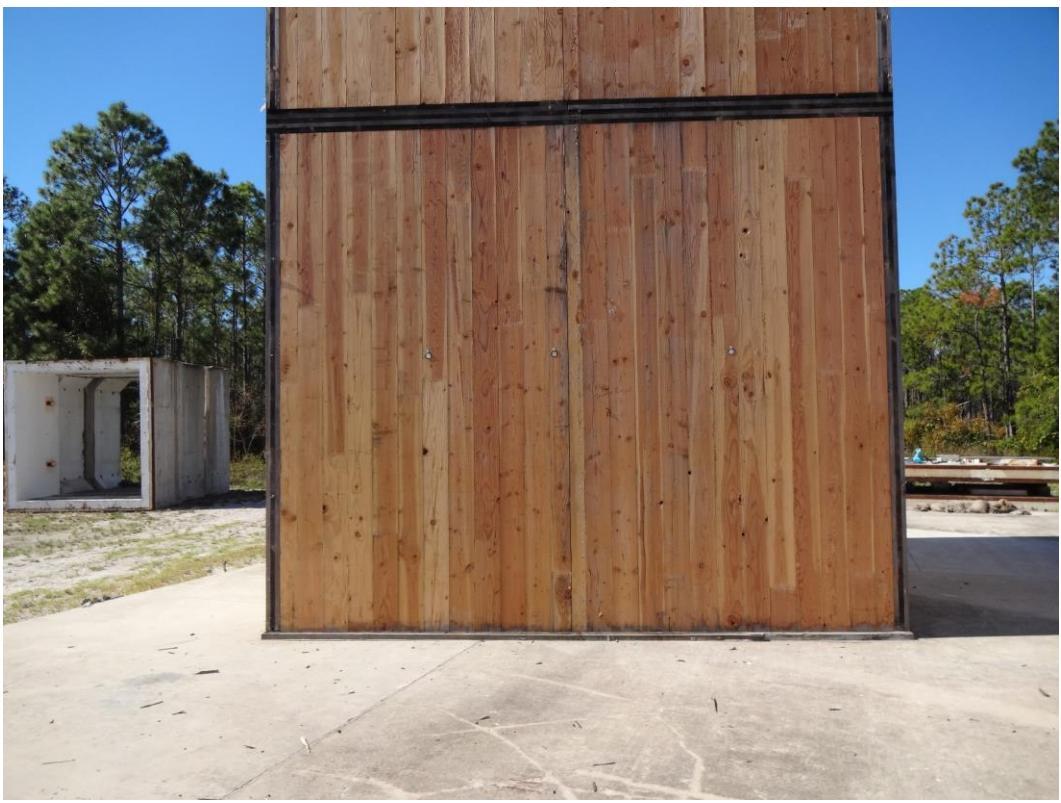
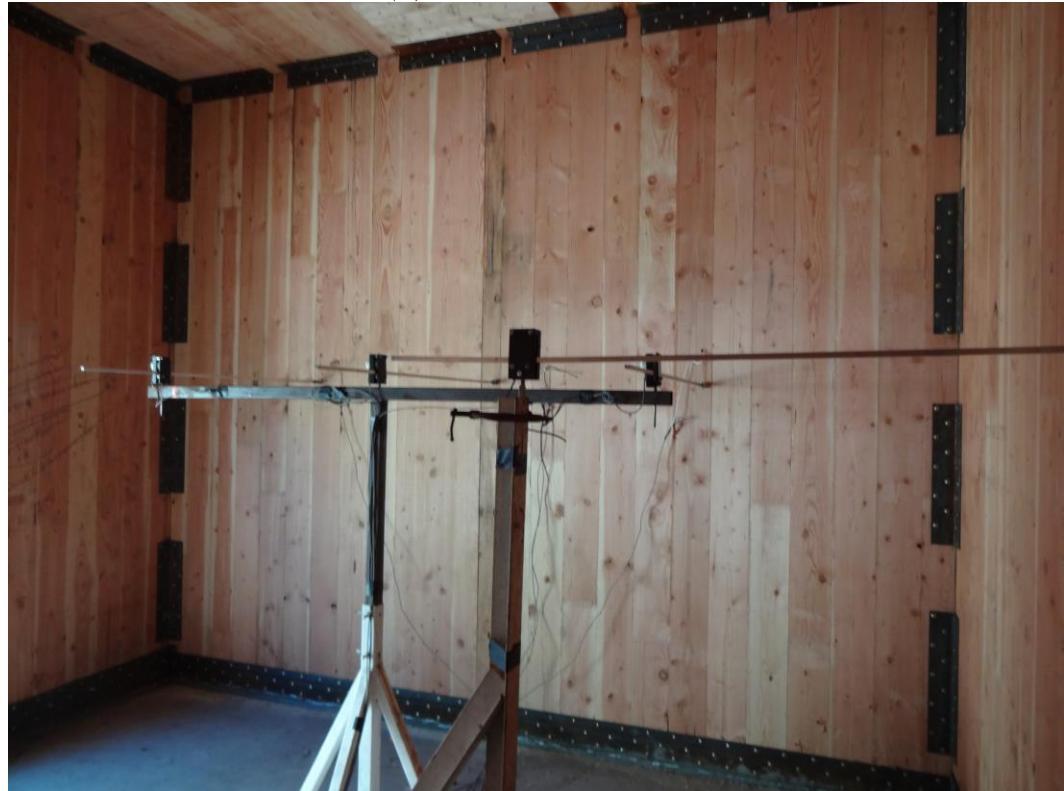
Photographs of the post-test condition of the first-floor panel directly facing the charge are included as Figure 4-11.

(a) Grade V1 – Exterior.

(b) Grade V1 – Interior. Figure 4-11. Test 6 Post-Test Photographs of First-Floor Front Panel.

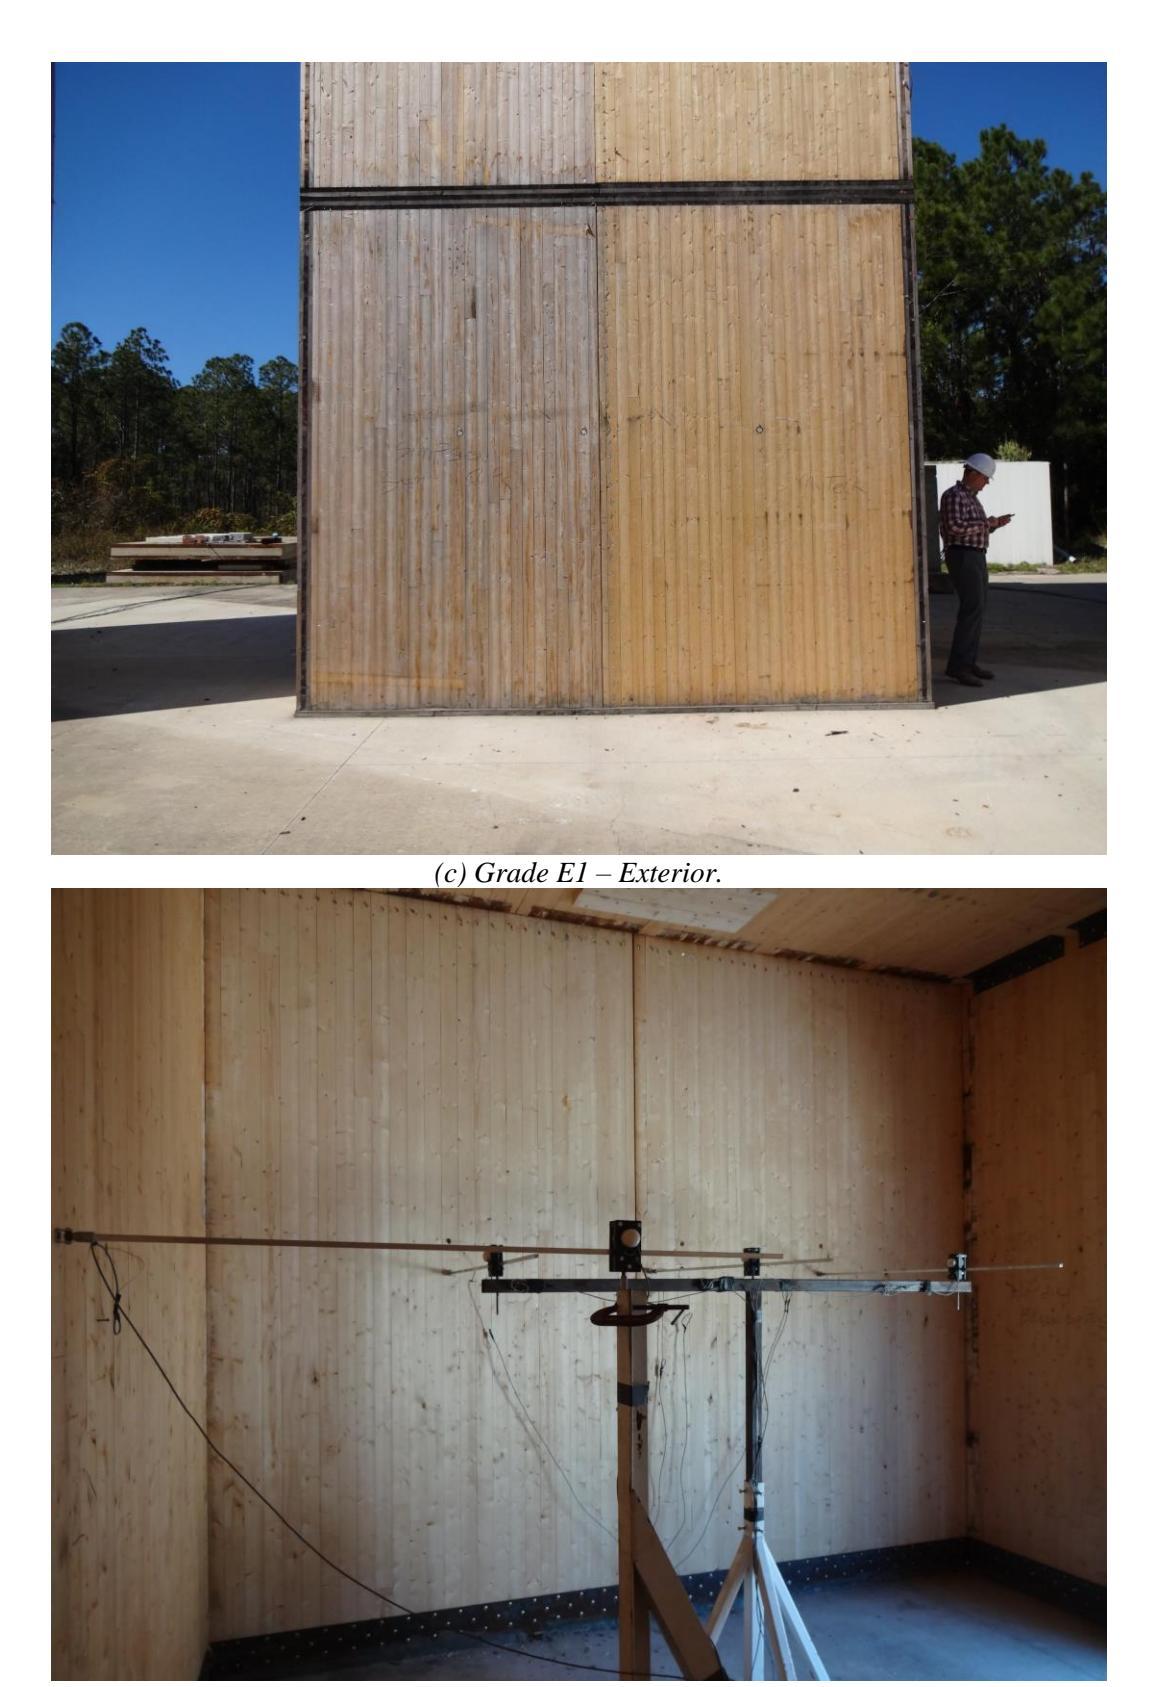
(d) Grade E1 – Interior. Figure 4-11. Test 6 Post-Test Photographs of First-Floor Front Panel. (Cont'd)

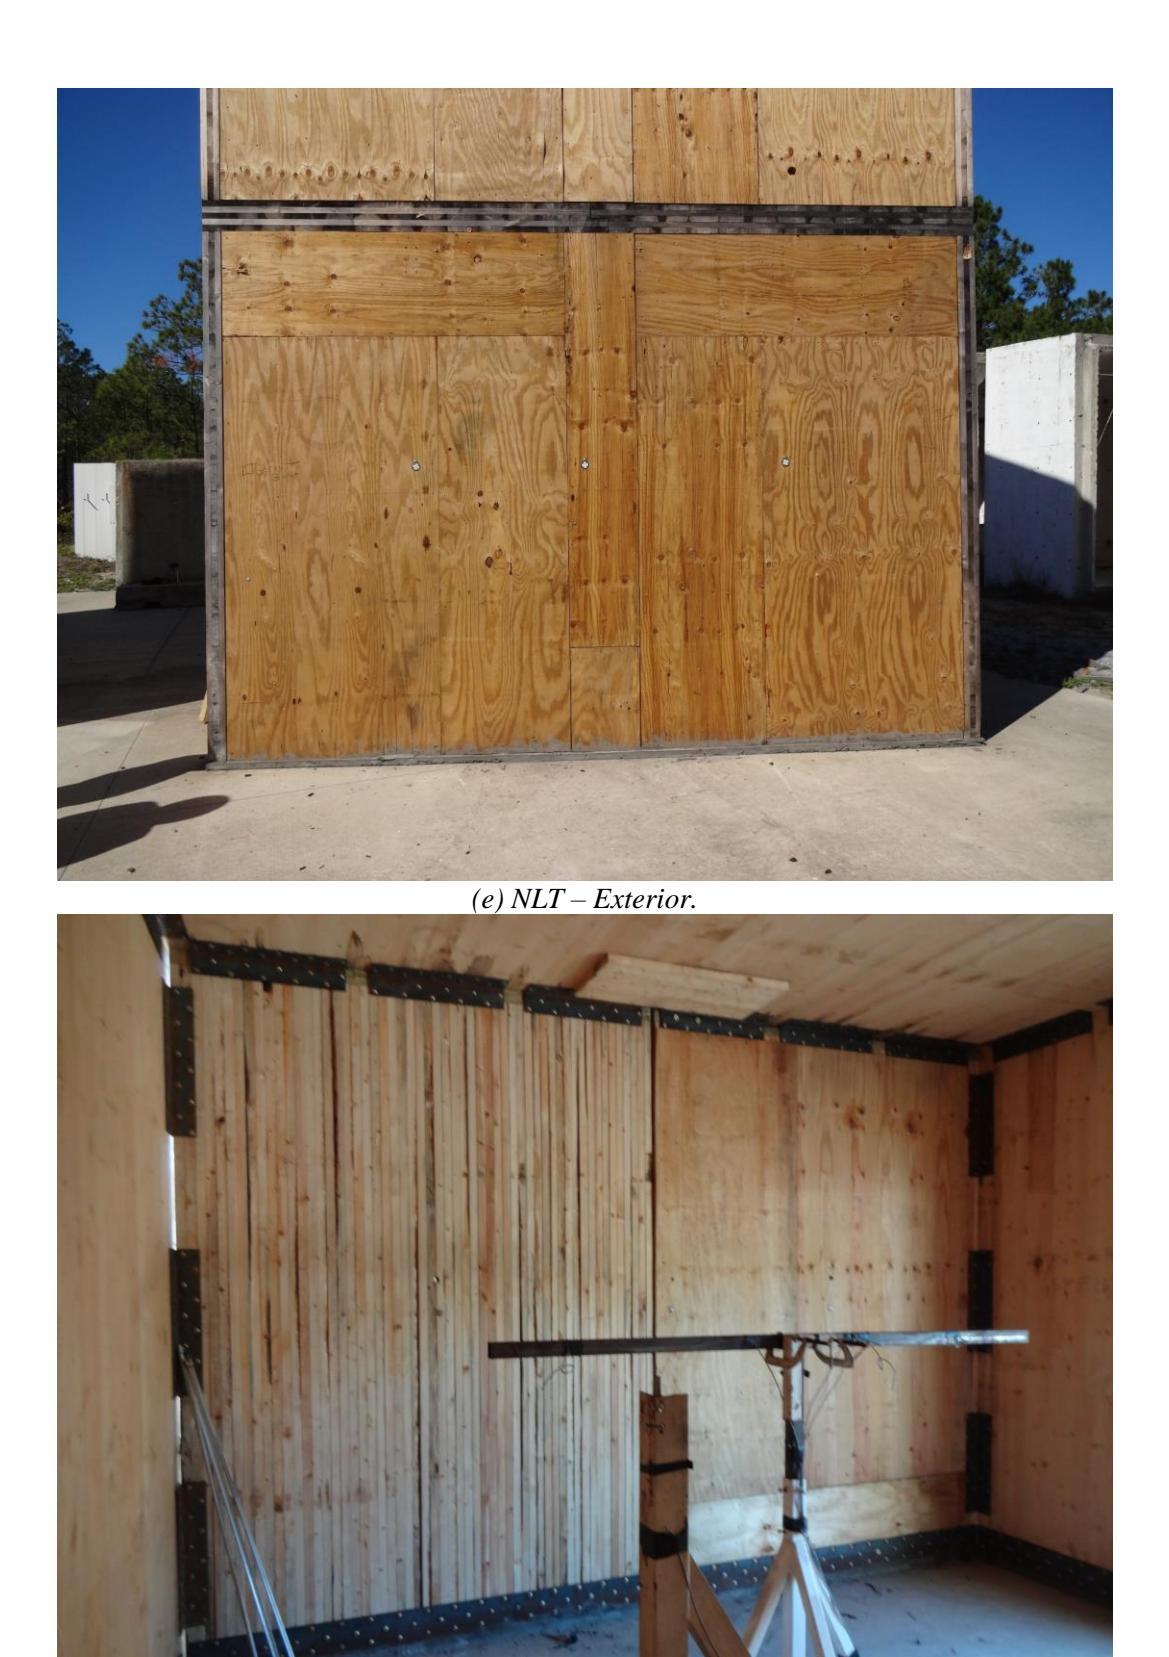
Test 6 was performed on the morning of October 26, 2017. No signs of damage to or permanent deformation in the constituent panels of the test structures with the CLT front walls were observed following Test 6. However, partial nail pullout was observed for the test structure with the NLT front walls at both the first and second floors (Figure 4-9). However, no nails pulled entirely out of the panel and full structural integrity remained intact (as plywood was not intended to contribute to bending capacity) at both test structure stories. No damage to the alternate connection configurations included in the Grade E1 CLT test structure was observed (Figure 4-10).

(f) NLT – Interior. Figure 4-11. Test 6 Post-Test Photographs of First-Floor Front Panel. (Cont'd)

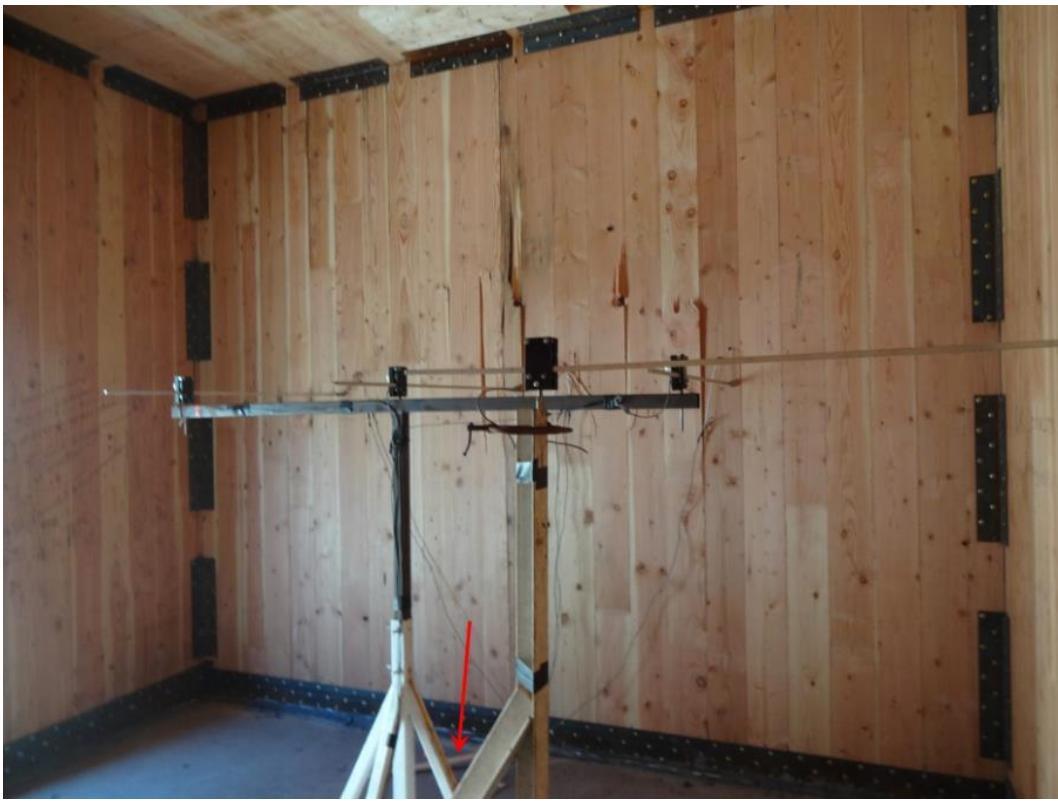
• **Front Wall**: Photographs documenting the damage to the 5-ply Grade V1 front wall panels are included in Figure 4-13. No damage was observed post-test at the exterior face of the front wall panels (Figure 4-13a). However, panel rupture over a significant portion of the wall at midspan was observed from the interior (Figure 4-13b and c). In addition, a few small pieces of debris were generated from the front wall panel rupturing (Figure 4-13b).

(b) Interior Face.
