# **RESULTS FROM PHASE 2 BLAST TESTS OF FULL-SCALE CROSS-LAMINATED TIMBER STRUCTURES**

Mark K. Weaver, S.E.<sup>1</sup> Charles Newberry, P.E.<sup>2</sup> Casey O'Laughlin, P.E.<sup>3</sup> Lisa Podesto, P.E.<sup>4</sup>

October 9, 2020

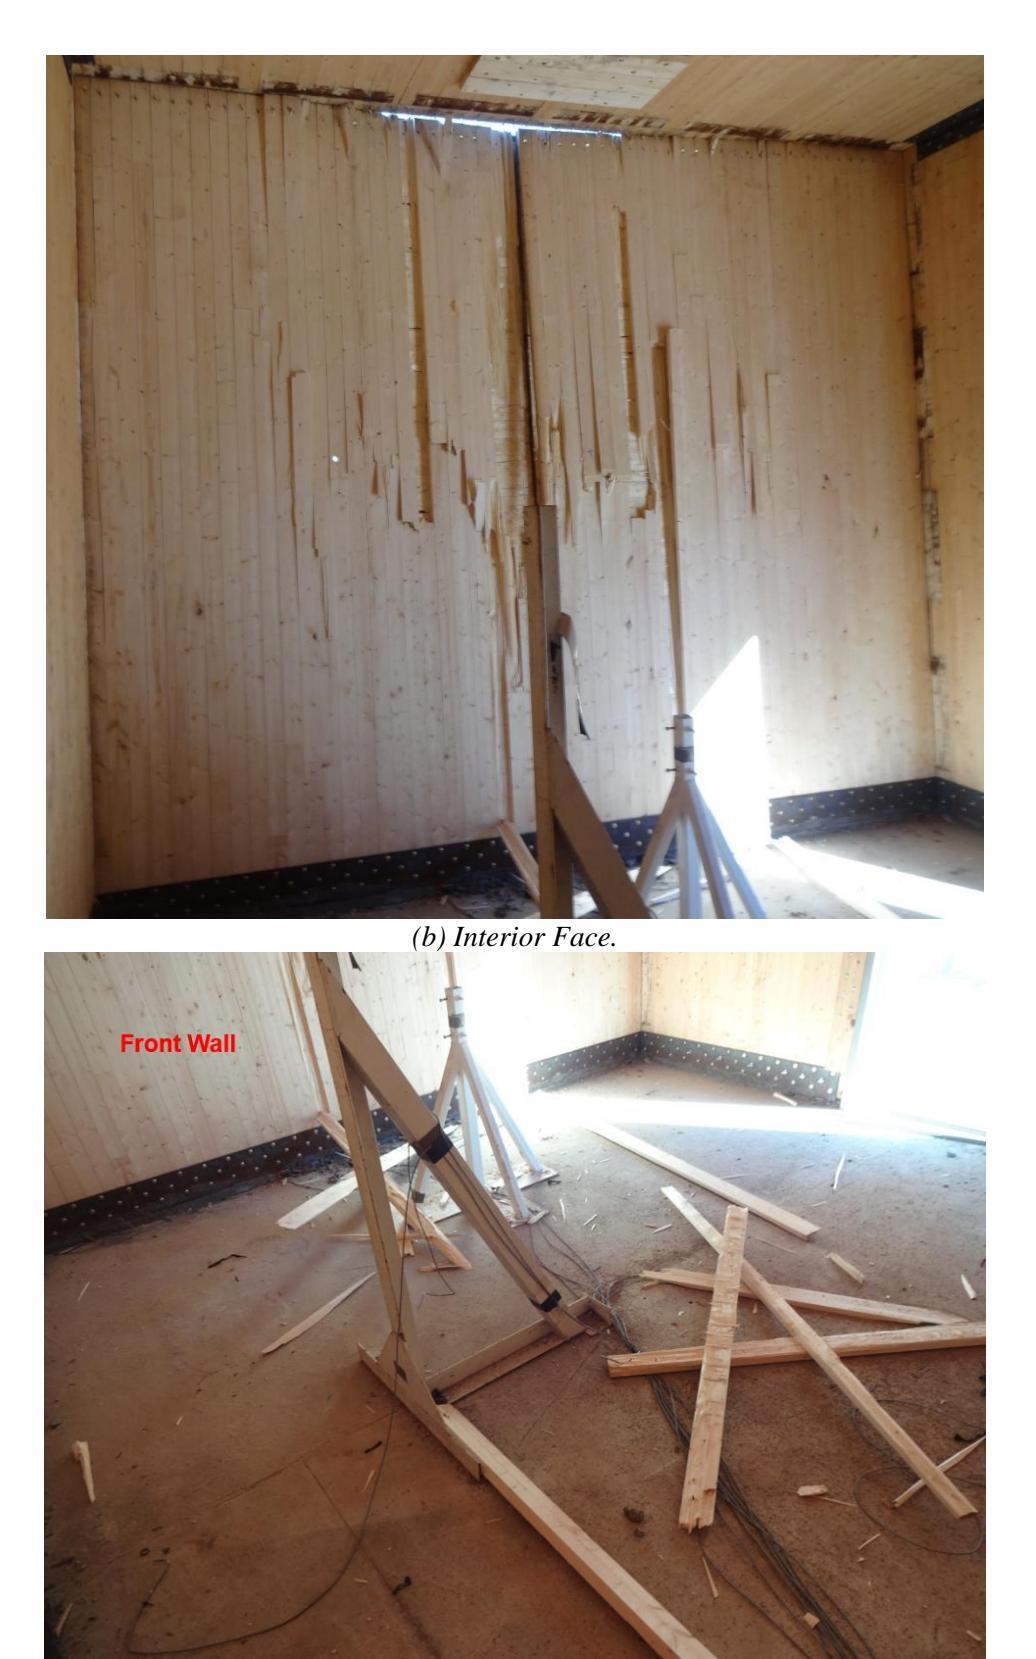
• Front Wall at First-Floor: Photographs documenting the damage to the 3-ply Grade E1 first-floor front wall panels are included in Figure 4-16. Significant damage was observed at the wall panel's exterior (Figure 4-16a) and interior (Figure 4-16b) faces at mid-span. Entire lamella separated on the interior face and were thrown into the interior space as debris (Figure 4-16c). Additionally, the screws connecting the first-floor wall panels to the first elevated floor pulled out of their respective "main member" panel (Figure 4-16d). One exception to this observation is indicated in Figure 4-16d. However, it should be noted that this screw was installed within 4D of an adjacent screw as shown in a pre-test photograph (Figure 4-16e). No damage was observed at the base angle connection (Figure 4-16f).

(c) Ground Inside Structure. Figure 4-16. Test 7 Post-Test Photographs of 1st Floor Front Wall Panels in Grade E1 Structure. (Cont'd)

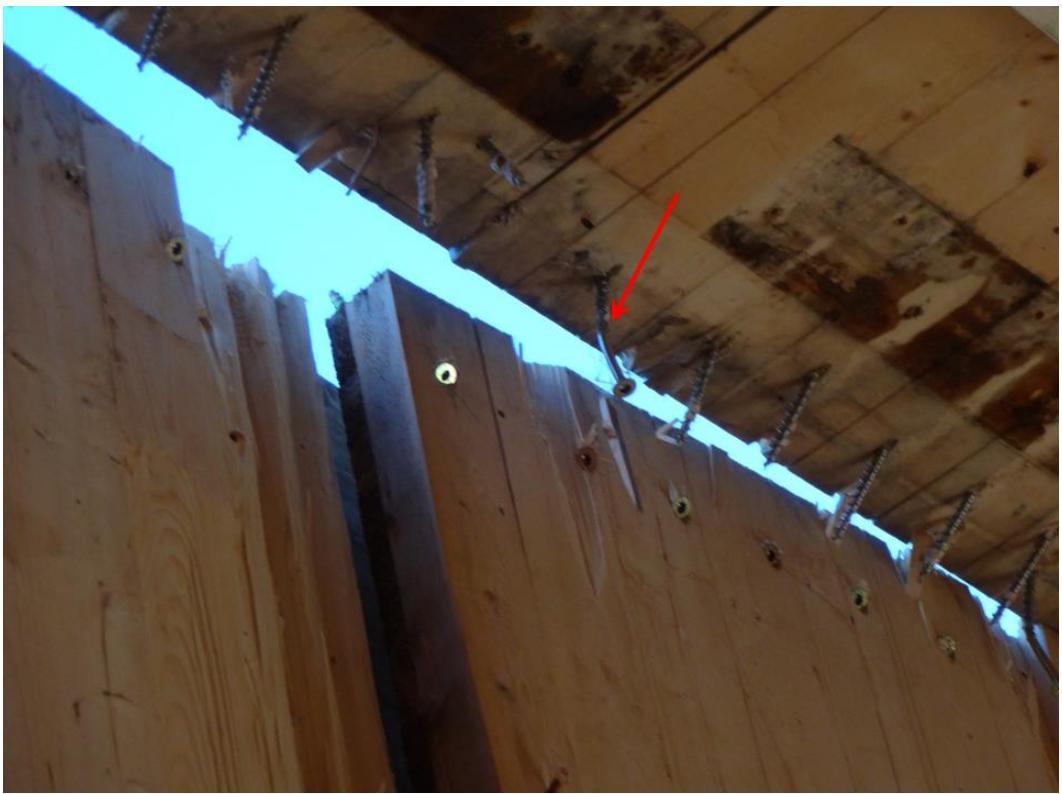
(d) Wall Panel at Top.

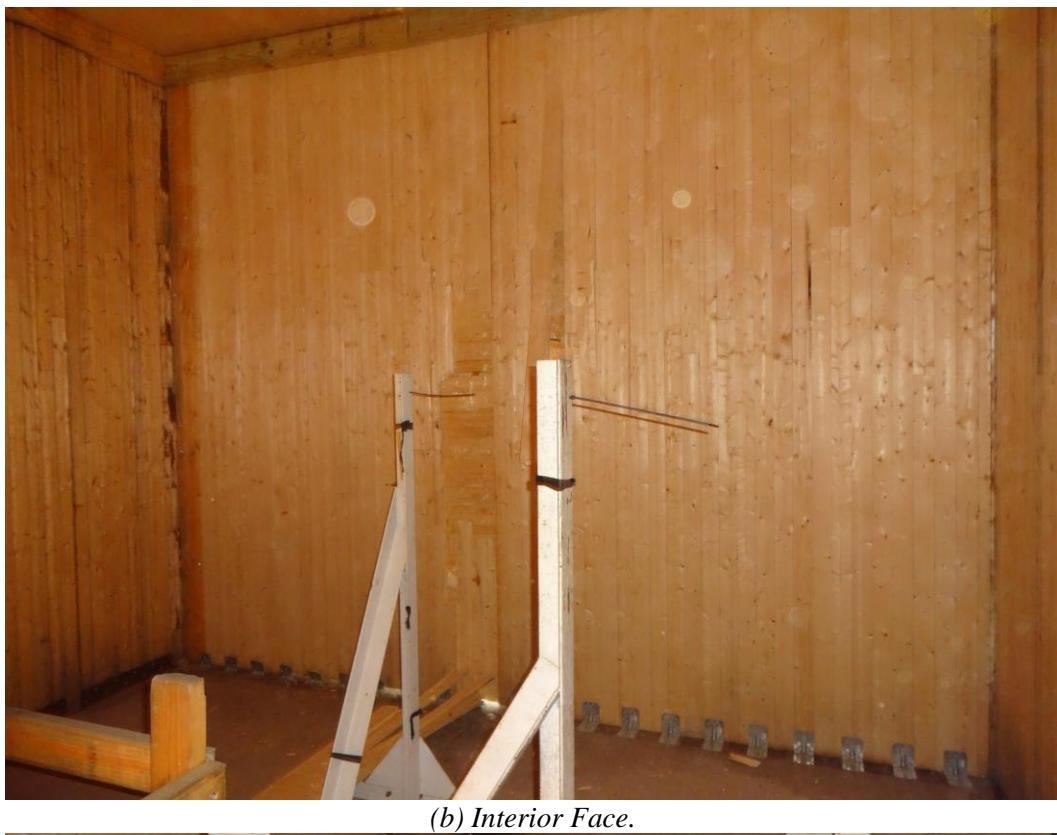
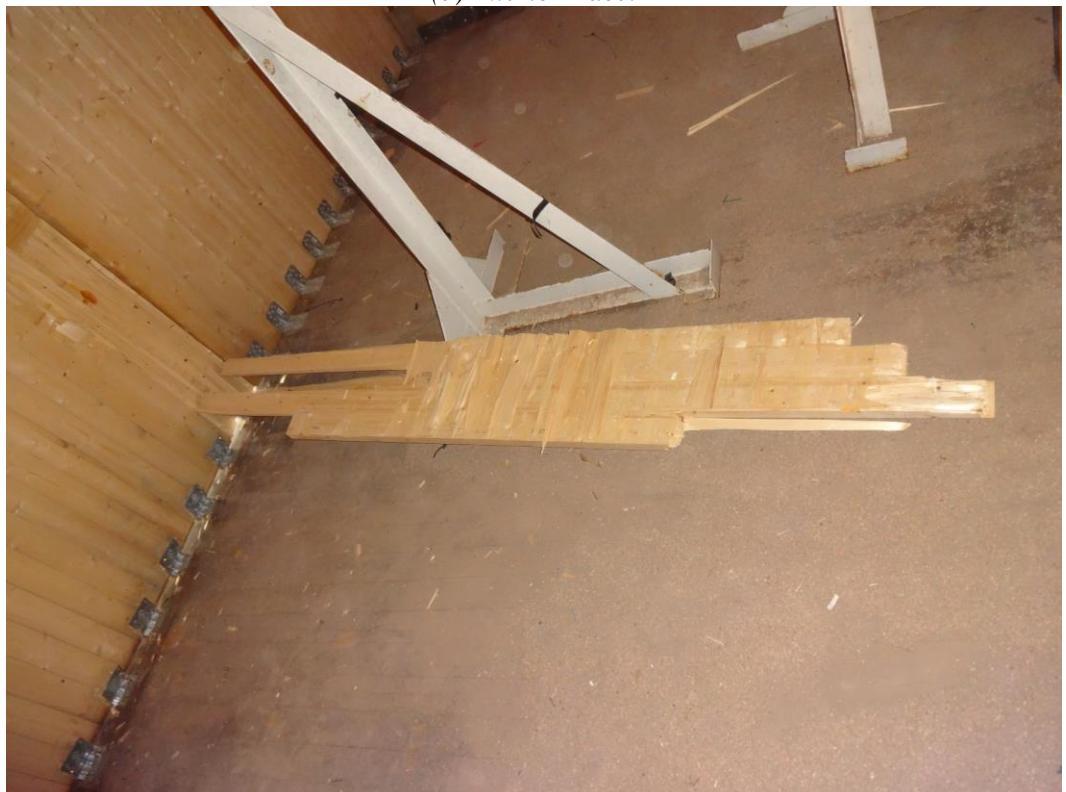
• **Front Wall at Second-Floor**: Photographs documenting the damage to the 3-ply Grade E1 second-floor front wall panels are included in Figure 4-17. While no damage was observed on the exterior face at the second-floor front wall panel (Figure 4-17a), several boards near mid-span of the wall separated at the glue line from the rest of the wall panel and fell straight down (Figure 4-17b and Figure 4-17c). No damage at the wall panel's connection was observed for the SST connection brackets (Figure 4-17d); however, significant angle yielding and fastener pullout were observed at the MiTek brackets. (It should be noted that due to a miscommunication, 1<sup>1</sup>/<sub>2</sub>-inch long screws rather than the specified 3<sup>1</sup>/<sub>2</sub>-inch long screws were installed with the MiTek angle. It is expected that the post-test result at this connection would be different in the event the longer screw was installed.)

(c) Delaminated Boards on Interior Face. Figure 4-17. Test 7 Post-Test Photographs of 2nd Floor Front Wall Panels in Grade E1 Structure. (Cont'd)

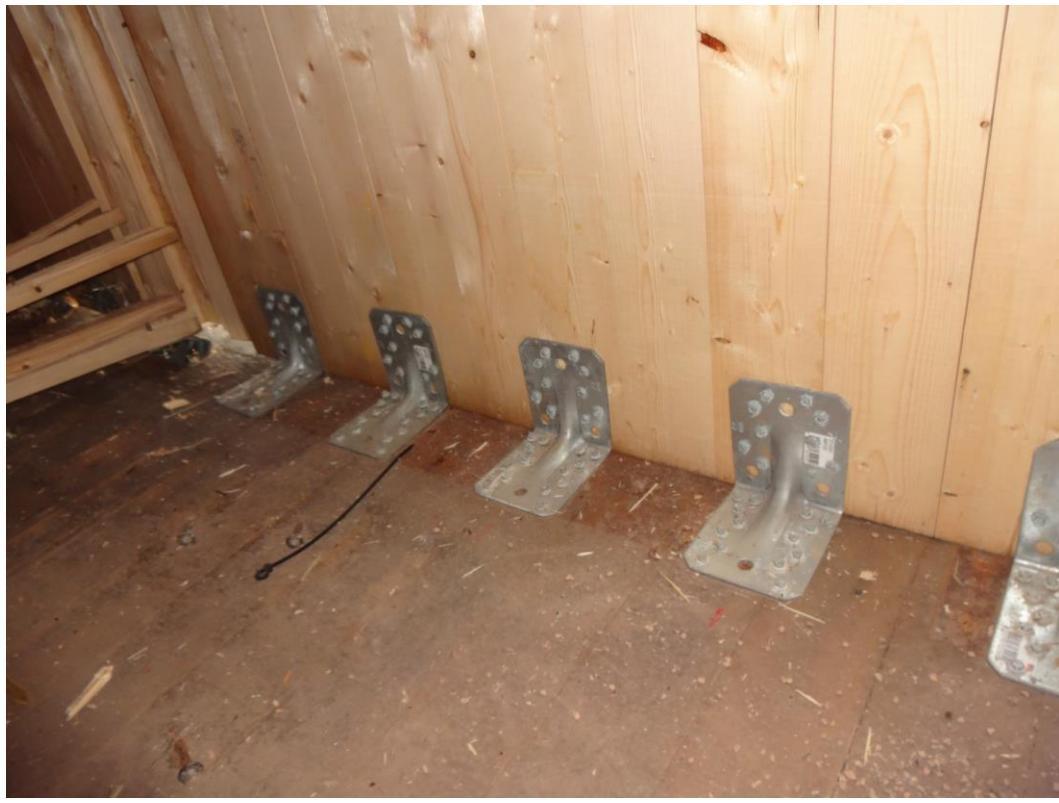
(d) SST Brackets.

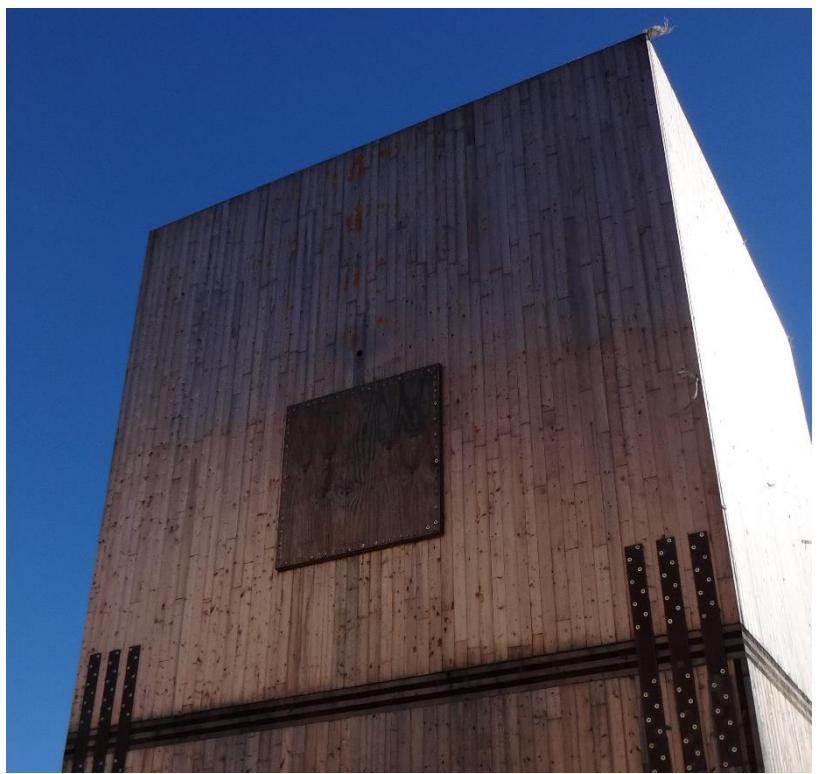
• Side Wall with Window: Photographs documenting the damage to the 3-ply Grade E1 window-side wall panels are included in Figure 4-18. Localized damage was observed on the exterior face of the first-floor side wall on the window side (Figure 4-18a). No corresponding damage was observed on the interior face at the first-floor. Additionally, no damage was observed at either the exterior or interior faces at the second floor (Figure 4-18b and c).

(b) 2<sup>nd</sup> Floor Exterior Face.

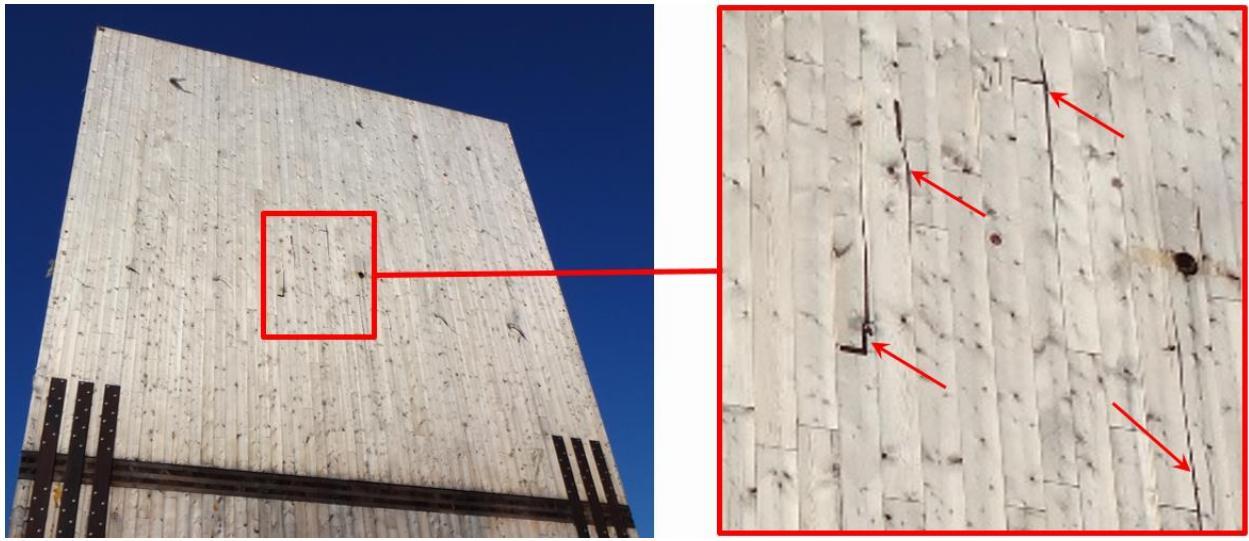
• Side Wall with Door: Photographs documenting the damage to the 3-ply Grade V1 doorside wall panels are included in Figure 4-19. Very localized damage in the CLT wall panel was observed on the exterior face near the top of the door frame (Figure 4-19a); however, no corresponding damage was observed on the interior face. Similarly, minimal damage was observed on the second-floor wall panel (Figure 4-19b) but no corresponding damage was observed on the interior face.

(b) 2<sup>nd</sup> Floor Exterior Face. Figure 4-19. Test 7 Post-Test Photographs of Door-Side Panels in Grade E1 Structure. (Cont'd)

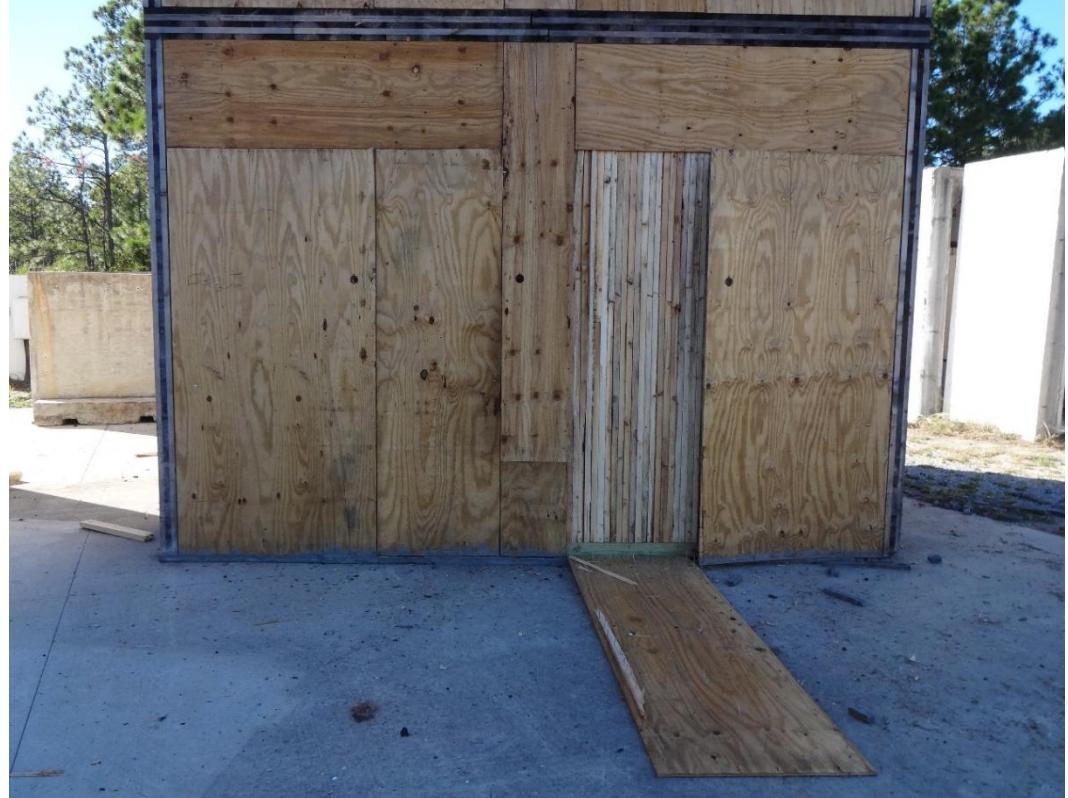
• Front Wall: Photographs documenting the damage to the 2x4 NLT first-floor front wall panels are included in Figure 4-20. For the half of the first-floor wall panel that did not have plywood sheathing on its interior face, significant damage was observed at panel mid-span (Figure 4-20a). Most of the 2x4 studs comprising the NLT panel were completely ruptured through (Figure 4-20b). Conversely, the portion of the NLT panel that had plywood sheathing did not appear to have ruptured studs (Figure 4-20c). At both the exterior and interior faces, plywood sheathing disengaged from the 2x members (Figure 4-20d, Figure 4-20e, and Figure 4-20f). Apart from the disengaged plywood, a small amount of timber debris, presumably from the ruptured 2x4 studs, was observed at the connections at the top and bottom of the wall, although several of the screws were slightly pulled out of the 2x laminations at the base angle (Figure 4-20h).

(d) Plywood Disengagement at Exterior Face – 1<sup>st</sup> Floor. Figure 4-20. Test 7 Post-Test Photographs of Front Panels in Grade V4 Structure. (Cont'd)

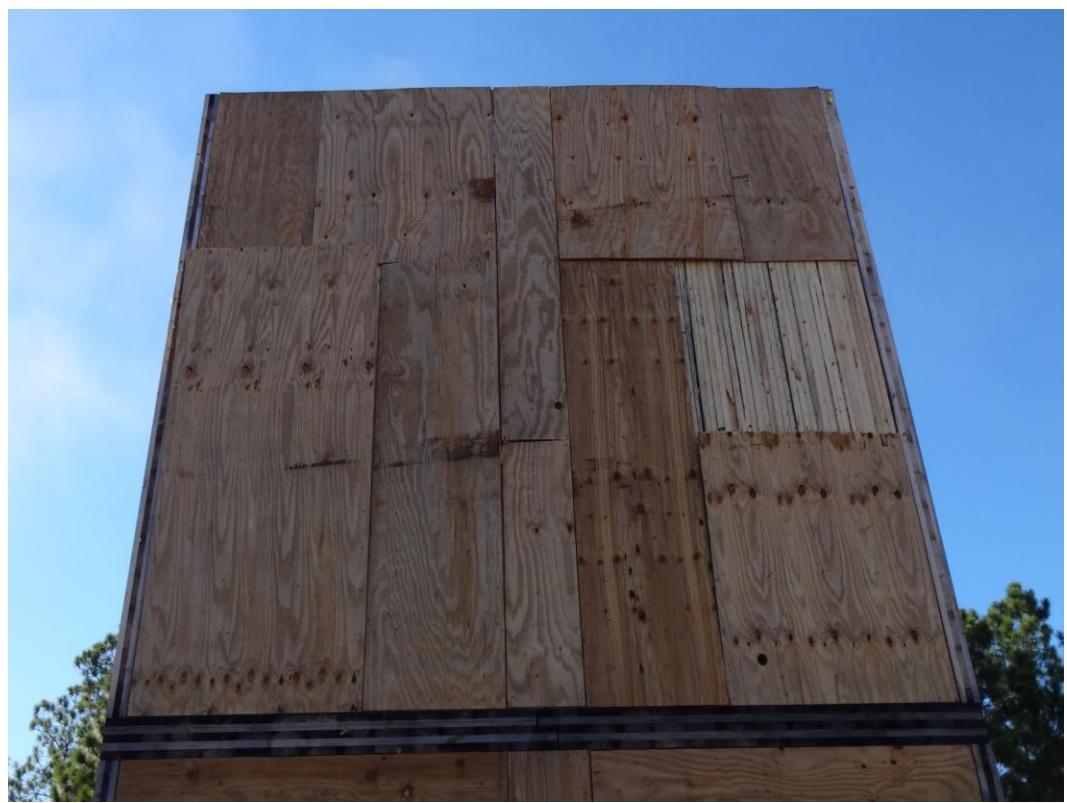
(e) Plywood Disengagement at Exterior Face  $-2^{nd}$  Floor.

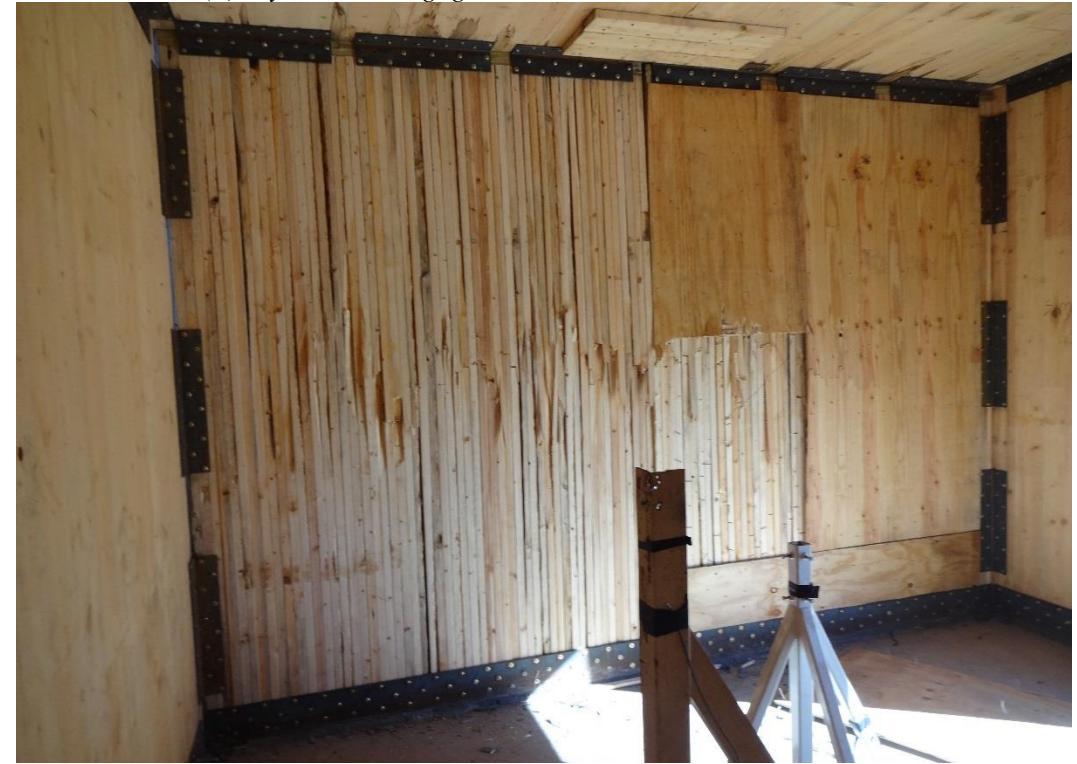
(f) Plywood Disengagement at Interior Face. Figure 4-20. Test 7 Post-Test Photographs of Front Panels in Grade V4 Structure. (Cont'd)

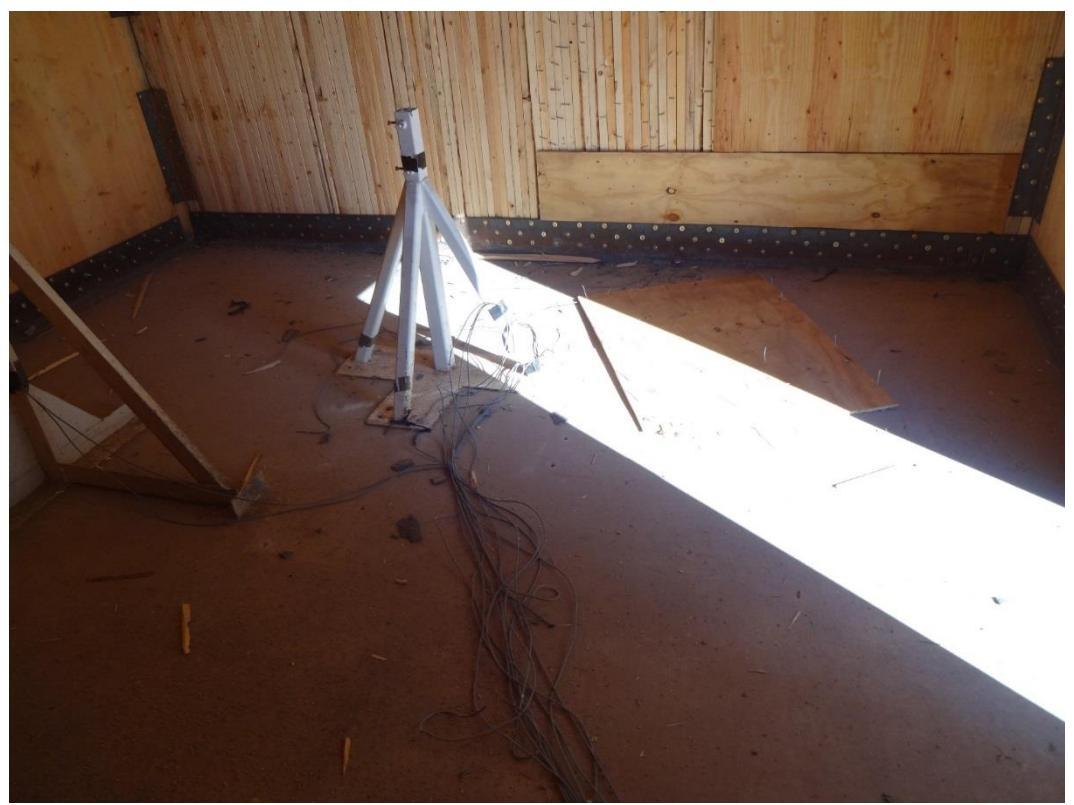
(g) Ground Inside Structure.

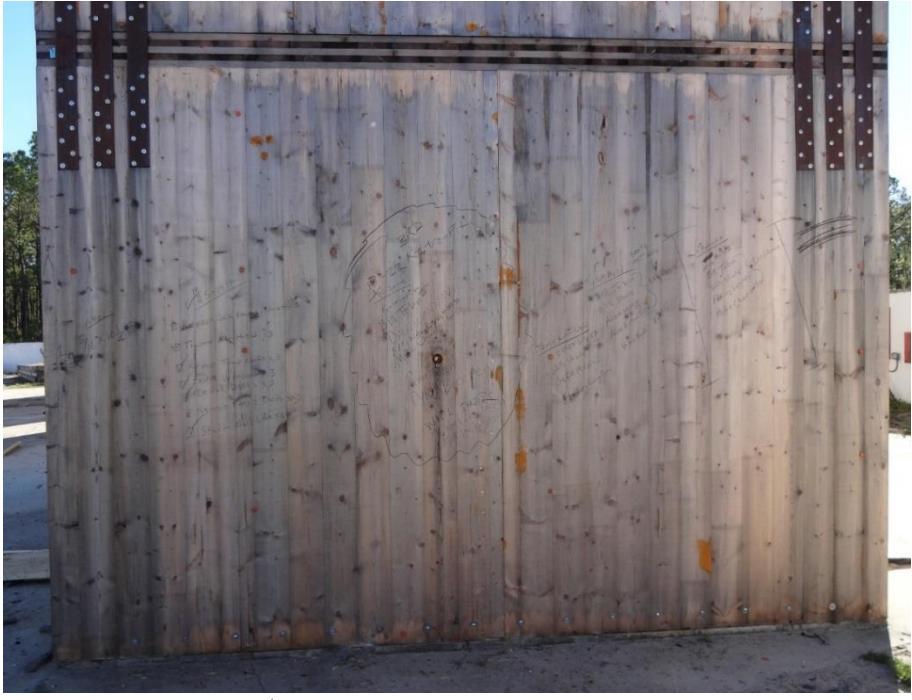
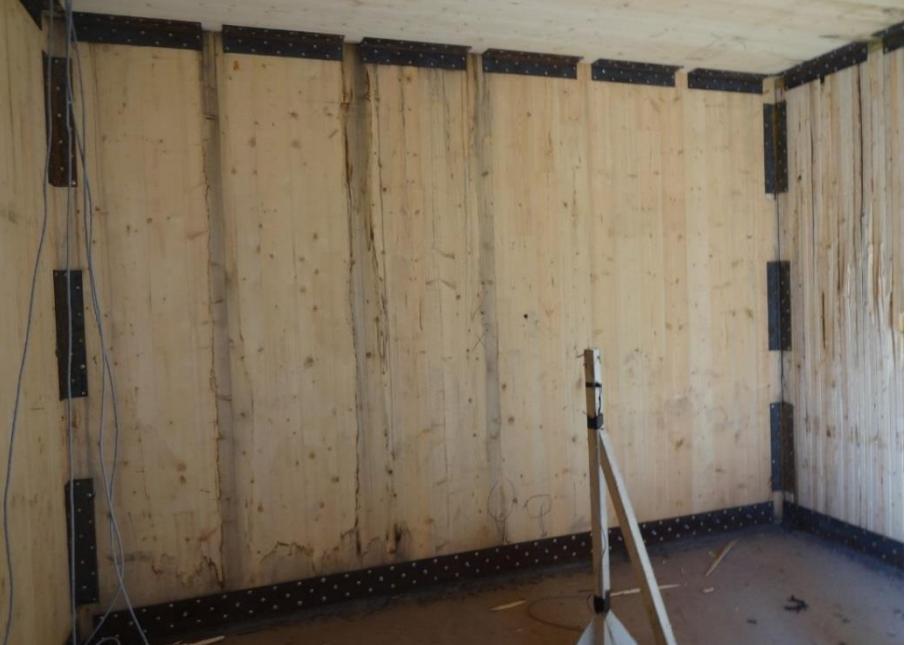
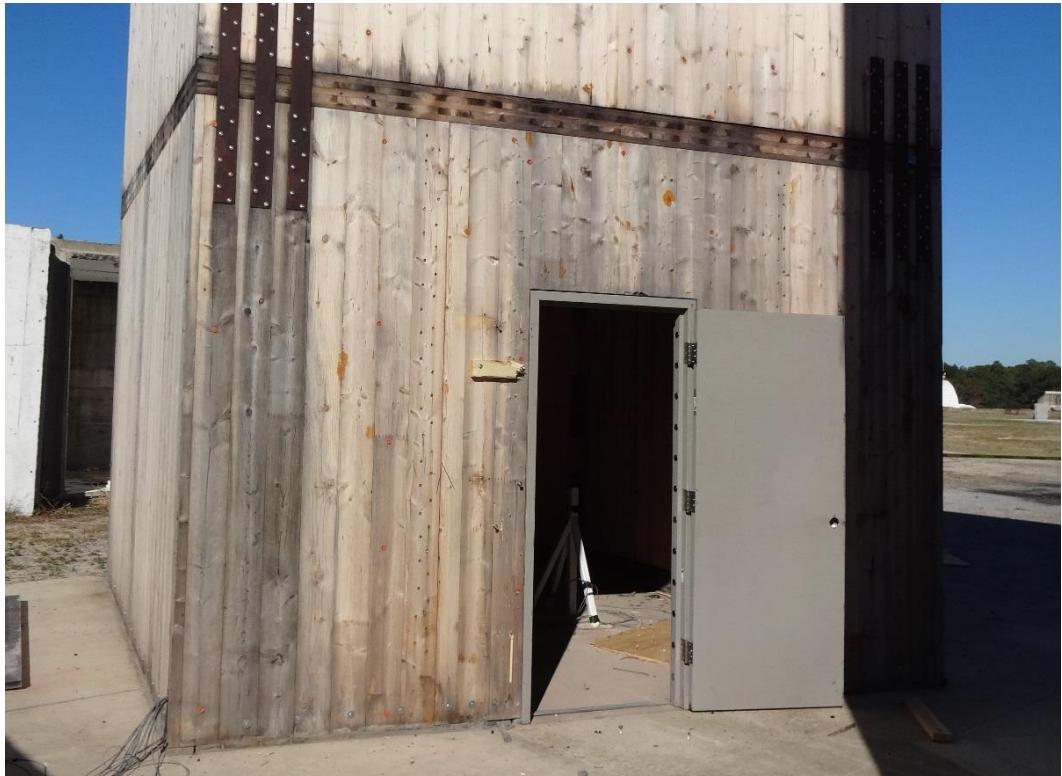
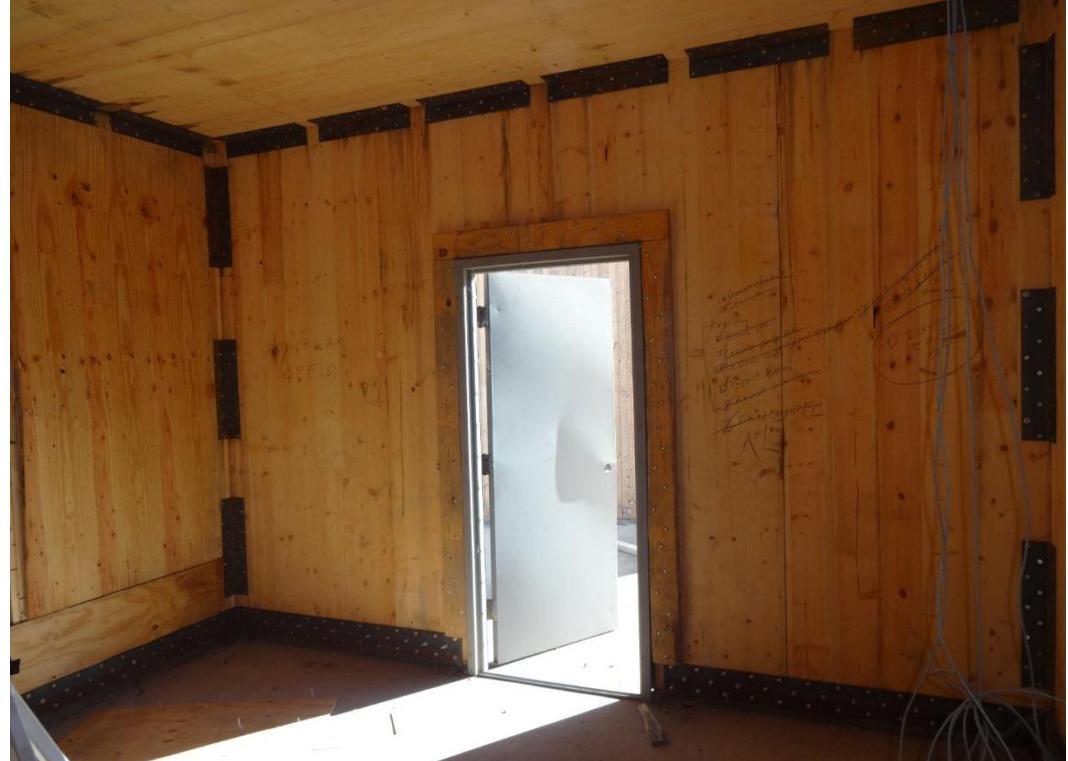
(h) Base Angle Connection. Figure 4-20. Test 7 Post-Test Photographs of Front Panels in Grade V4 Structure. (Cont'd) • Side Walls: Photographs documenting the condition of the 3-ply Grade V4 CLT side wall panels are included in Figure 4-21. Figure 4-21a and Figure 4-21b show the first-floor wall panel at the exterior and interior faces, respectively. Similarly, Figure 4-21c and Figure 4-21d show the first-floor wall panel at the exterior and interior faces, respectively. No damage to the side walls, either on the first or second floor, was observed at the conclusion of Test 7.

(a) 1<sup>st</sup> Floor Exterior Face – Window Side.

(b) 1<sup>st</sup> Floor Interior Face – Window Side. Figure 4-21. Test 7 Post-Test Photographs of Side Wall Panels in Grade V4 Structure.

(c) 1<sup>st</sup> Floor Exterior Face – Door Side.

(d) 1<sup>st</sup> Floor Interior Face – Door Side. Figure 4-21. Test 7 Post-Test Photographs of Side Wall Panels in Grade V4 Structure. (Cont'd)

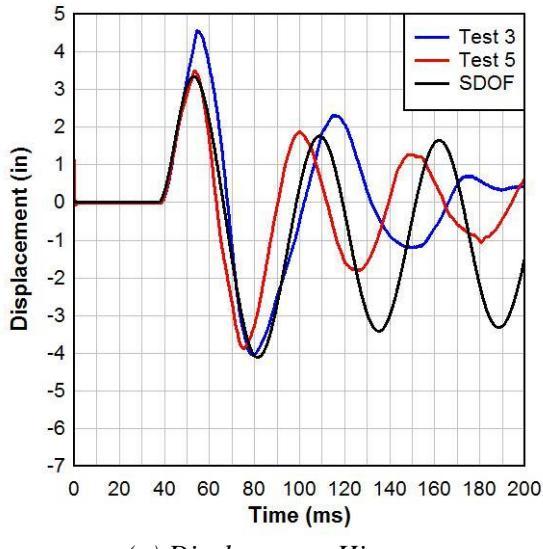
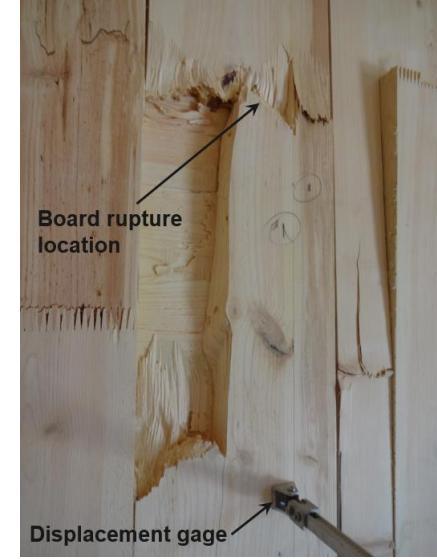
(a) Displacement History. (b) Test 3 Gage Location. **Figure 5-6. First-Floor Front Panel Comparison in Grade V4 Structure for Tests 3 & 5.**

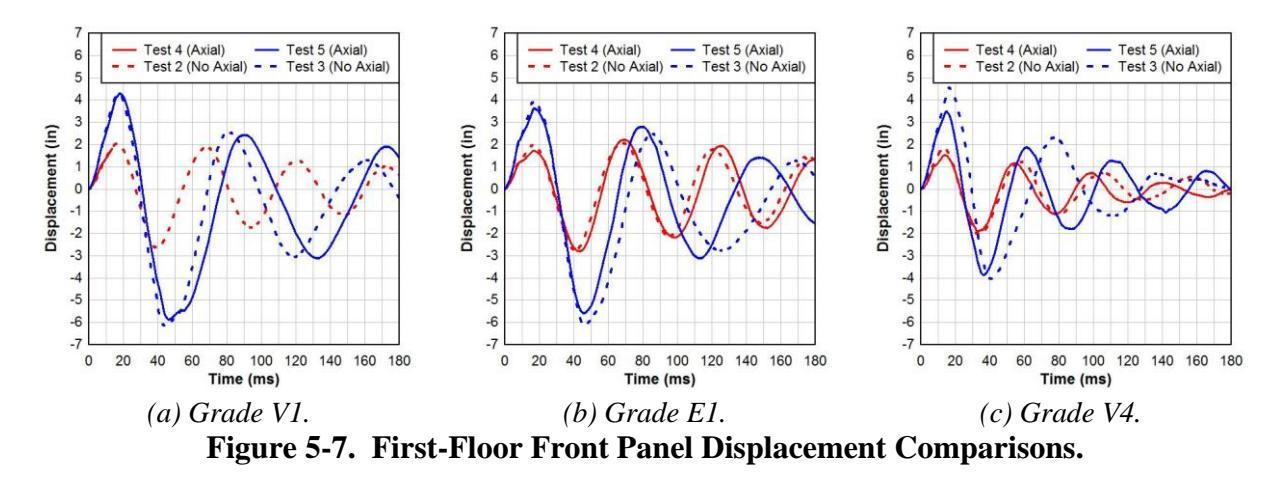
Figure 5-7 compares the first-floor front wall displacement histories obtained from the Phase 1 and 2 testing. As indicated by reviewing the displacements in Table 5-11, the recorded

displacement histories align well for all test structures given the Grade V4 structure caveat discussed above.

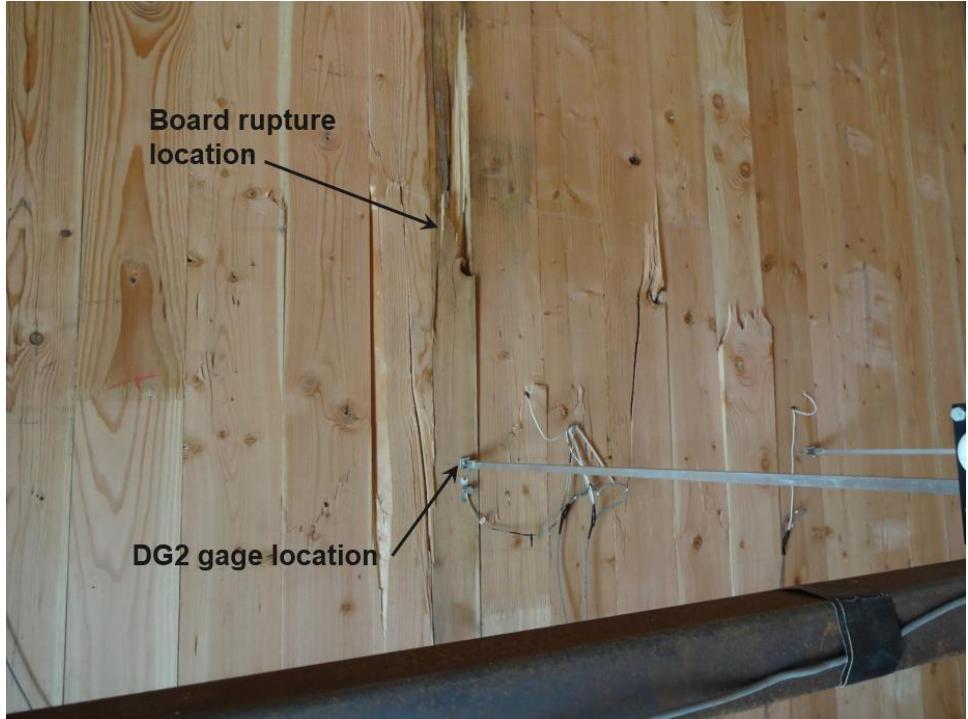
Figure 5-9. Location DG2 in 5-Ply Grade V1 First-Floor Front Wall Panel.

(1) In general, the elasto-plastic resistance function constructed using the SIF/DIF factors identified in this chapter well approximated, or was conservatively higher than, the initial inbound and rebound displacement responses of the 5-ply CLT wall panels for the blast loads associated with Tests 6 and 7 (Table 5-6). One notable exception is the first-floor front panel response at DG2 in Test 7. It is clear upon reviewing the displacement history in Figure 5-5a that the SDOF calculation fails to approximate this initial inbound displacement. However, as for the first-floor front panel gage in Test 3, the DG2 gage is located on a board that ruptured during Test 7 (Figure 5-9) and it is possible that the board locally deflected more than the wall as a result. More testing on 5-ply CLT panels that are brought to failure should be conducted to further assess the robustness of the SDOF model for 5-ply panels in the post-peak realm.

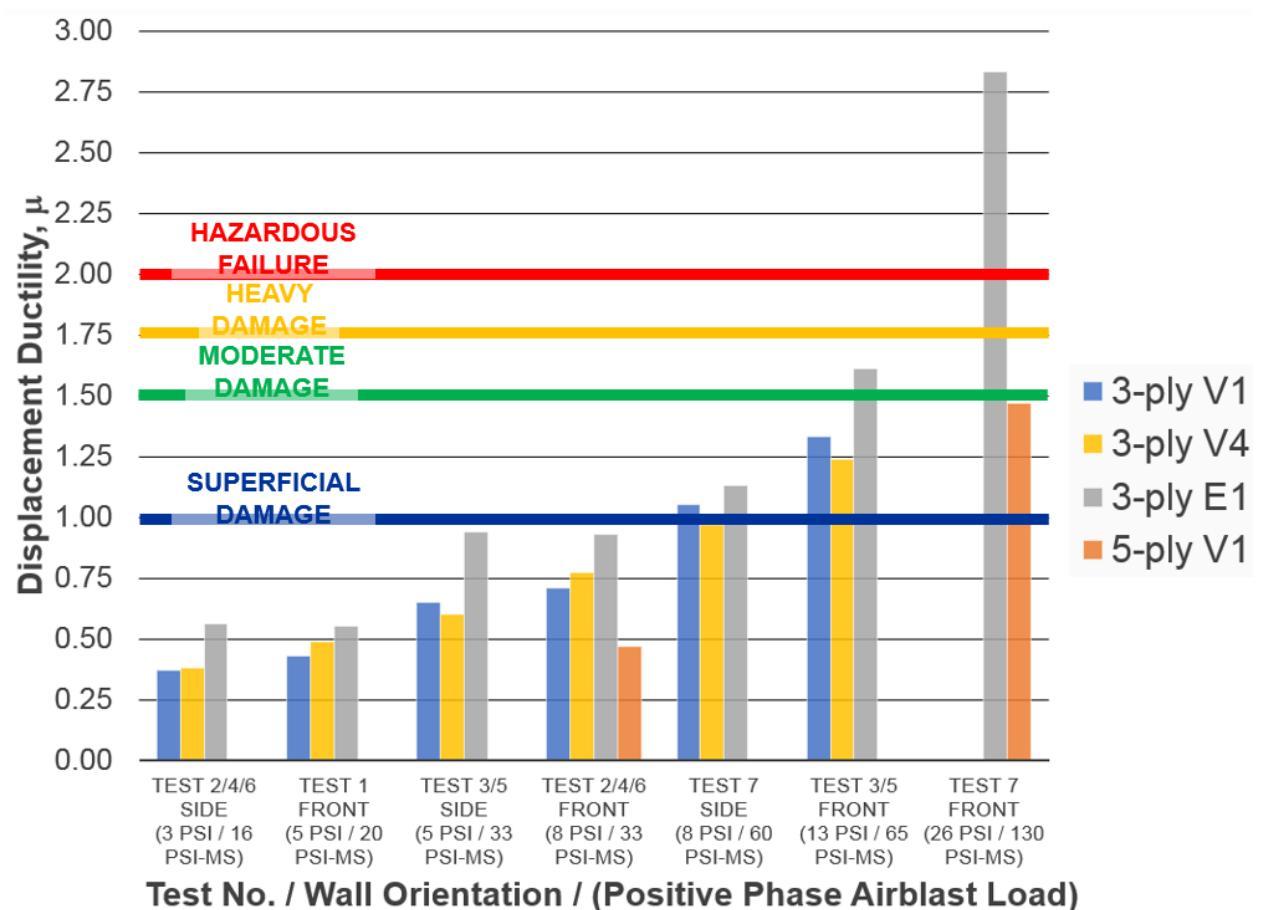
Figure 6-1. Applied Blast Load vs. Computed Displacement Ductility with PDC-TR 06-08 Component Damage Levels Indicated.

Using the pressure histories recorded during Tests 1 through 7 as the input blast loads and the resistance function generation process, SIFs, and DIFs documented in Section 5.2, a bar chart can be constructed that plots computed displacement ductility of the first-floor front and side wall panels across a spectrum of blast loads. In addition, this plot designates where the PDC-TR 06-08 component damage levels fall.

- Superficial Damage ( $\mu < 1.0$ ): When the computed displacement ductility is less than one, no visual signs of damage were observed in the CLT wall panels.
- Moderate Damage  $(1 \le \mu < 1.5)$ : The extent of the damage observed in most of the front wall panels following Tests 3, 5, and 7 was limited and localized near midspan. It is thought that such wall panel could be repaired relatively easily with additional lumber boards and/or thin gauge steel plates.
- Heavy Damage  $(1 \le \mu < 1.75)$ : No examples matching the "heavy damage" description appear in the testing performed. This response limit is simply placed halfway between the "moderate damage" and "hazardous failure" component damage levels.
- Hazardous Failure  $(1.75 \le \mu < 2)$ : The displacement ductility value of 2 is based on the reasoning included in Section 2.6 of this report.

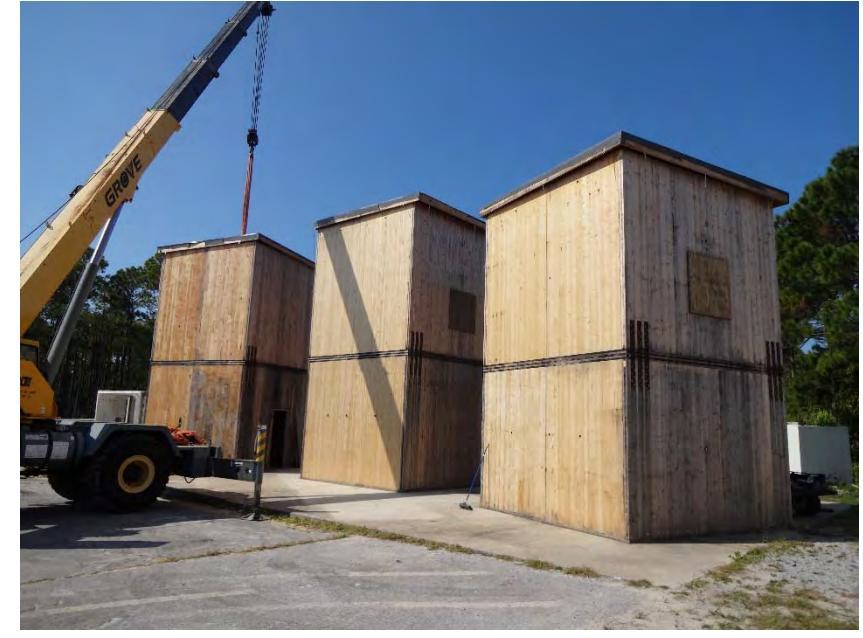
## **Full-Scale Validation #4**

Pre-test/Post-test\*

\*Also indicative of post-test condition. Structures remained elastic

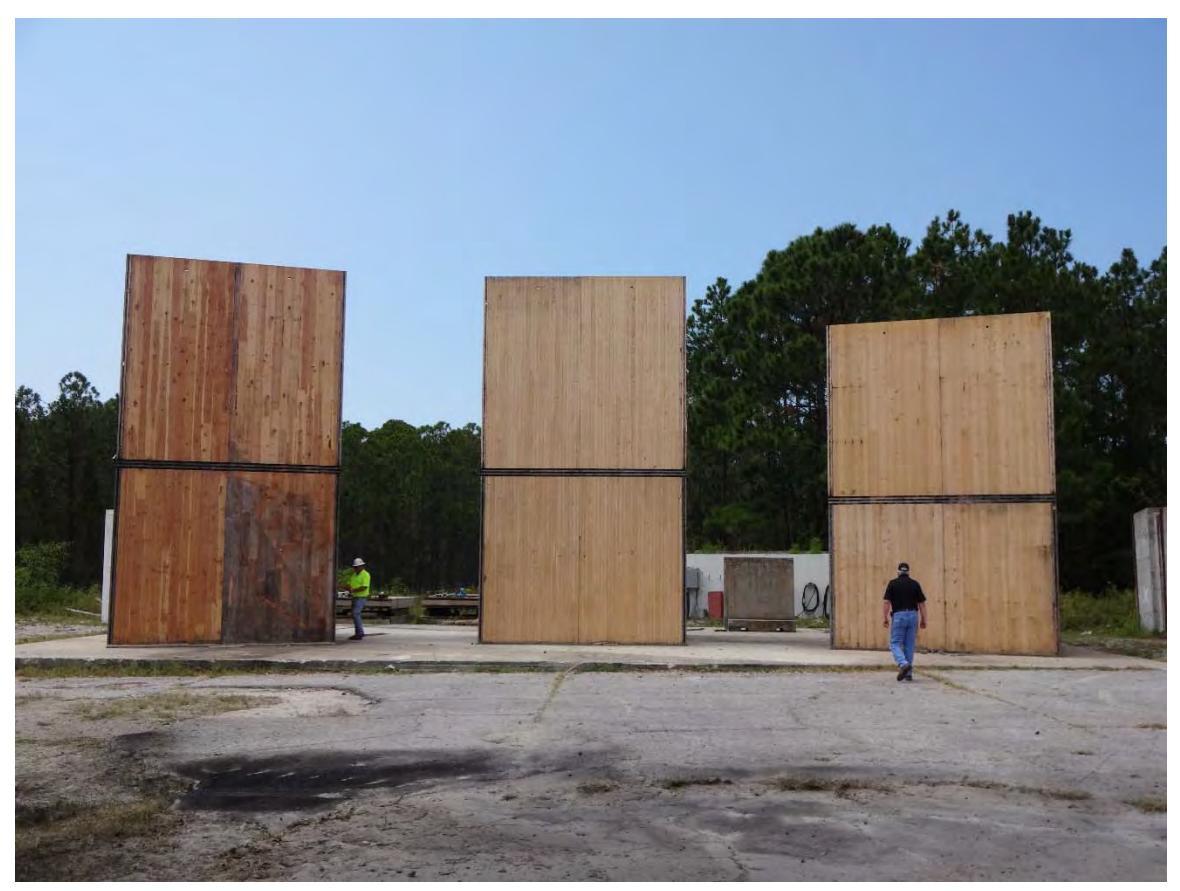
## **Full-Scale Validation #5**

Post-test
