Expert Tips

Splicing Shear Wall Top Plates at Wall Discontinuities

Design and detailing considerations to ensure appropriate transfer of loads across shear wall and diaphragm chords/collectors.

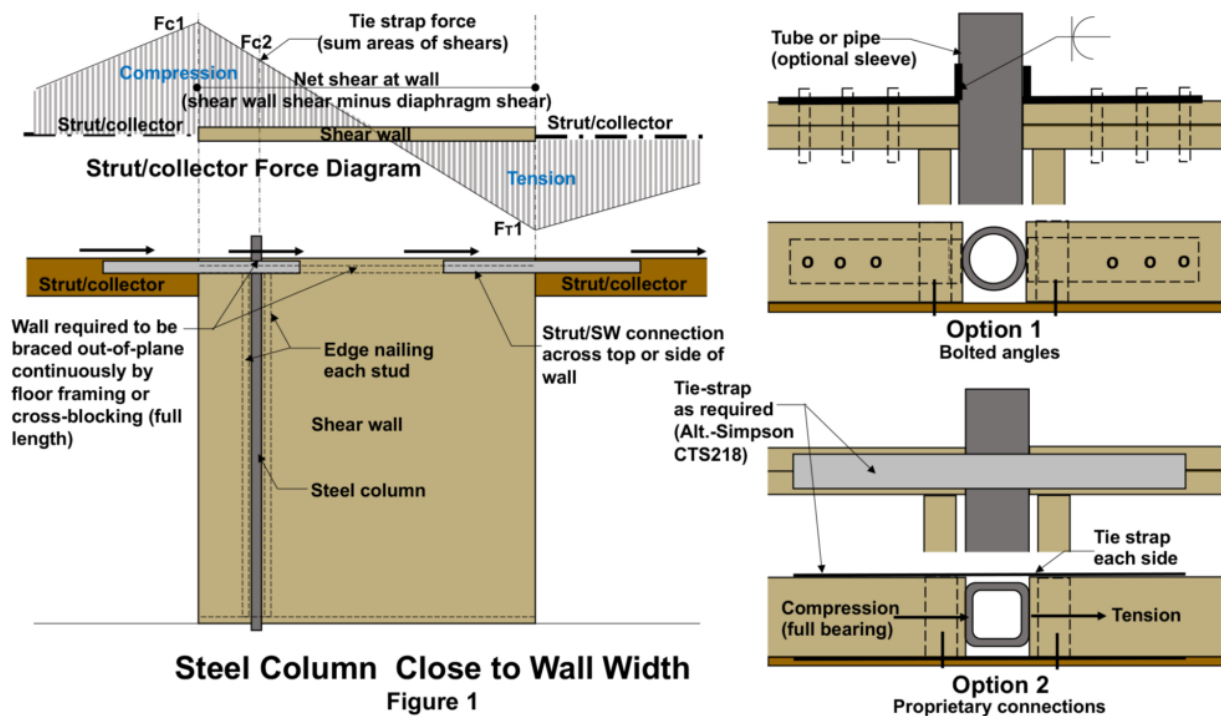
determining the net shear acting along the shear wall (shear wall shear minus the diaphragm shear), then constructing a force diagram as shown in Figures 1 and 3 below. The wall sheathing cannot be used to splice the wall top plates at these locations, in accordance with the American Wood Council's Special Design Provisions for Wind and Seismic (SDPWS) Section 4.1.4.

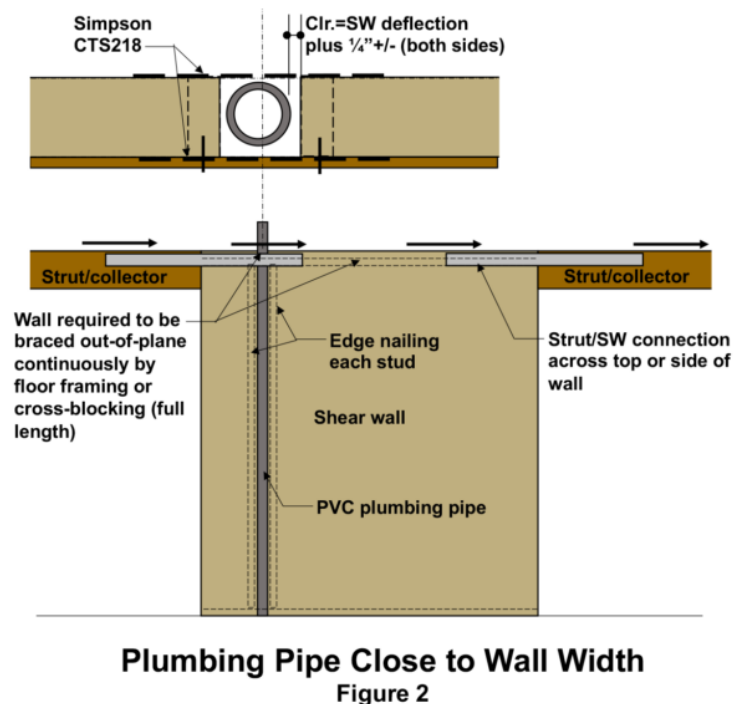
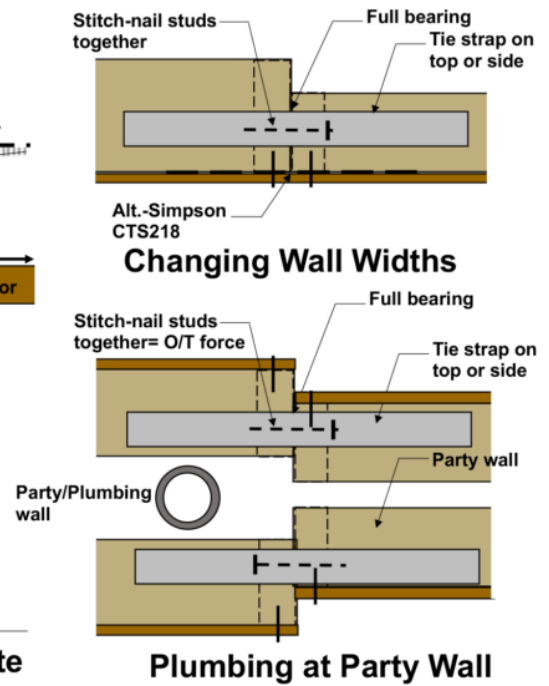
Suggested detailing showing possible solutions for shear wall top plate discontinuities are shown below. These details are generic, and other methods can also be used. For assistance on shear wall designs, including discontinuities, contact your local WoodWorks [Regional Director](#) or email our help desk at help@woodworks.org.
