## **Compartment Fire Testing For Exposed Wood in Tall Timber Structures**

Jason Smart, PE Manager, Engineering Technology American Wood Council jsmart@awc.org

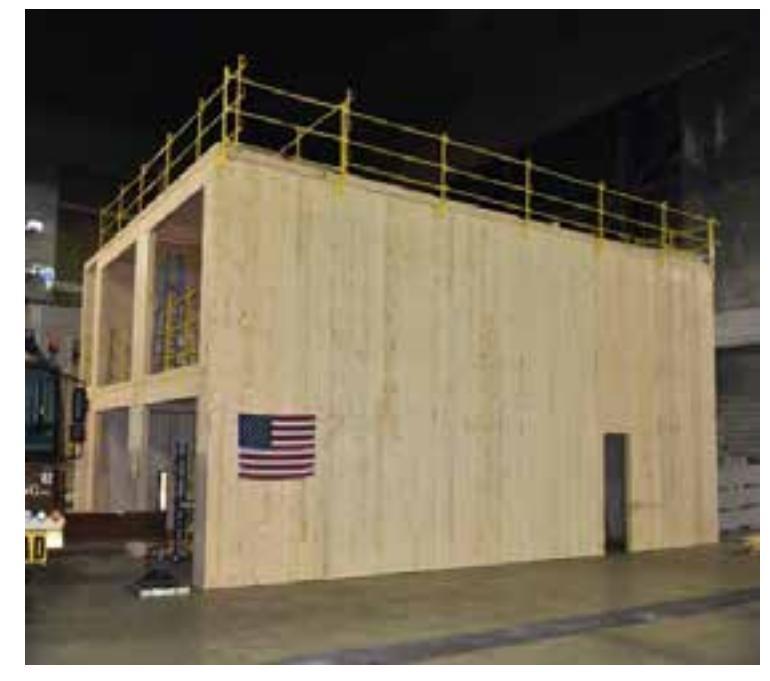
- Large test structure (multi-story)
- 30' x 30' interior dimensions
- Fuel load of 570 MJ/m<sup>2</sup>; 85<sup>th</sup> percentile for residential
- Tests 2 & 3: Exposed mass timber on ceiling and walls
- Exposed areas targeted safe levels based on materials available at the time
- Code limits were established based on these tests
- However, materials have evolved since the tests, and exhibit better fire performance now

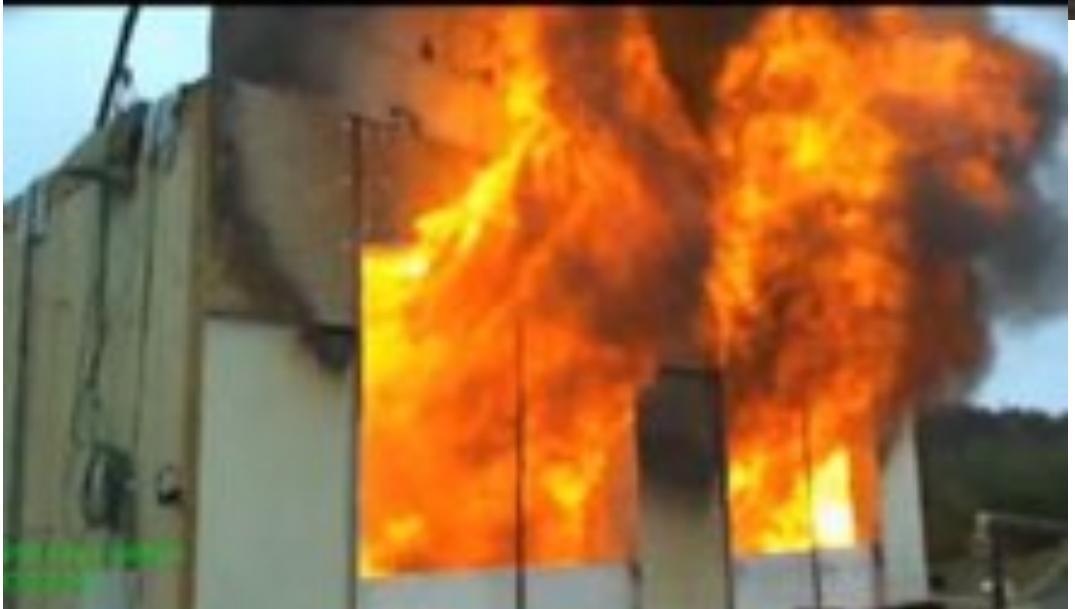
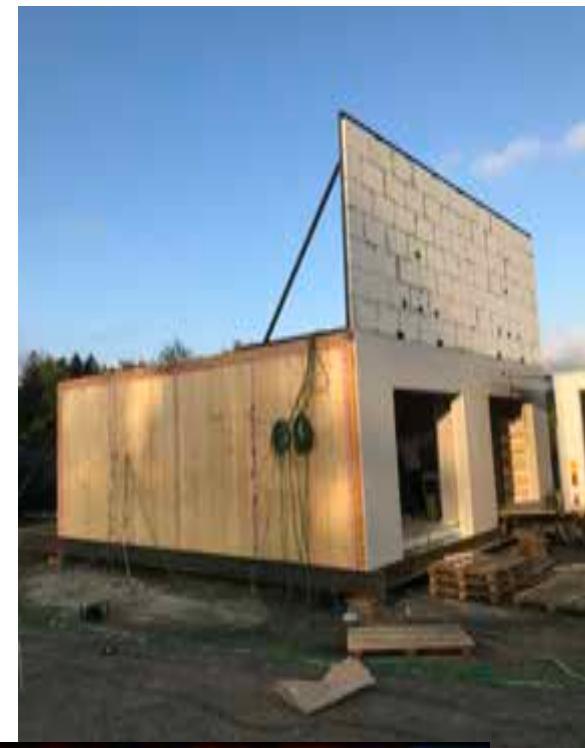
# Similar to compartment tests in 2018, EXCEPT:

- Using PRG 320-18 compliant CLT
- Enhanced fire performance
- Increased areas of exposed mass timber

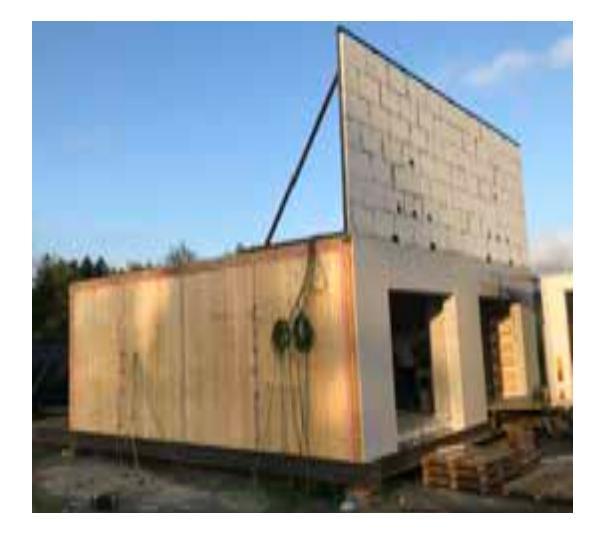
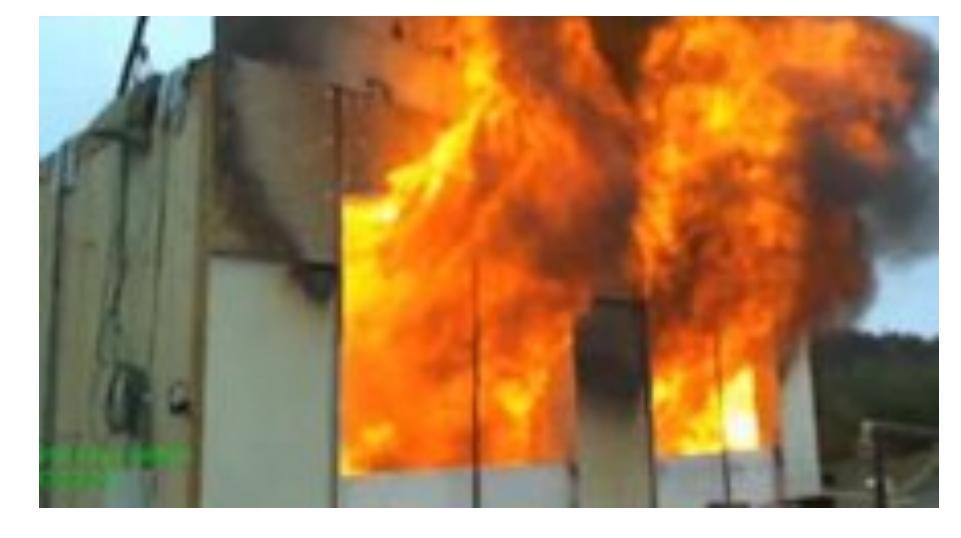
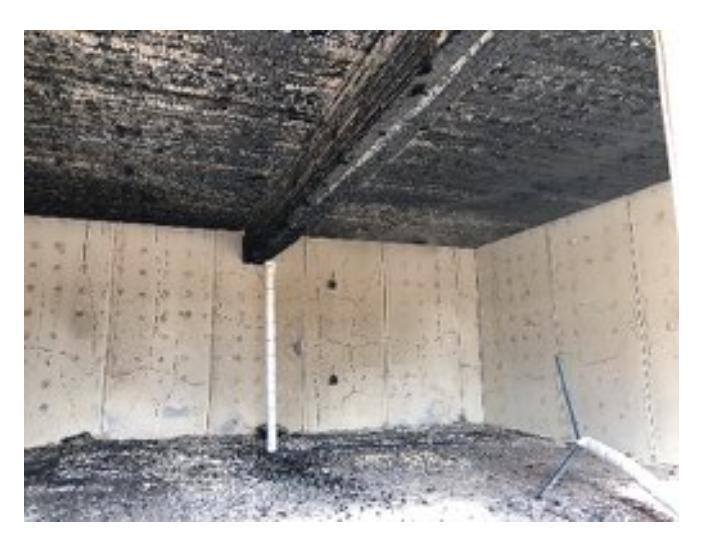
Test Number	Description	Result
Test 1	Two openings; ceiling exposed	No fire re-growth; "passing" criteria met
Test 2	Two openings; ceiling and two opposing walls exposed	No fire re-growth; "passing" criteria met
Test 3	Two openings; ceiling, two opposing walls, and front walls exposed (protection only on back wall)	Fire re-growth at 3.5 hours; "passing" criteria not met
Test 4	Six openings; ceiling, two opposing walls, and front walls exposed (protection only on back wall)	No fire re-growth; "passing" criteria met
Test 5	Repeat of Test 3, but with small, strategically placed areas of protection on walls	No fire re-growth; "passing" criteria met
